## **CITY OF MERRITT**

### **2015 MERRITT BRIDGE INSPECTION REPORT**

**Issued: December 15, 2015**

**WATSON ENGINEERING LTD.**

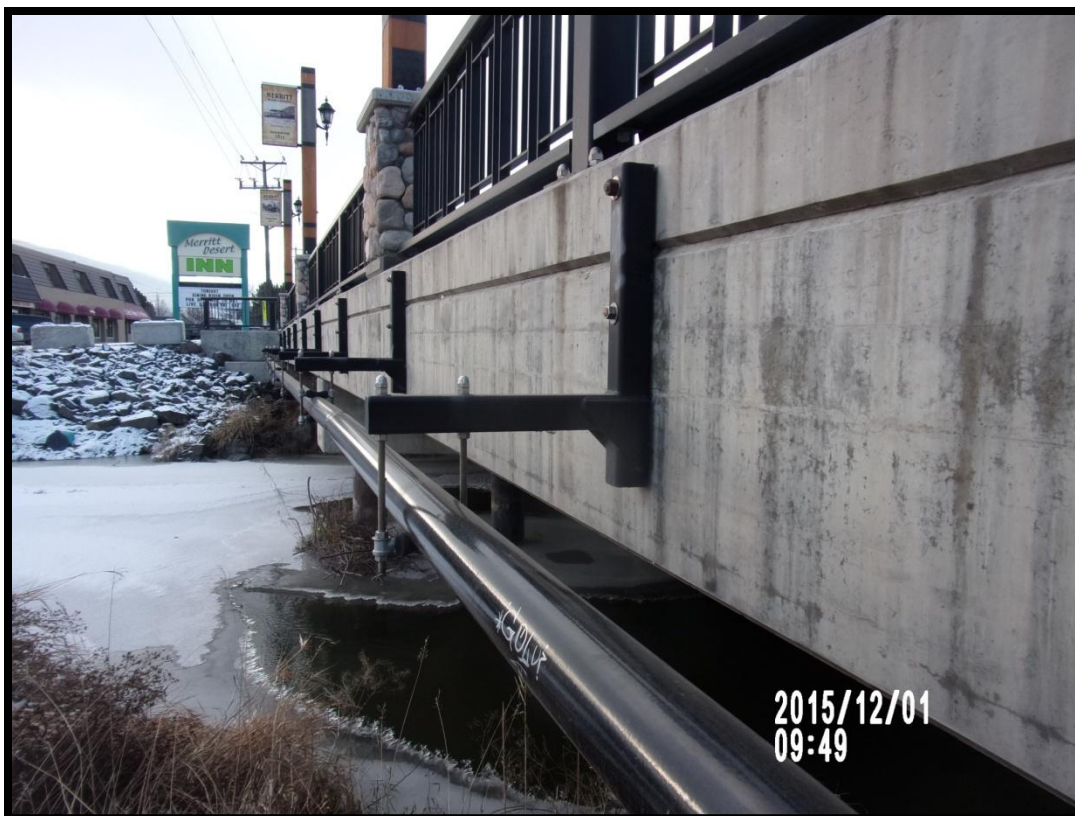
Photo #9. Gasline On South Side.

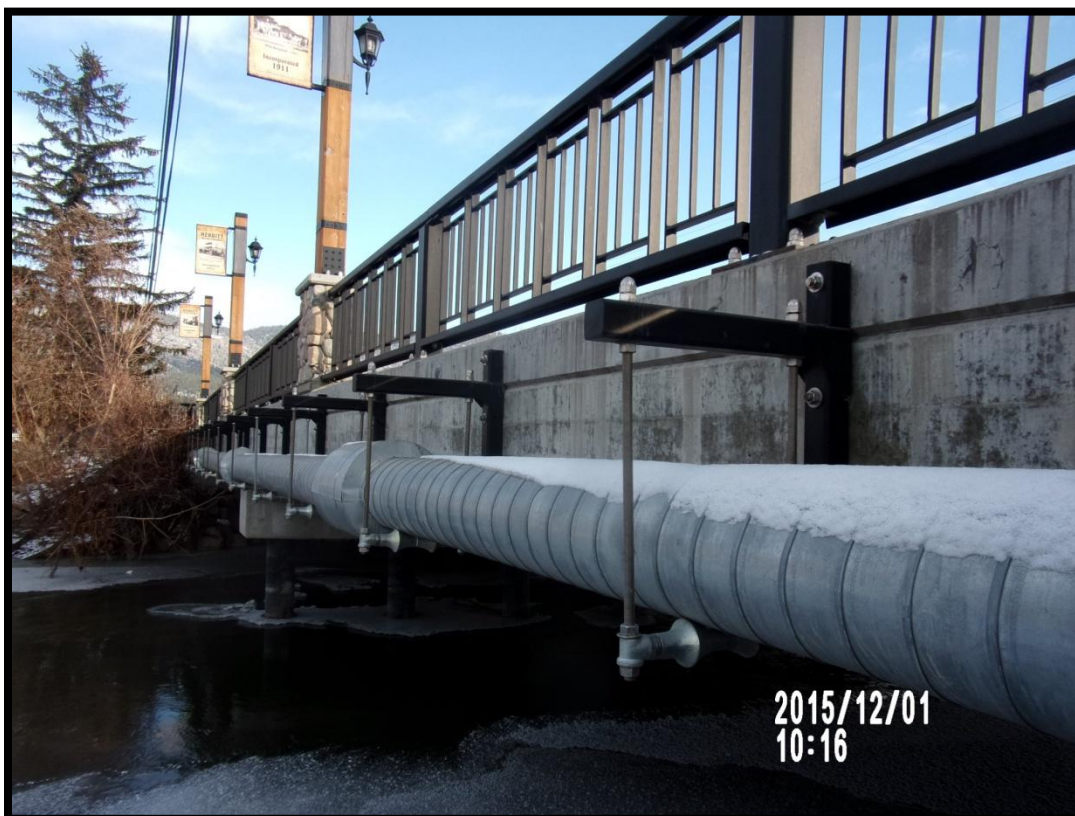
Photo #10. Waterline On North Side.

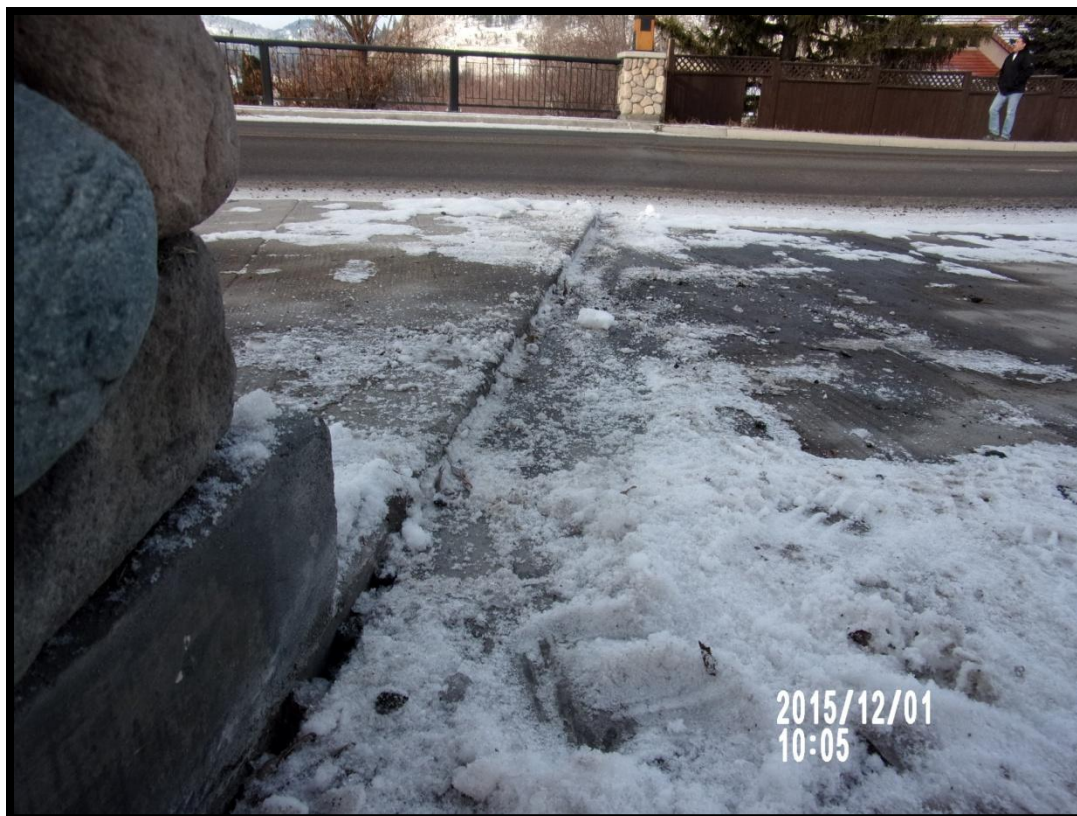
Photo #11. 10 - 25mm Settlement Of Concrete Sidewalk On Bridge Approaches.

Item	Approved		Completed		Description	Comments
	Initial	Date	Initial	Date		
1					Bridge Approach Settlement Has Caused Asphalt Road Surface And Concrete Sidewalk Surface Elevation Differences At The Bridge End Joints.	Grind Concrete Sidewalk To Remove Lip To Match Elevations For Smooth Pedestrian Use And Continue Sealing Cracks In Asphalt At Bridge End Joints.
2					Steel Railing Base Plates.	Require Corrosion Removal And Re- Painting.
3					Concrete Surface Spalling on Upstream Sidewalk In Approximately 3m <sup>2</sup> Area.	Repairs Not Required, Does Not Affect Usage Of Sidewalk.
4					Steel Piling With Black Epoxy Coating On Exposed Lengths. Epoxy Coating Has Peeled Off In Various Sections On Exposed Areas.	Require Corrosion Removal And Re- Painting.

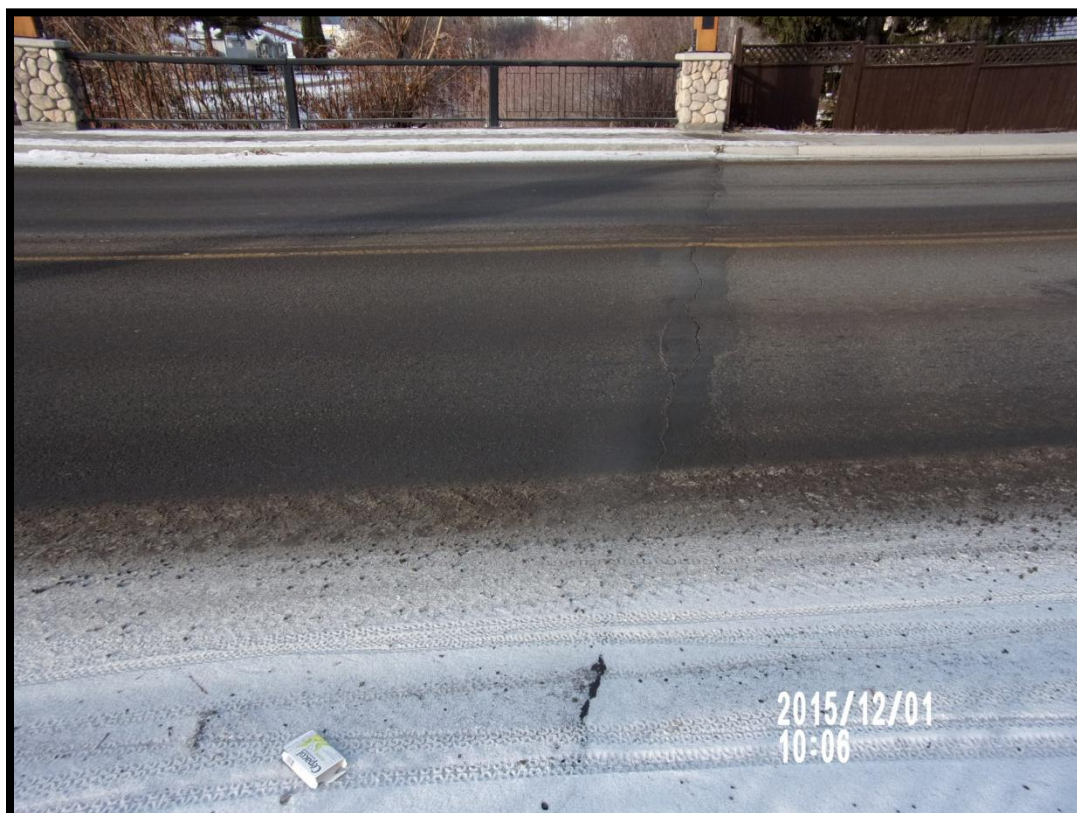
Photo #12. Asphalt Cracking And Settlement At North Abutment.

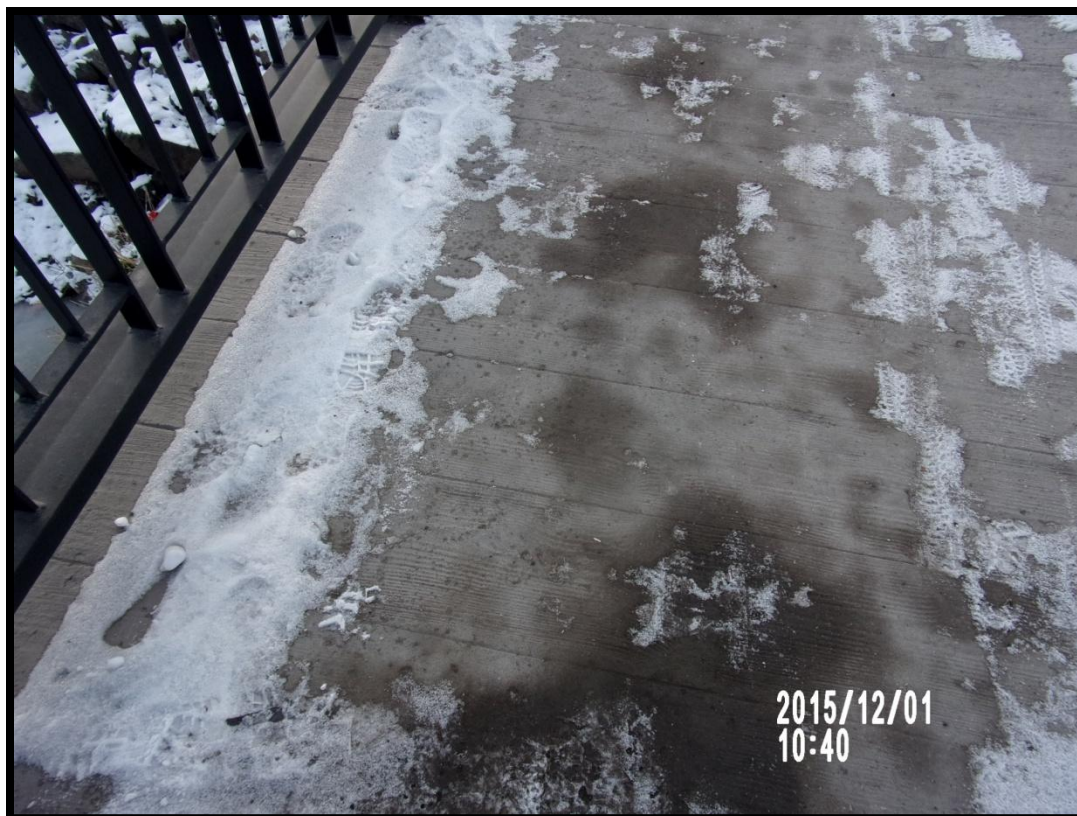
Photo #13. Surface Spalling Of Sidewalk Concrete.

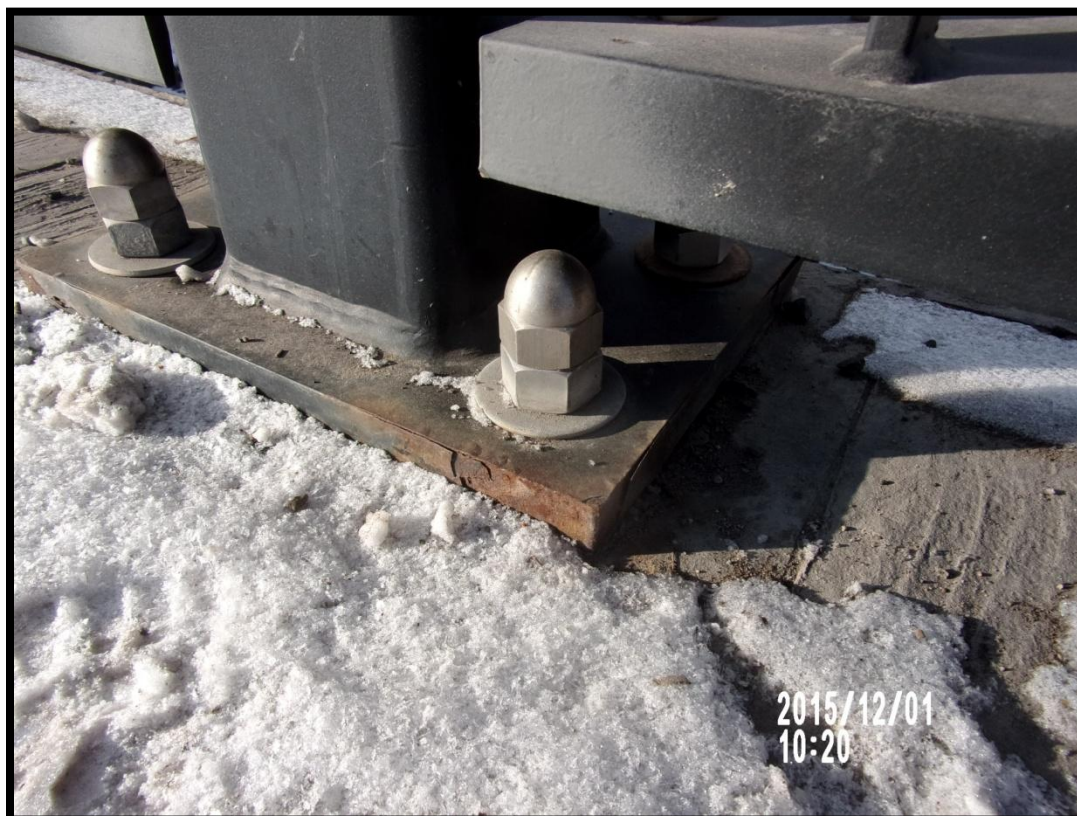
Photo #14. Railing Baseplate Corrosion.

Roadway Type: Condition:	Asphalt. Fair. Surface Is Showing Signs Of Wear With Wheel Path Groves Appearing Since Last Inspection.	
Roadway End Joint Type: Condition:	None.	
Approach Slabs Type: Condition:	None.	
Approach Embankment Type: Condition:	None.	
Drainage Type: Condition:	CB's Near Merritt Avenue Otherwise Surface Drainage Only.  Good.	
Abutment Fencing Type: Condition:	Modified MoT Steel Guardrail, Powder Coated Black. Good. Steel Railing Post Base Plates Are Corroding, Possibly Due To Road Salt Accumulation During Winter Months.	Remove Corrosion And Paint Baseplates

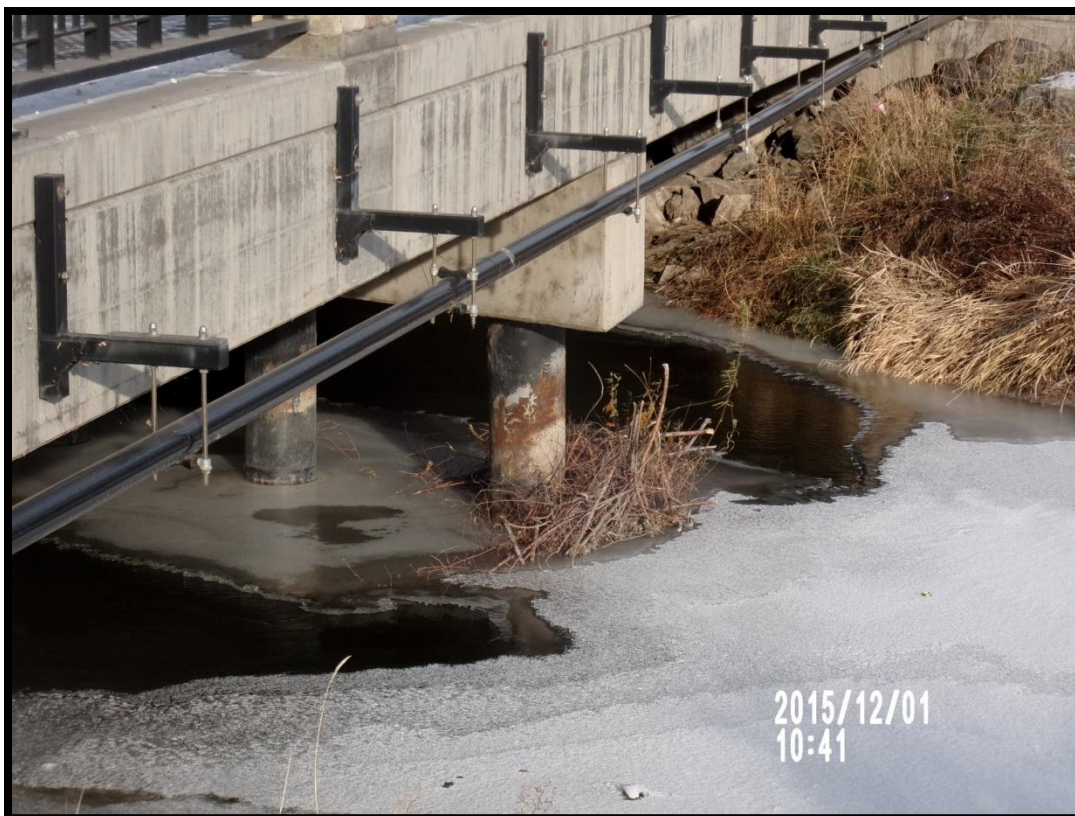
Photo #15. Pier Piles With Peeling Paint And Corrosion.

<p>Pier</p> <p>Type: Condition: Foundation:</p> <p>Slope Protection</p> <p>Location: Type: Condition:</p> <p>Waterway Channel</p> <p>Alignment: Flow:</p> <p>Stability:</p>	<p>CIP Concrete Pile Cap. Good. Steel Piling With Black Epoxy Coating On Exposed Lengths. Epoxy Coating Has Peeled Off In Various Sections On Exposed Areas.</p> <p>Upstream, Downstream And At Abutments. Rip Rap. Good</p> <p>Good. Moderately High Water With Ice At The Time Of Inspection. No Issues Found. Good.</p>	<p>Recoat With Black Epoxy During Low Water Level.</p>
---	--	--

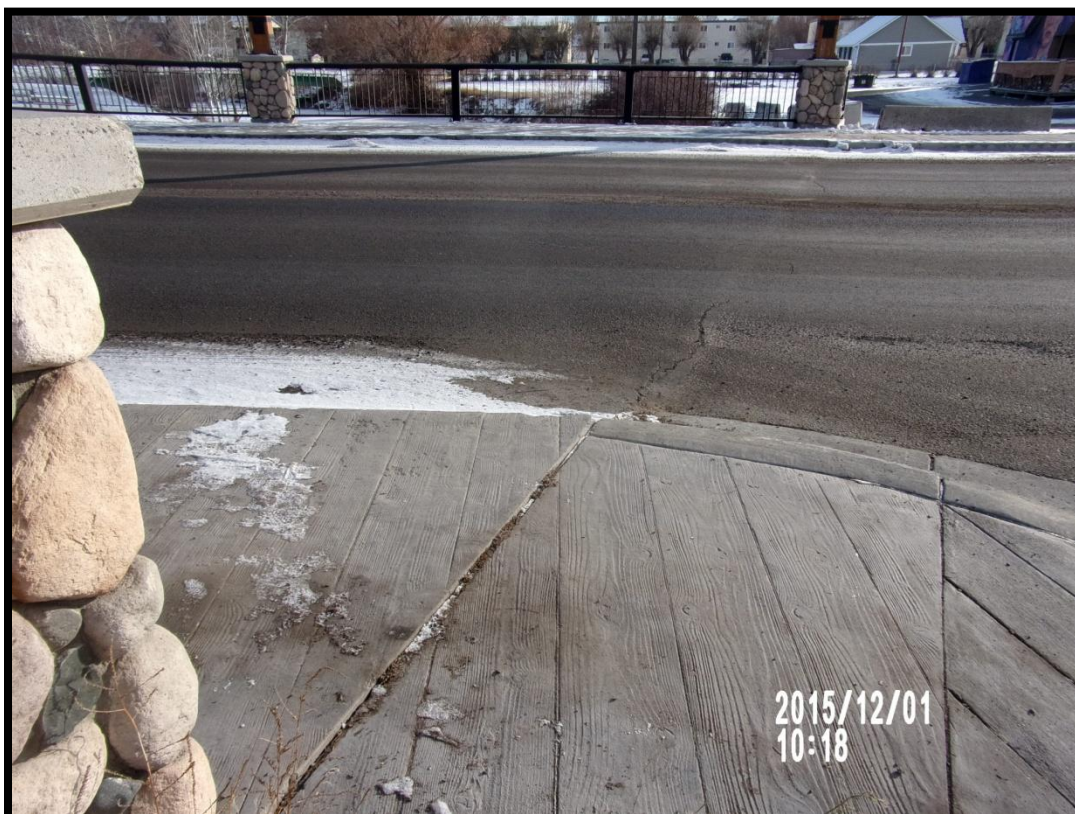
Photo #16. Asphalt Cracking And Settlement At South Abutment.

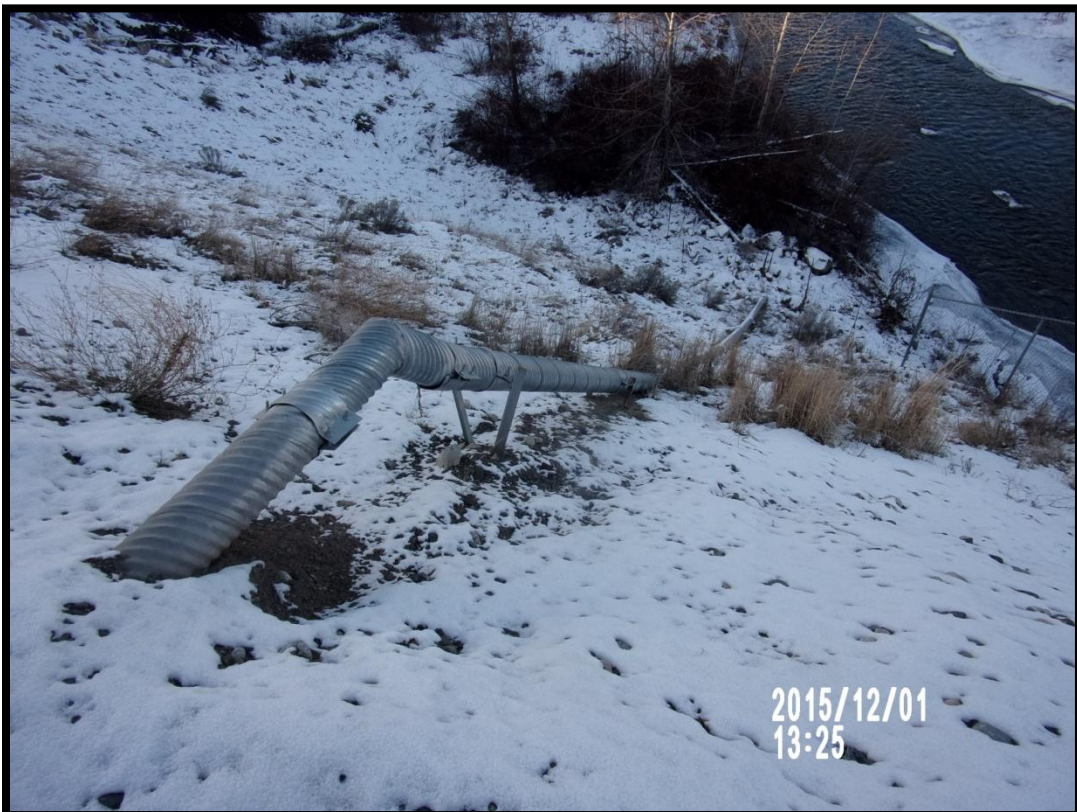
Photo #25. Downstream South Approach Catch Basin. Note: Found Filled With Debris.

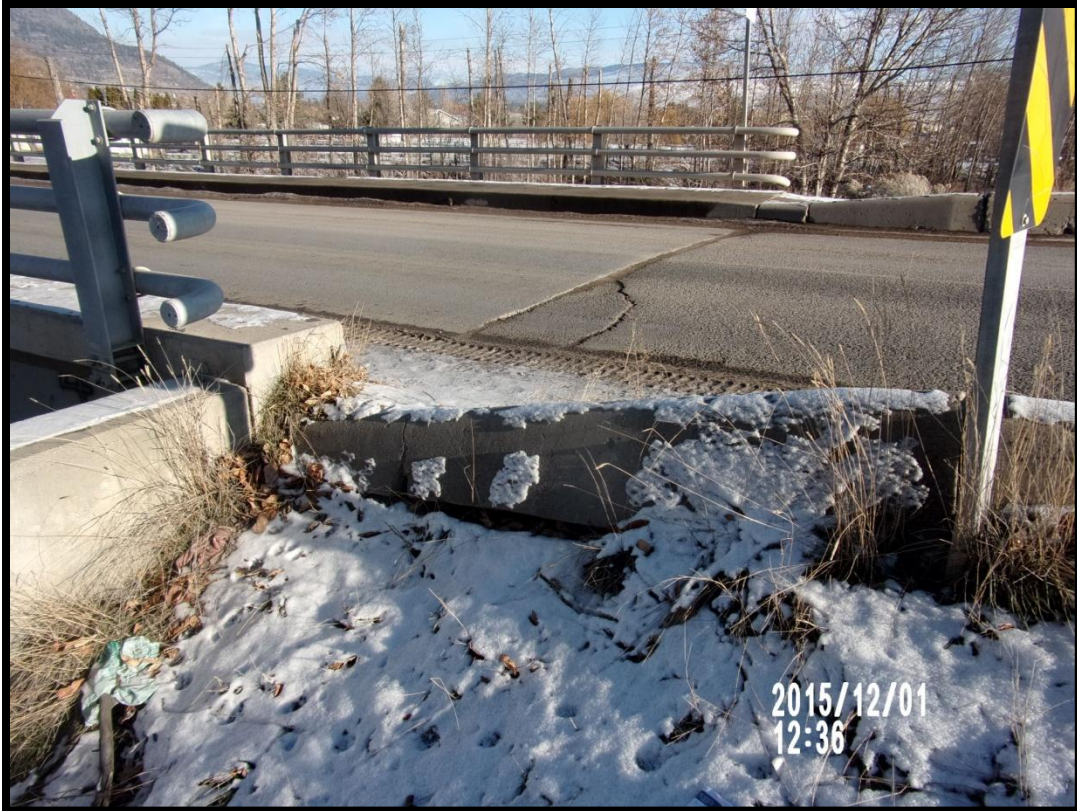
Photo #15. Barriers At West Abutment. Note Erosion Of Slope Materials.

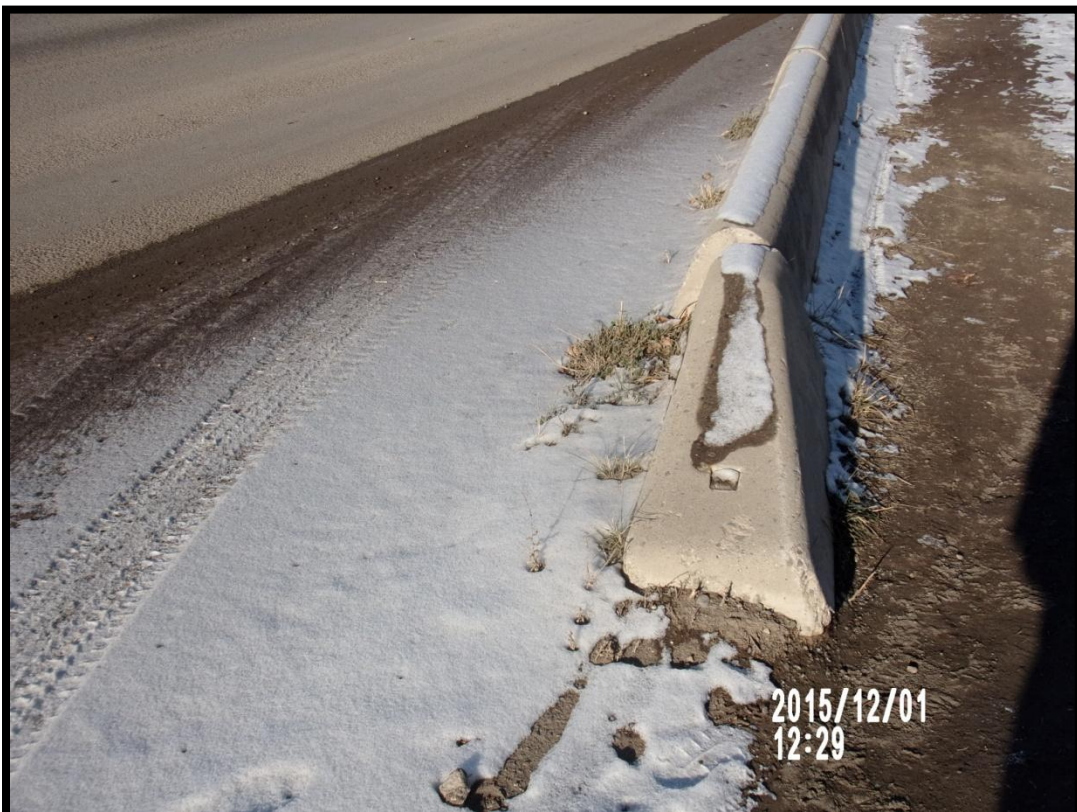
Photo #16 Displaced Concrete Barrier Bullnose On Upstream West Approach.

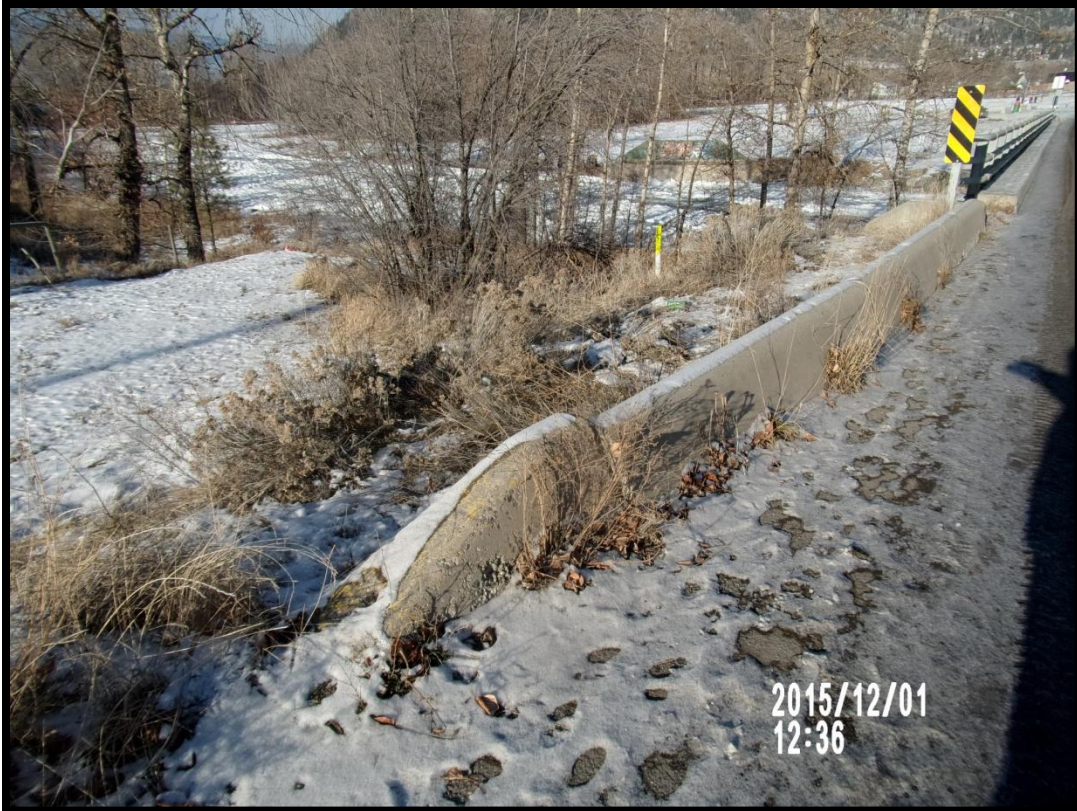
Photo #17. Miss-Aligned Concrete Barrier Bullnose On Downstream West Approach.

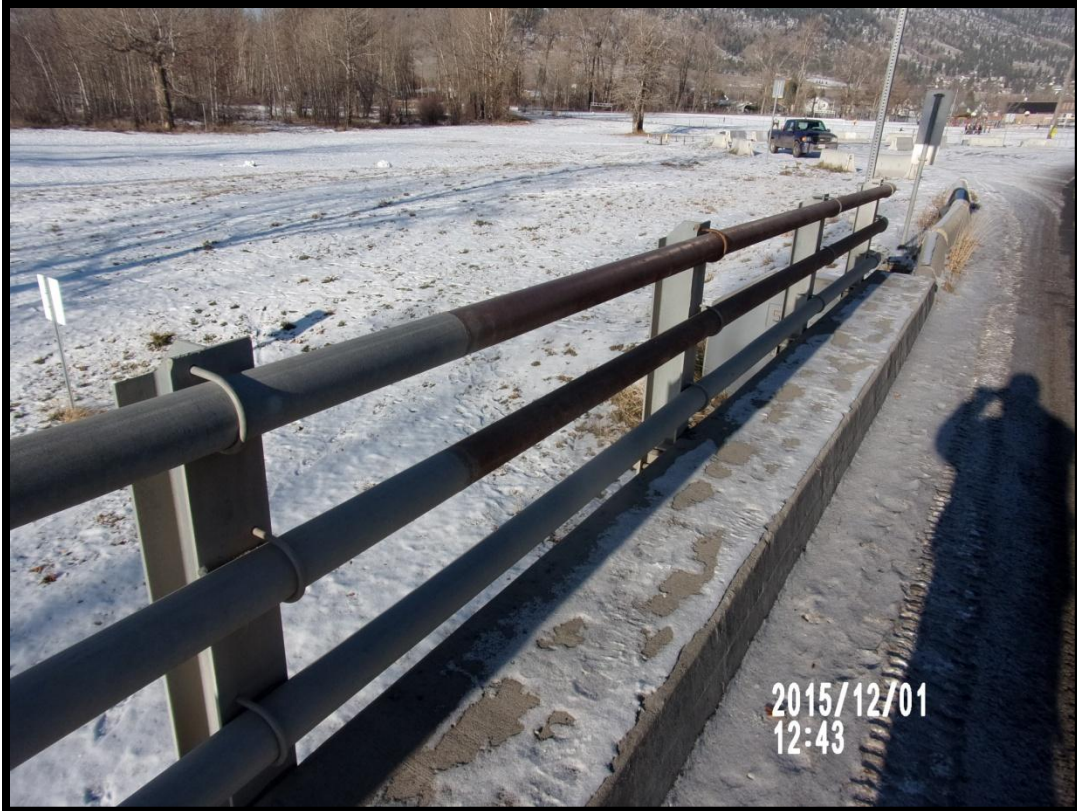
Photo #19. Railing At Downstream East Abutment. Note: Corroded Rails.

Item	Approved		Completed		Description	Comments
	Initial	Date	Initial	Date		
1					Repair / Reposition Bent Railing Posts.	Repair / Reposition Bent Railing Posts.
2					Corrosion Of Guard Rail.	Clean And Coat Corroded Railing With Zinc Rich Paint.
3					CRB Displaced And Out Of Alignment Due To Settlement Of Supporting Materials.	Repair South West CRB By Replacing Supporting Materials And Repositioning. Consider Adding Asphalt Curb To Move Drainage Away From Abutment.
4					Approach Sidewalk In Poor Condition And Present Liability Issues.	Rebuild Approach Sidewalks.
5					South Bullnose Barriers Displaced.	Replace Concrete Bullnose Barriers.
6					Four Missing Railing To Post Bolts	Replace Railing To Post Bolts.
7					Unknown River Bed Condition At Centre Pier	Consider Scour Inspection Of Centre Pier.

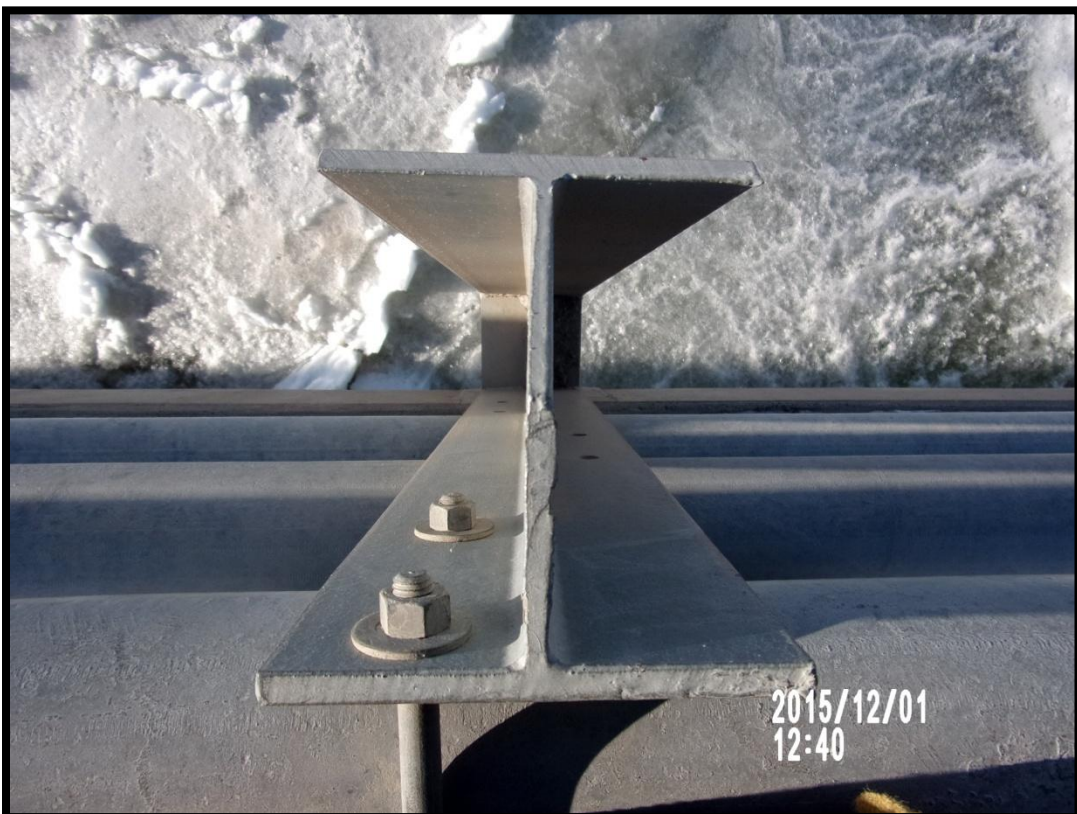
Photo #20 Railing Post Clamps Missing Upstream And Downstream Side.

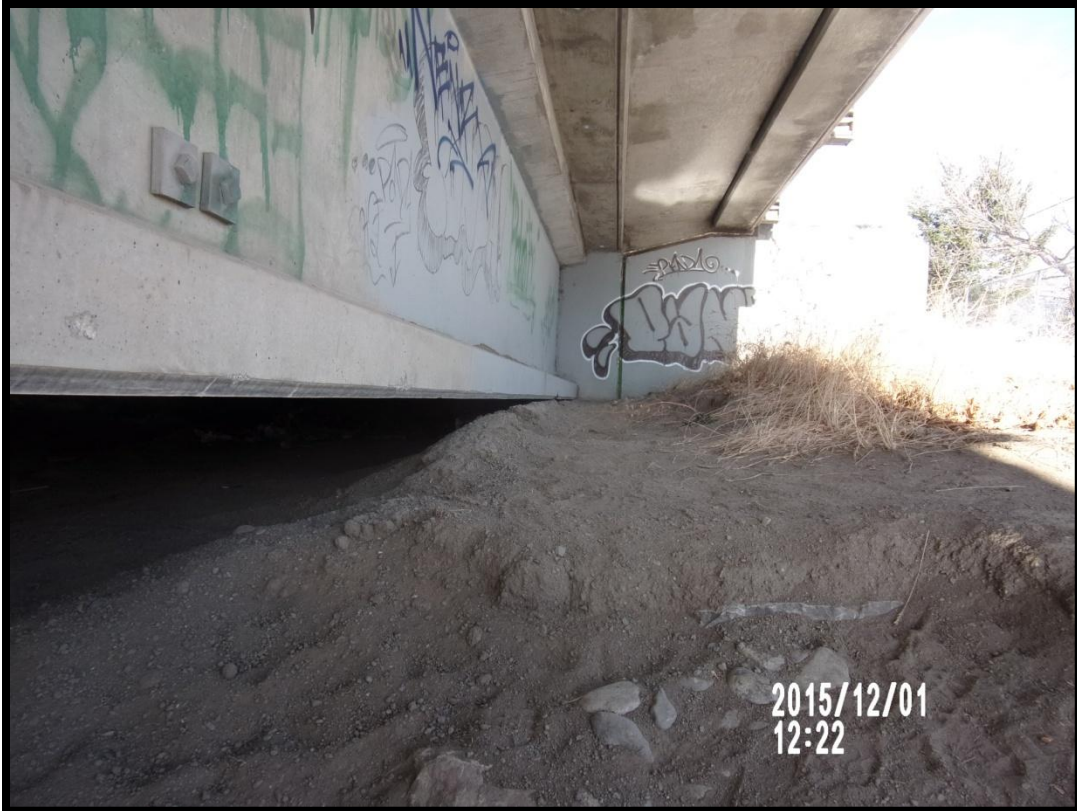
Photo #21 East Abutment. Note: Material Accumulating Close To Girder.

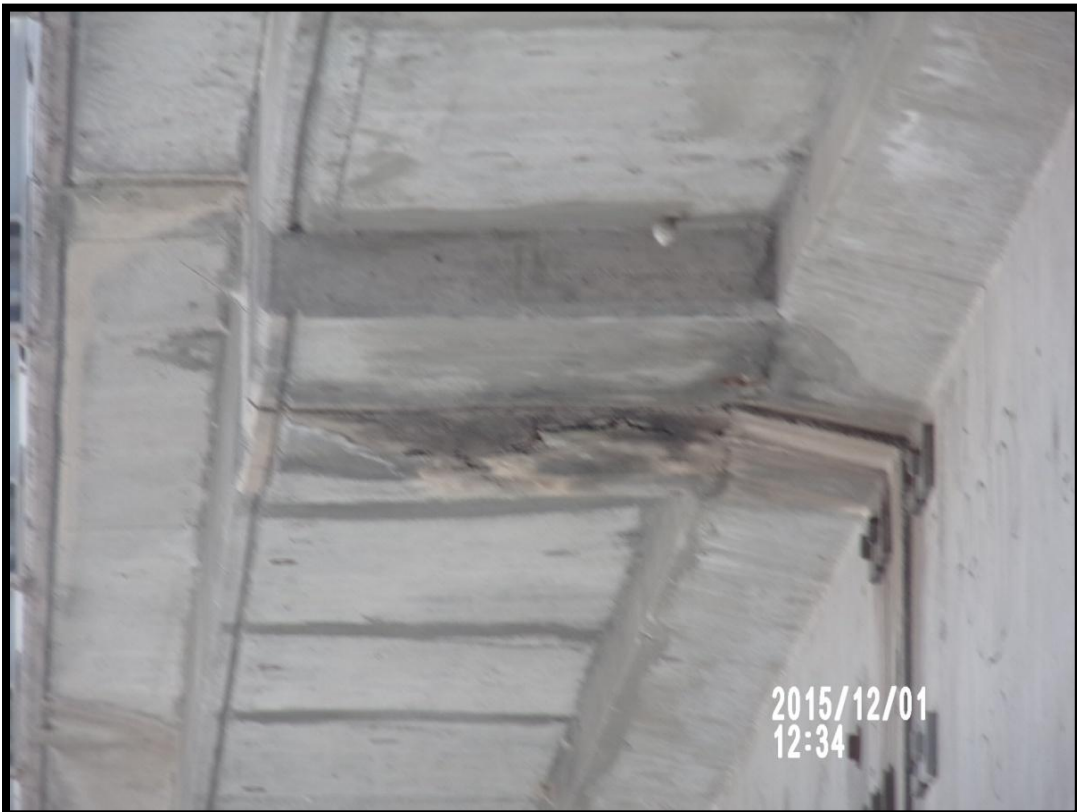
Photo #22 Centre Pier Joint. Note: Leakage And Corrosion At Joint.

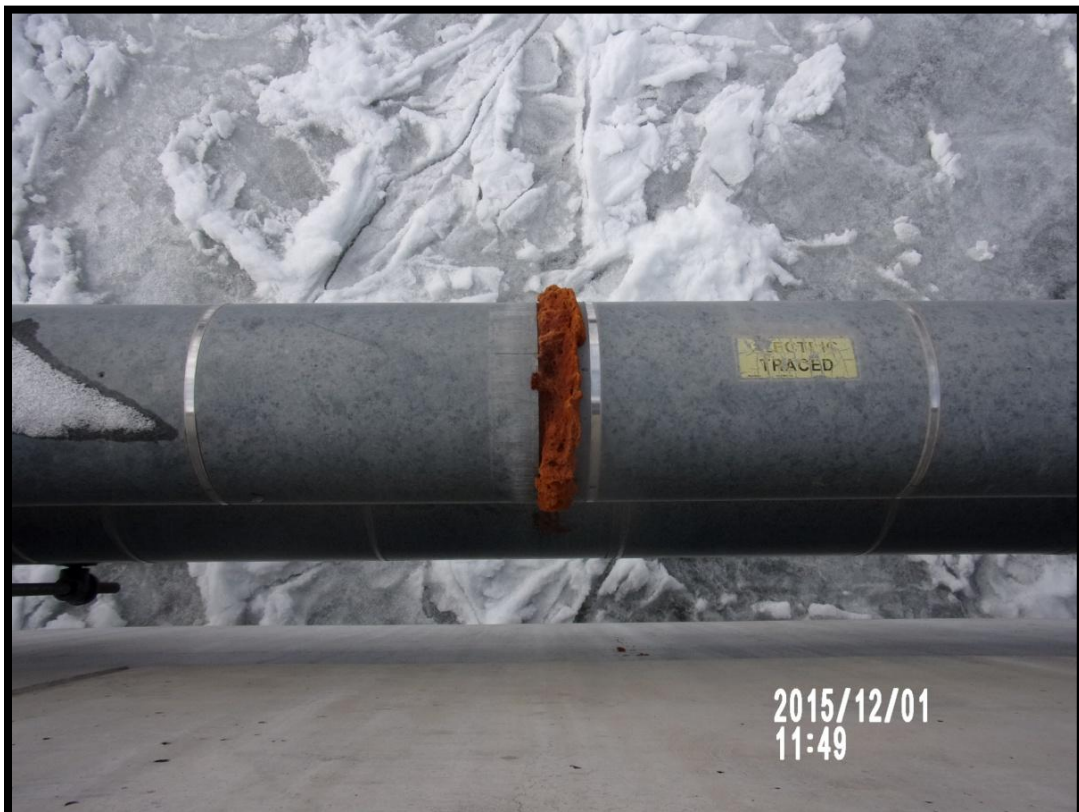
Photo #14. Waterline Near Mid-Span. Note: Missing Pipe Insulation Joint And Deterioration Of Insulation.

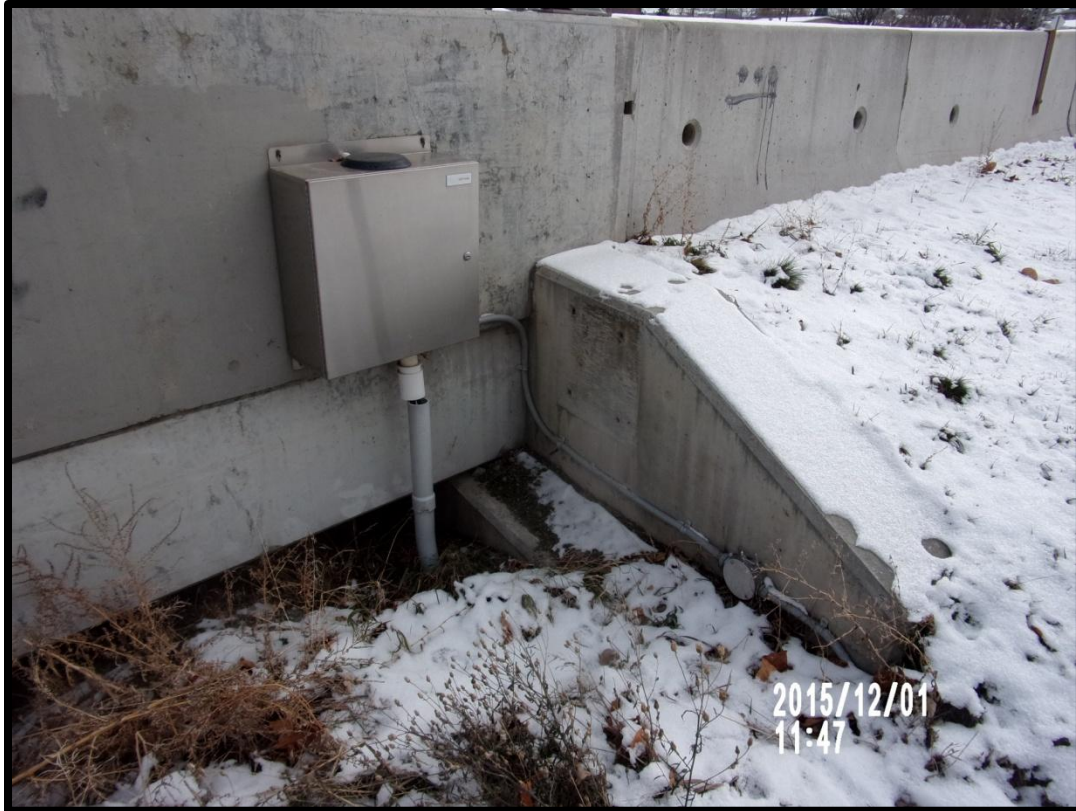
Photo #15. Utility Box At Downstream West Abutment. Note: Loose And Open Conduit.

Observations	Recommendations
Utilities Over Bridge BC Hydro: BC Tel: Other:	Overhead On South Side. Overhead On South Side. Unknown.	
Utilities On Bridge BC Hydro: BC Tel: BC Gas: Water:  Sanitary: Sewer: Other:	None. None. None. Insulated Waterline On North Side. Insulation Steel Covering Requires Joint Repair At Exposed Pipe Joint Near Centreline.  Insulated Forcemain On North Side. None. Junction Box For Unknown Utility Service.	Re-Seal Insulation Joint And Repair Exposed Insulation At One Pipe Joint.
Utilities Adjacent To Bridge BC Hydro: BC Tel: BC Gas: Water: Sanitary Sewer: Storm Sewer: Other:	Unknown. Unknown. Gas Line Underground 5m Downstream Of Bridge Unknown. Unknown. Unknown. Junction Box For Heat Trace On North East Approach Embankment. Junction Box For Unknown Utility Attached To North West Side Of Concrete Box Girder has Open Conduit.	Repair Open Conduit.

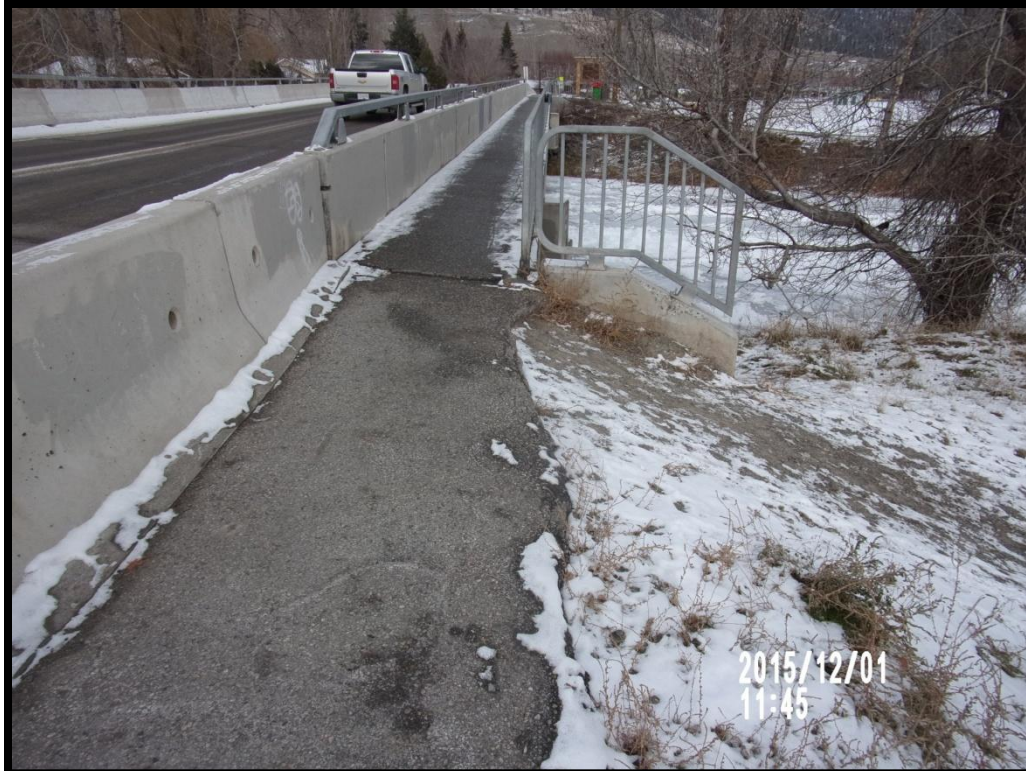
Photo #17 Sidewalk At West Wing Wall. Note: Damage To Wing Wall And Repositioned Rail Base.

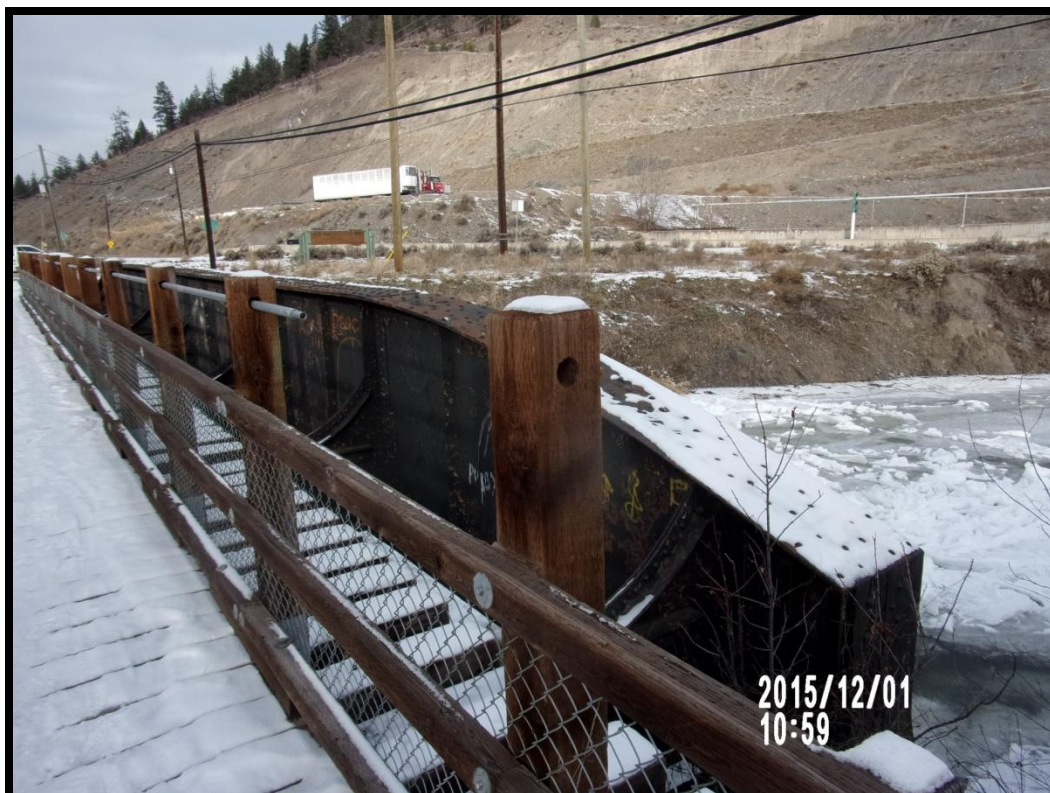
Photo #15. Upstream Railing. Note: Missing Pipe Rail End Section.

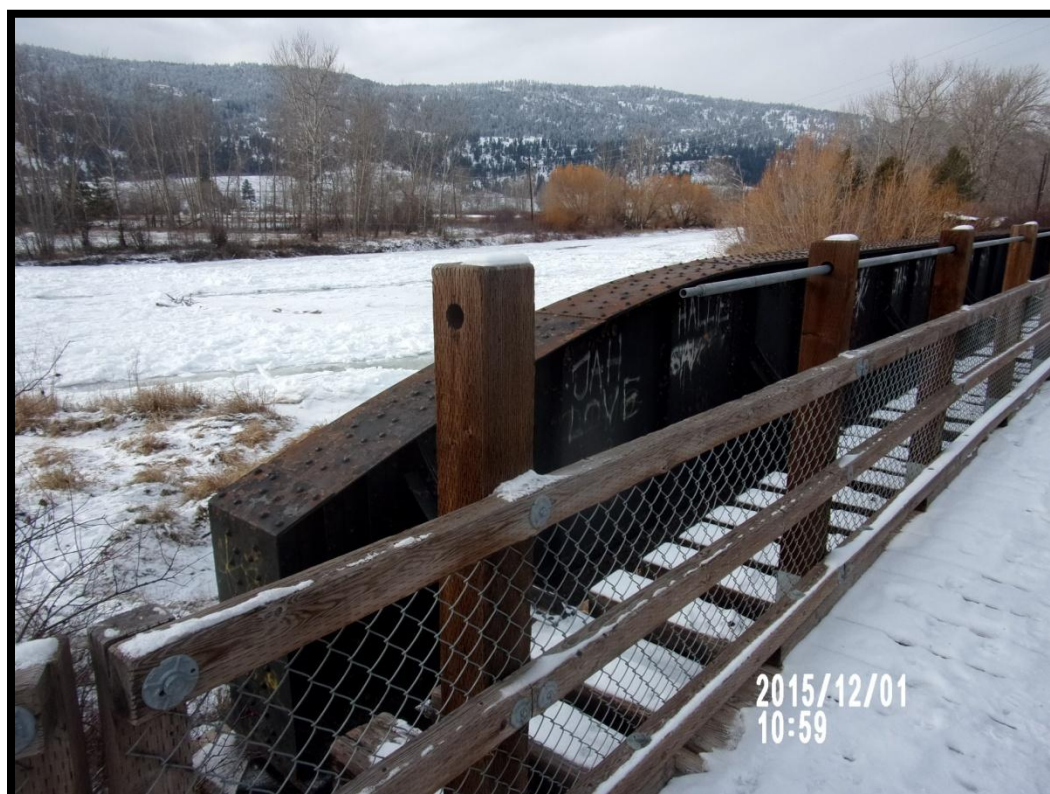
Photo #16. Downstream Railing. Note: Missing Pipe Rail End Section.

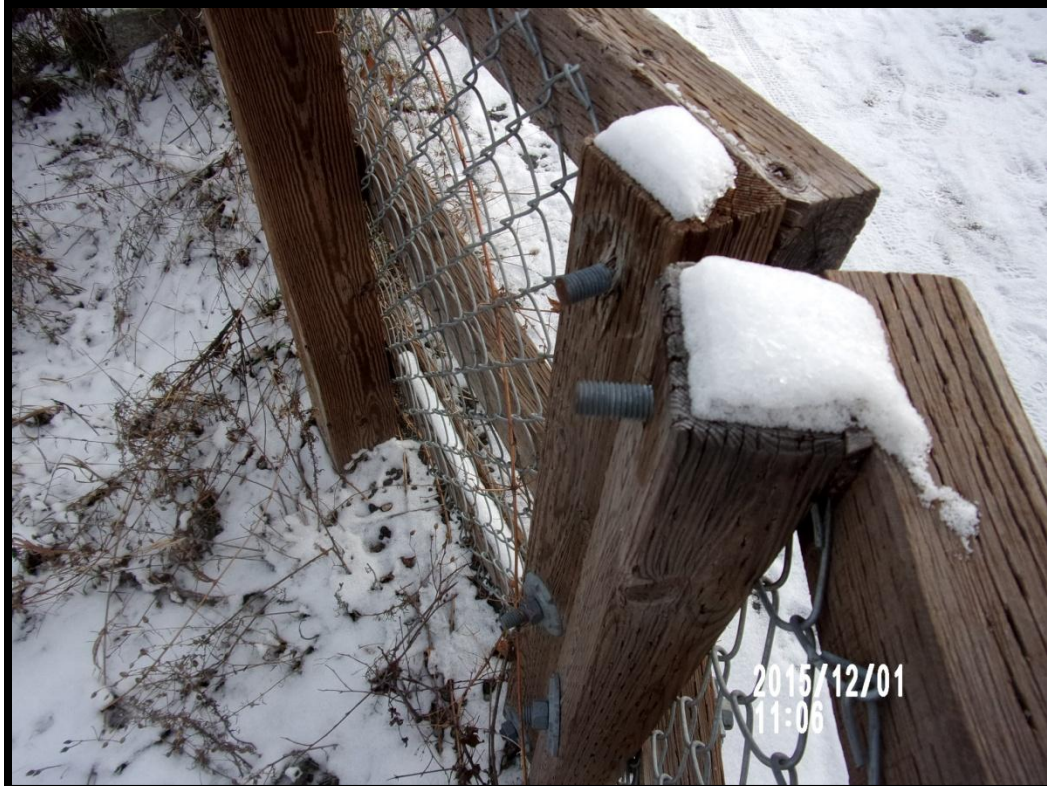
Photo #17. Upstream Rail. Note: Railing Nuts And Washers Found Missing At South End.

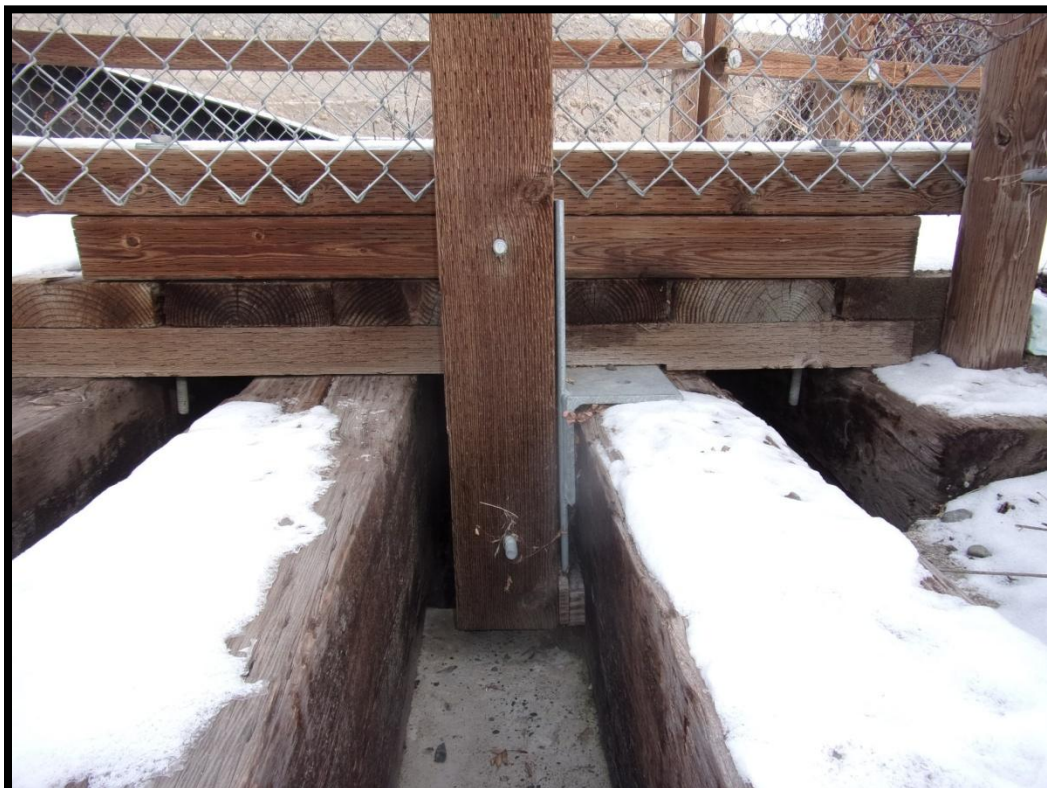
Photo #18. Downstream Rail. Note: Nuts And Washers Missing.

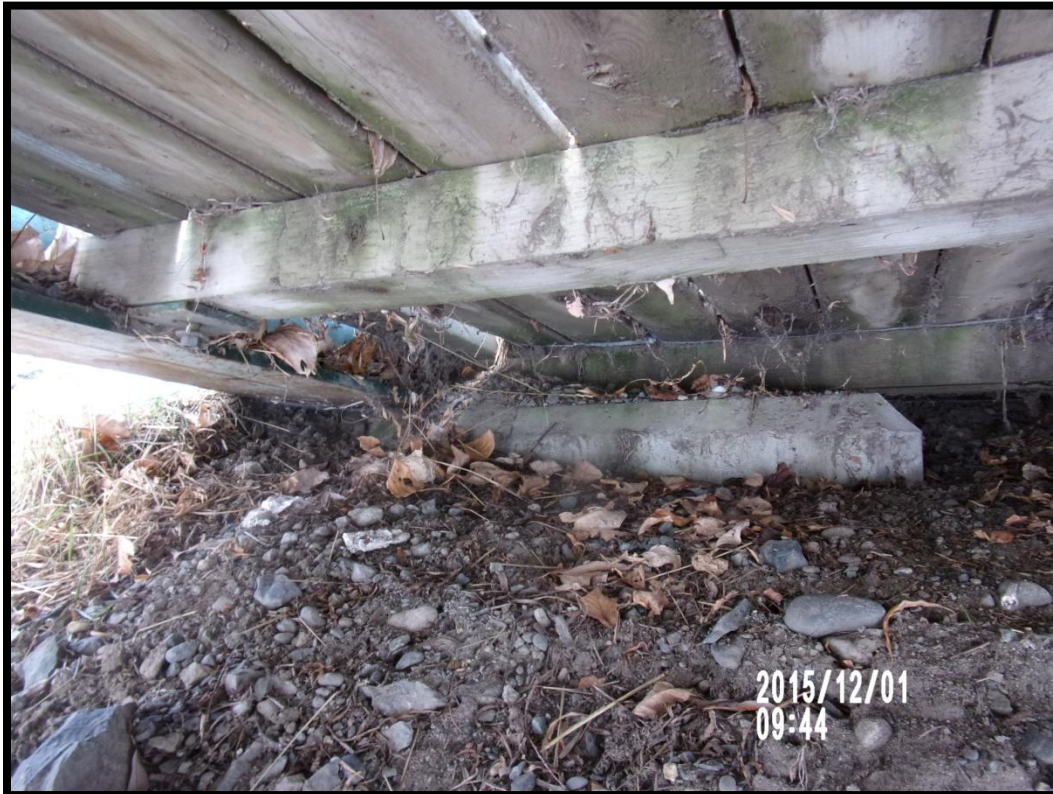
Photo #10 North Abutment. Note Material Leaking Through Deck Plank Gaps.

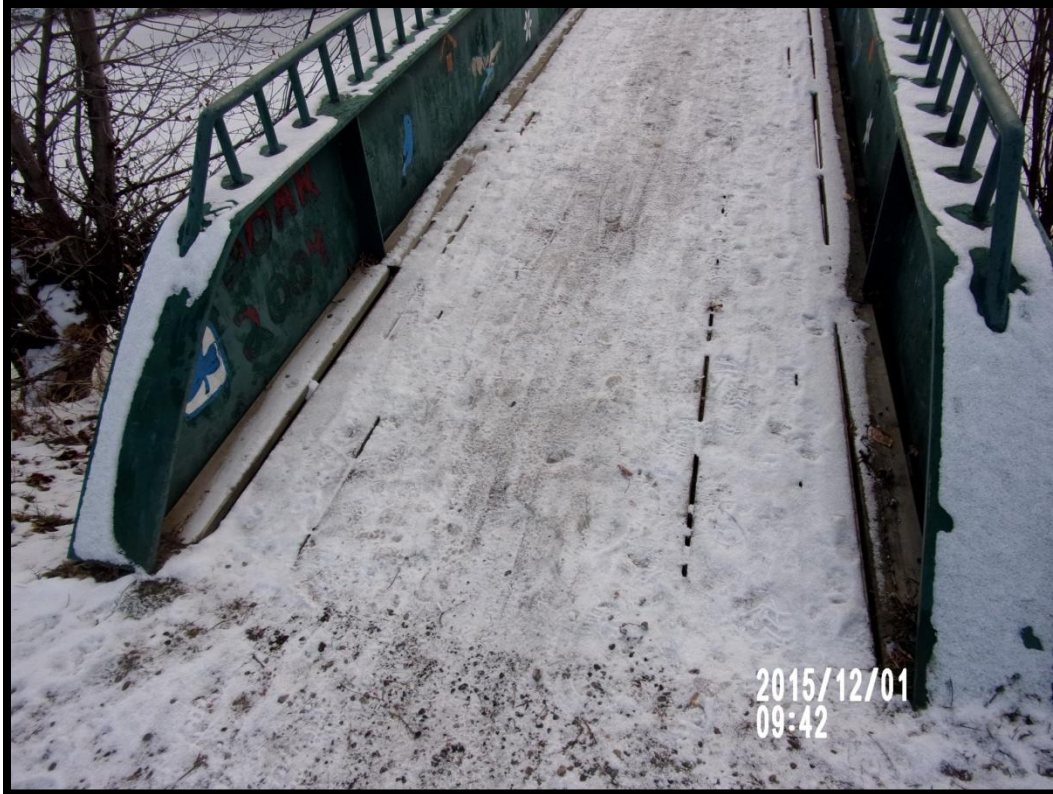
Photo #11 North Deck. Note Gaps In Deck Planks.
