## **CITY OF MERRITT**

### **2015 MERRITT BRIDGE INSPECTION REPORT**

**Issued: December 15, 2015**

**WATSON ENGINEERING LTD.**

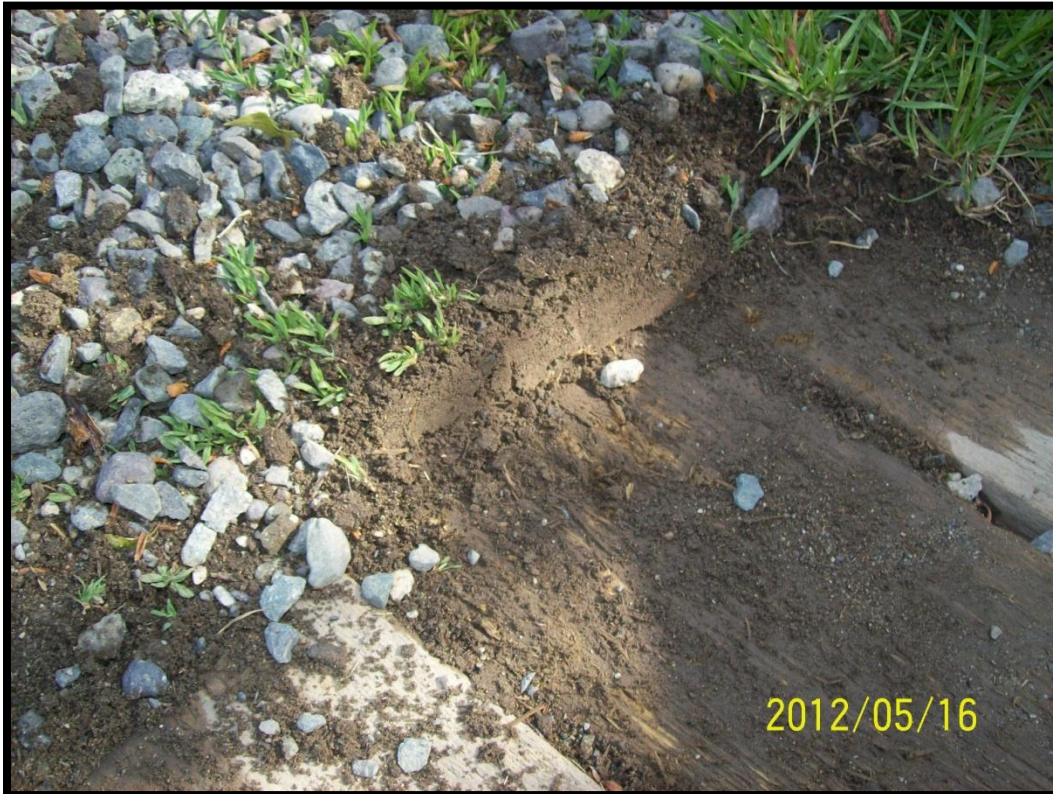
Photo #12 North Abutment. Note End Of Deck Planks Buried And Deteriorated.

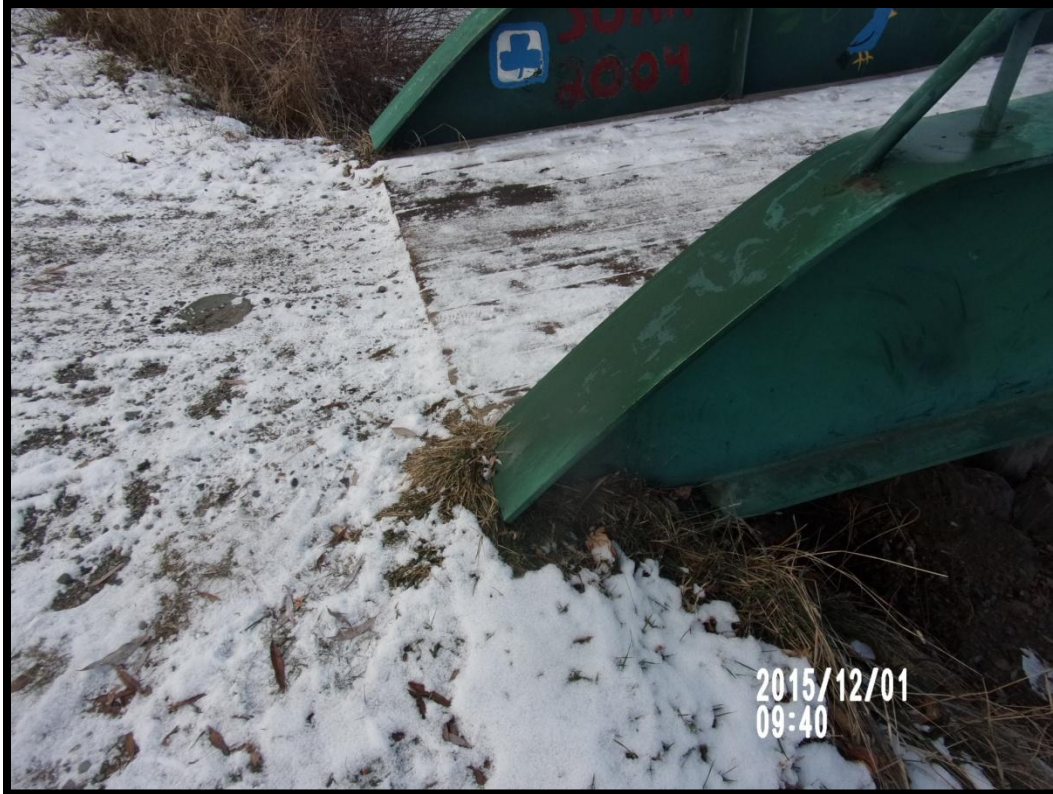
Photo #13 South Abutment. Note: Steel Girder Buried.

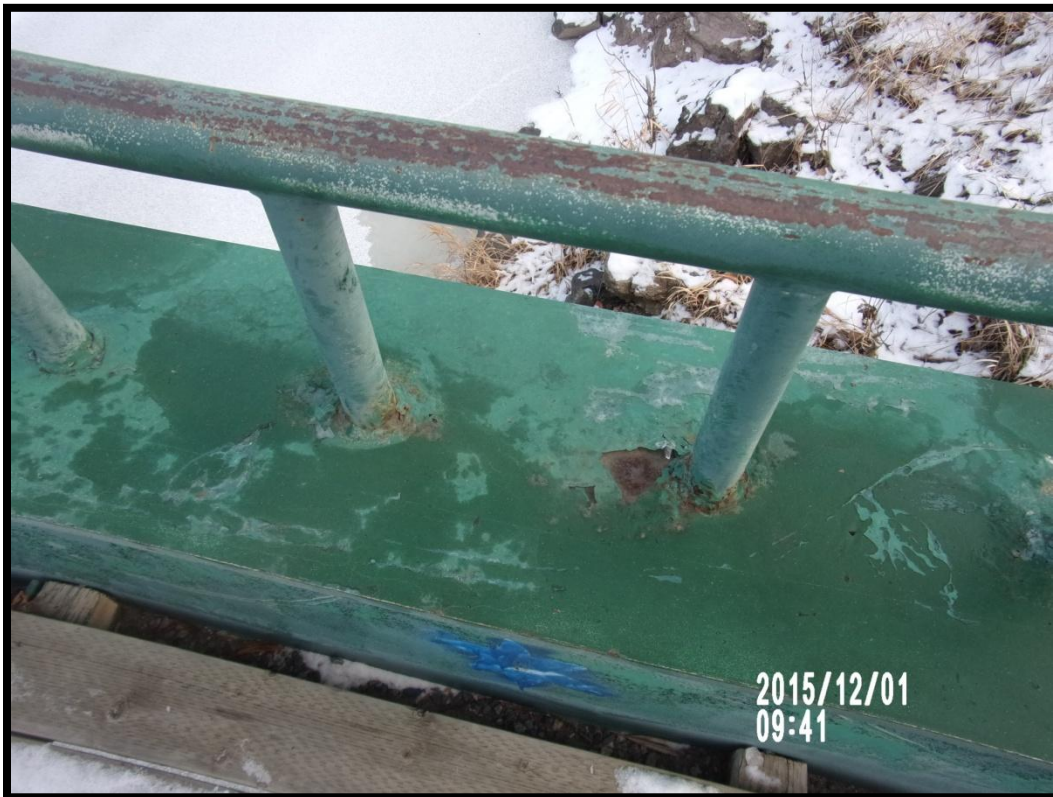
Photo #15 Upstream Handrail. Note: Corrosion.

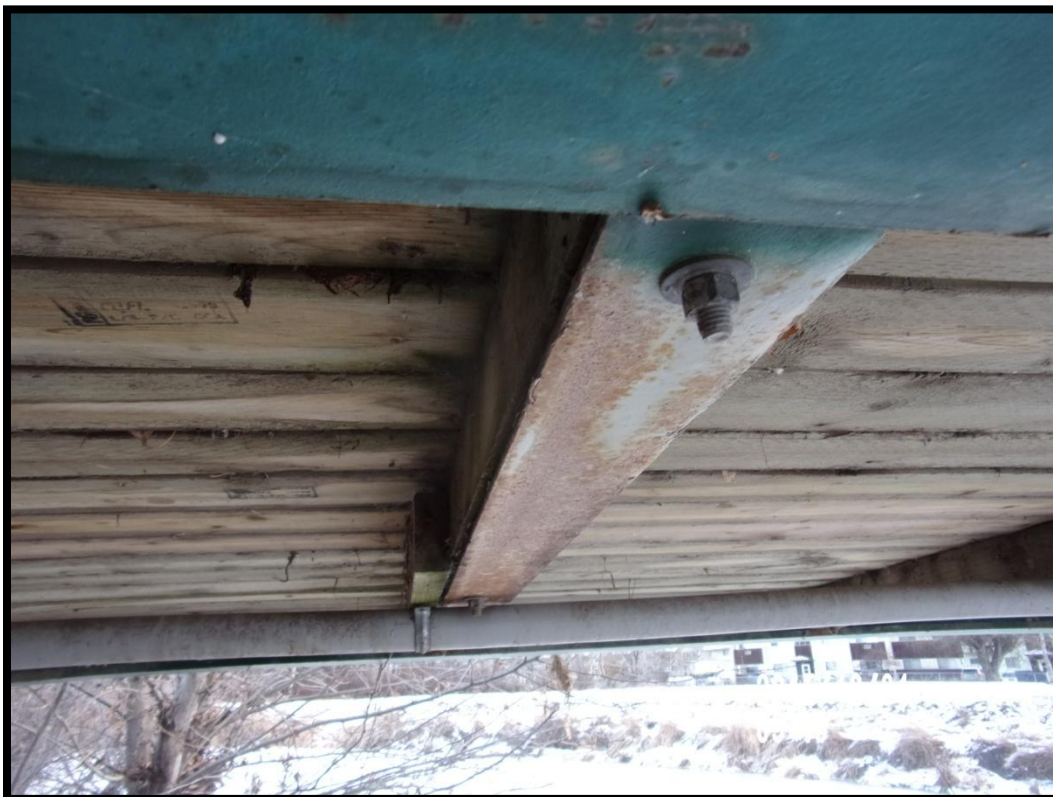
Photo #16 Deck Underside. Note: Corrosion Of Steel Floorbeam.
