City of Merritt

Integrated Stormwater Master Plan

REPORT

Re: CITY OF MERRITT INTEGRATED STORMWATER MASTER PLAN

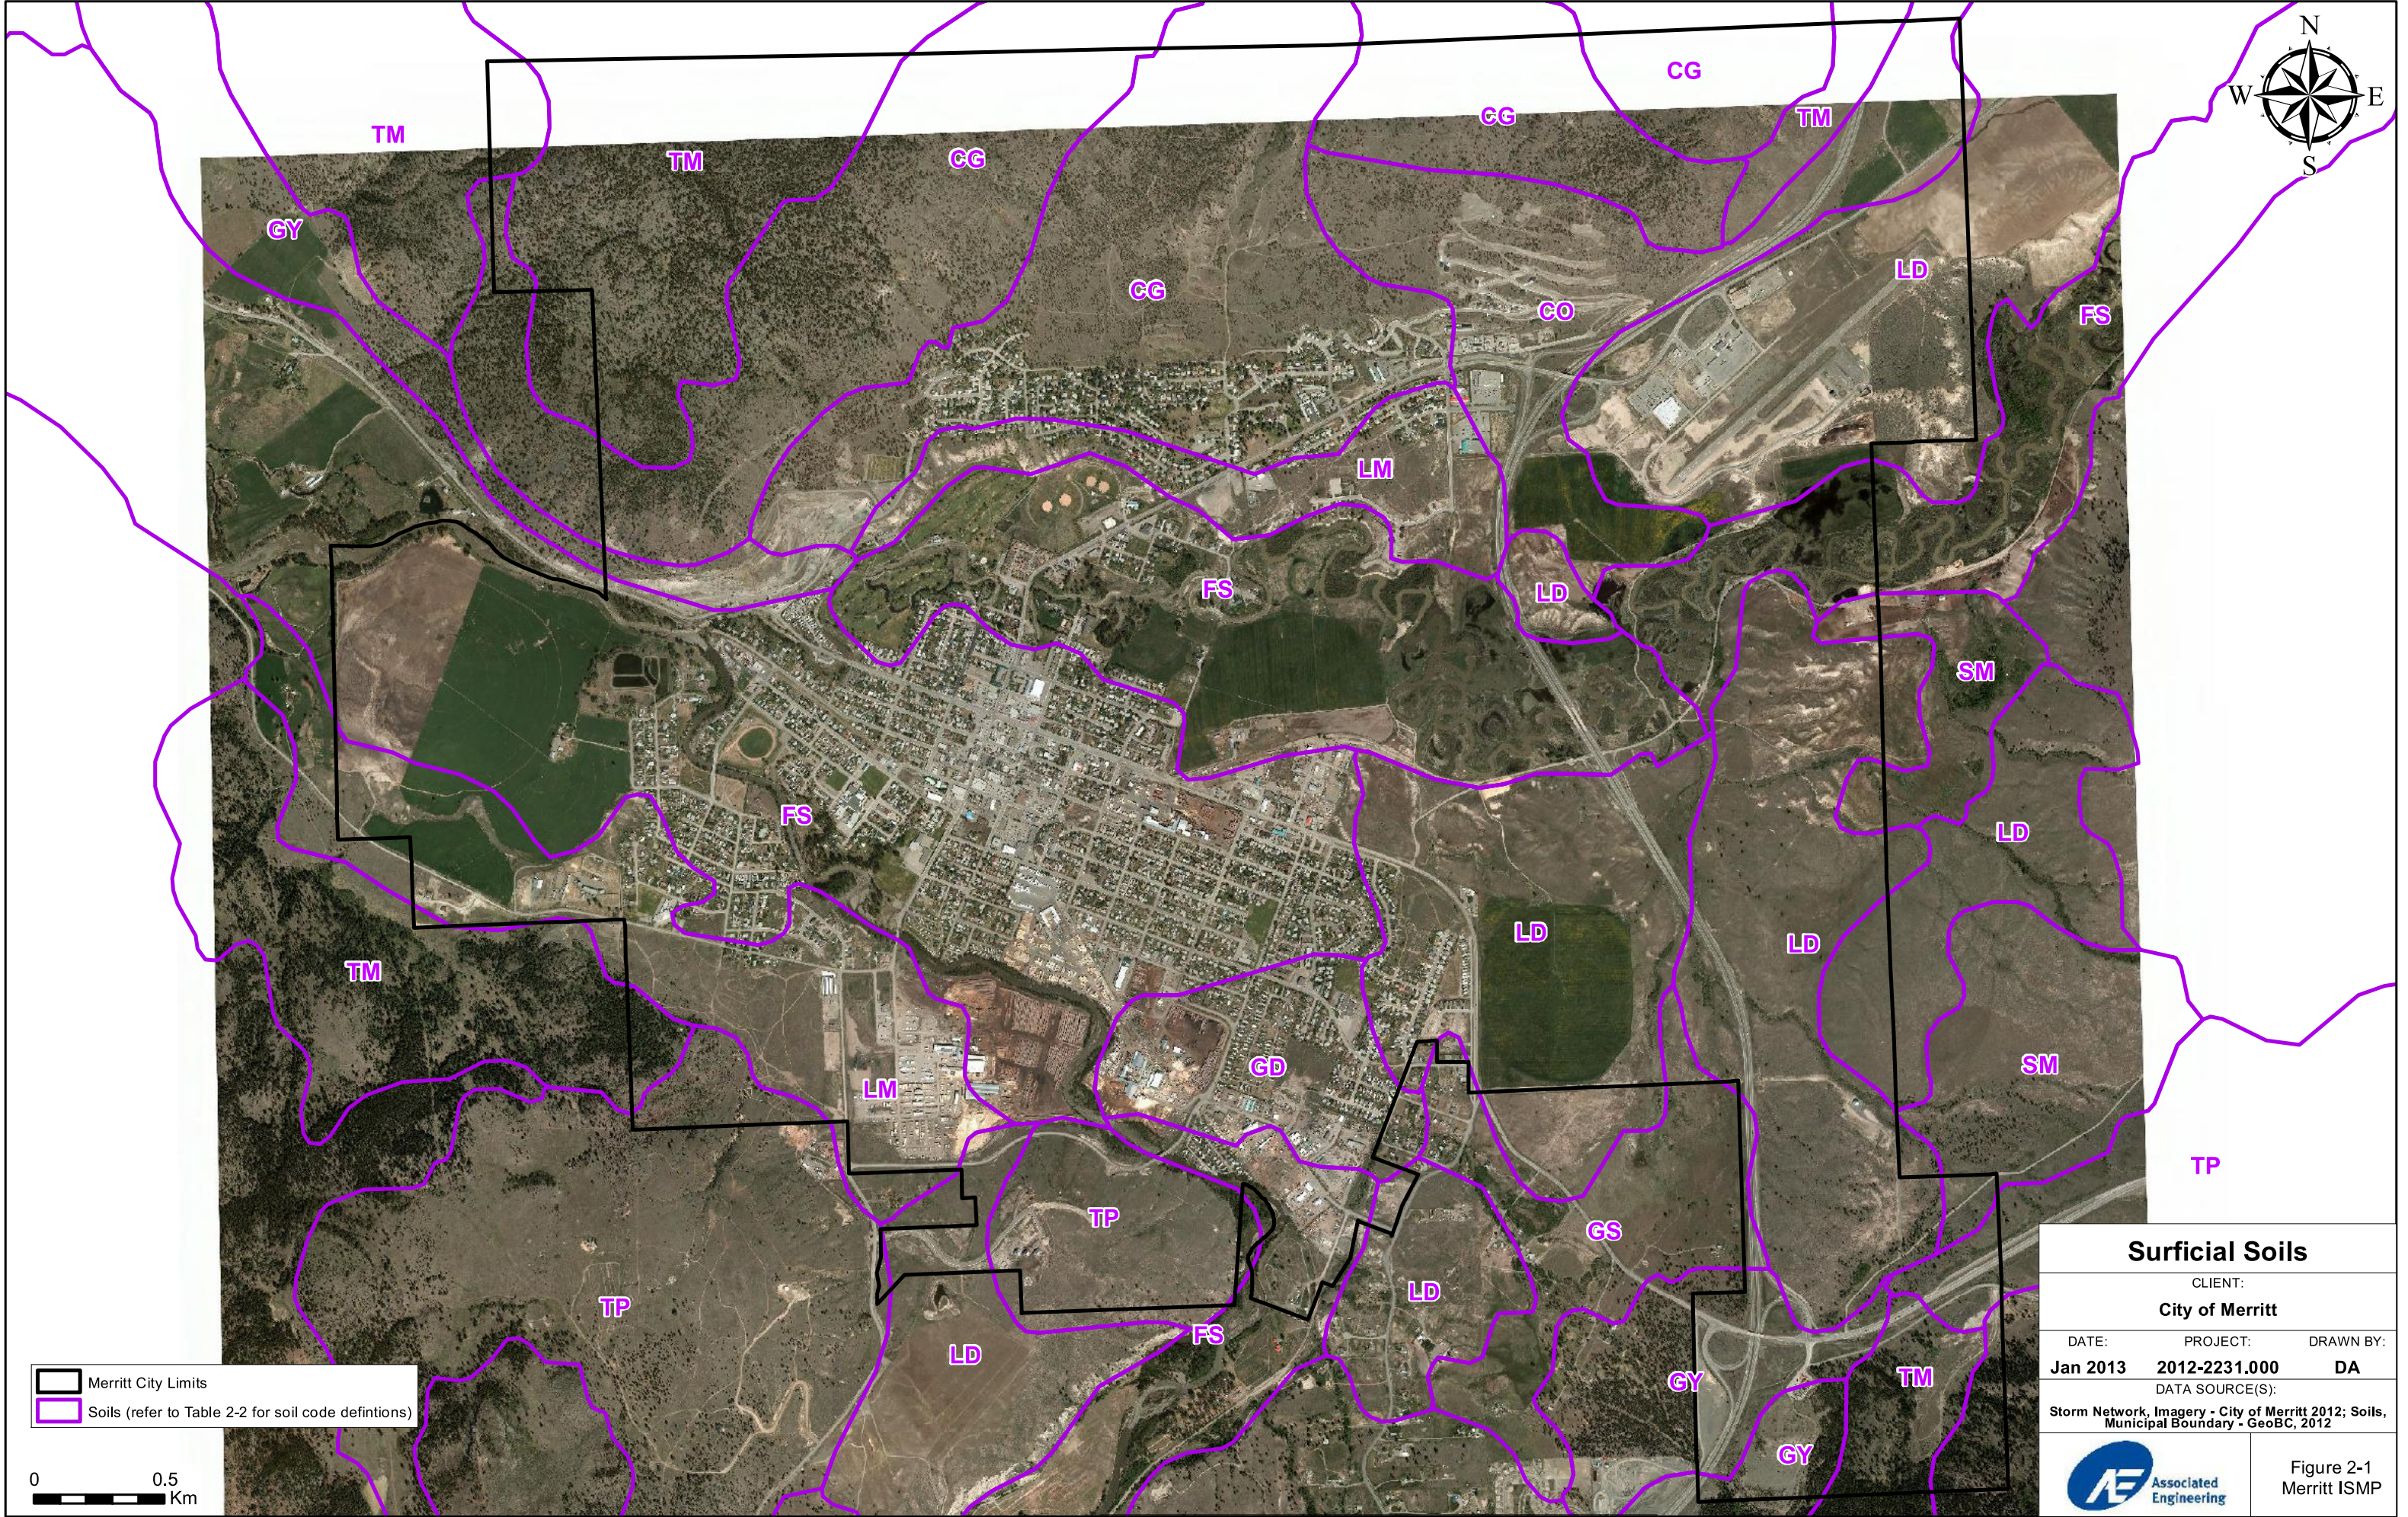
— Merritt City Limits
— Soils (refer to Table 2-2 for soil code definitions)

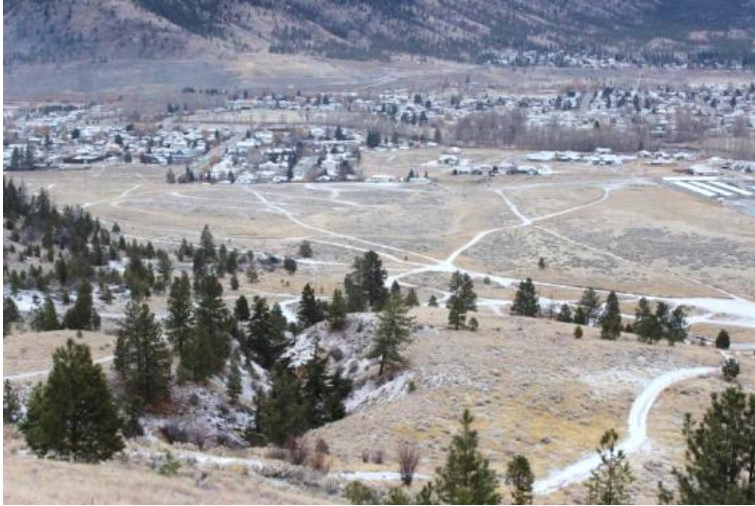
Photo 1: View from south side of Merritt over the gullied hill slopes and former mining area, over to the city residential areas along the Coldstream and Nicola Rivers.

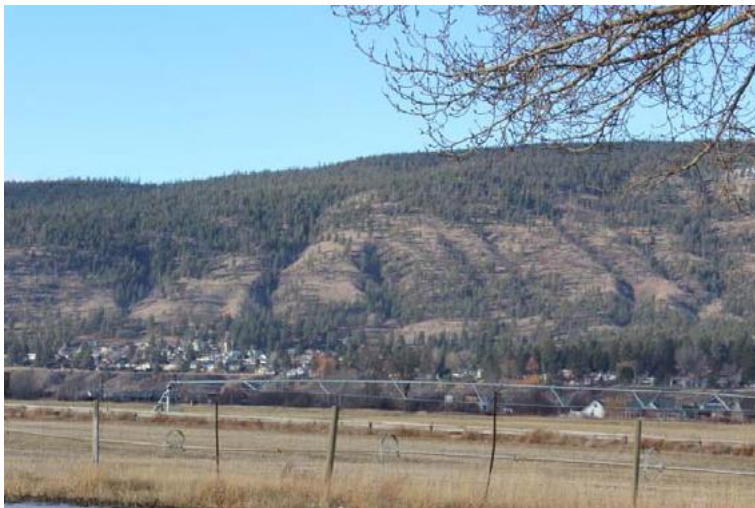
Photo 2: Overview of natural gullied hill slopes above the west end of Merritt.

The landforms in Merritt consist of the main gently-sloped Nicola River valley, adjoined by valley slopes and rolling uplands, leading up to steep bedrock hills with talus aprons (Photos 1, 2 and 3, in Appendix A).

The glacial lake deposits (Figure 2-1, Unit LD in the Hydrogeology Appendix) have a tendency to erode through gullying, block falls, slumps, piping and surface sheet erosion. These deposits tend to form steep, gullied slopes where eroded by the rivers and tributary streams and surface runoff (Photos 2, 3 and 4).

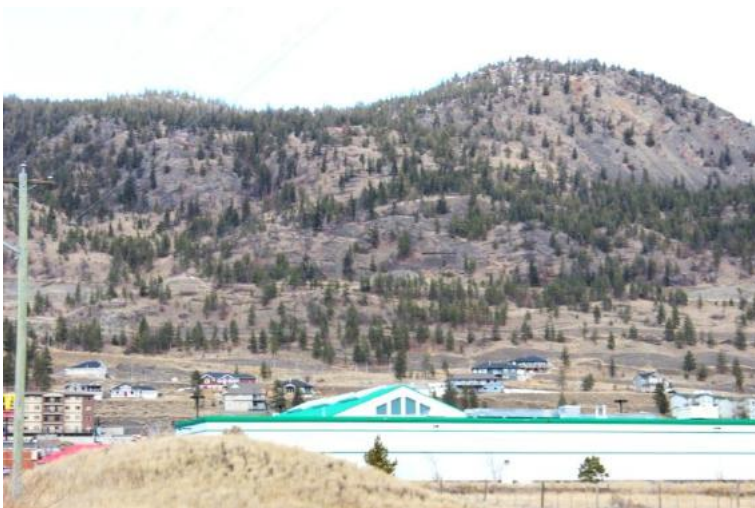
Photo 3: In photo centre, development permit area on steeper slopes above northeast part of Merritt. Hilltop has mainly bedrock and talus.

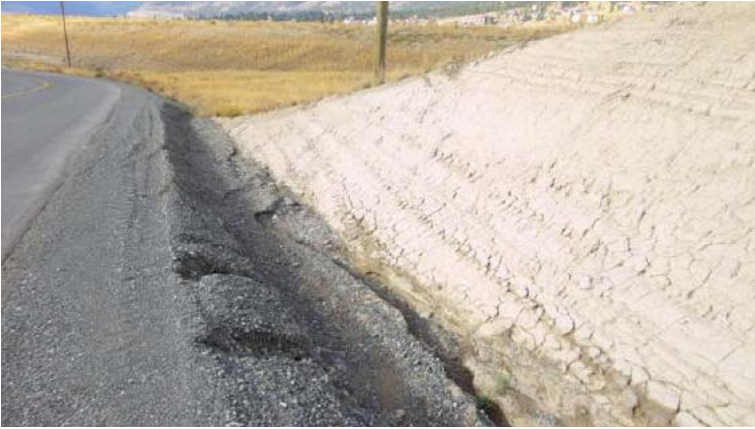
Photo 4: Road cut in horizontally layered lacustrine sediments, with initial rilling of cut and ditch.

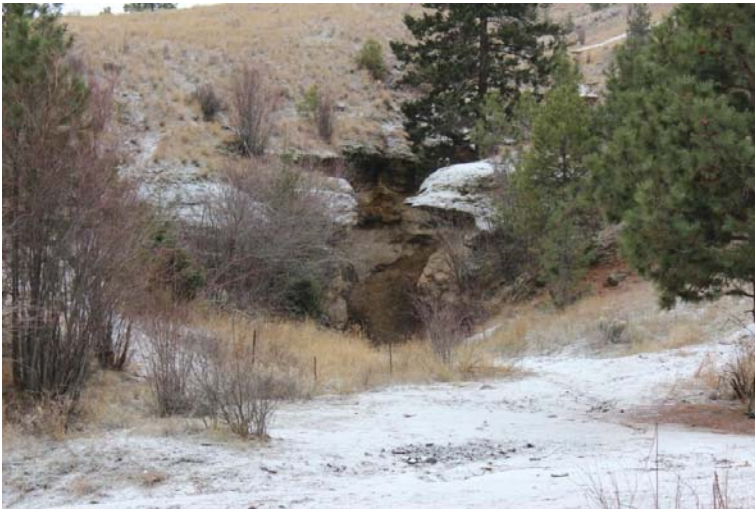
Photo 5: Recent gully from uncontrolled stormwater drainage formed at base of natural old gully, northwest part of Merritt.

After deglaciation, the glacial lake deposits were eroded during incision by the Nicola River along the north boundary of its active meander belt. Steep slopes were left which were gullied and rilled over time by natural drainage. Since land development, uncontrolled stormwater drainage from streets has caused further gullying and ravine formation at a number of locations along the north valley bottom (Photo 10). As well, motorcycle and ATV use along the steep slopes has caused rutting and compaction which has resulted in water redirection and surface erosion. With this new gullying and erosion, the ravines may widen and erode headward, sediment will be deposited downstream and the local slopes may be destabilized.

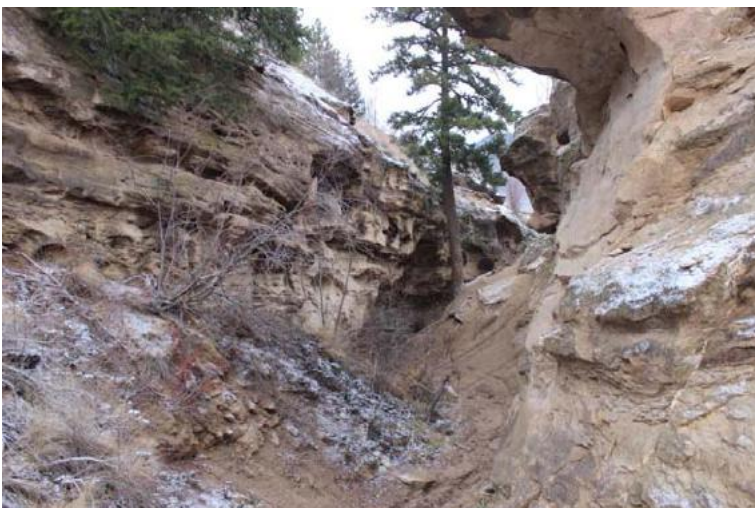
Photo 6: Detail of gully eroded into lacustrine sediment formed by uncontrolled stormwater drainage, northwest part of Merritt.

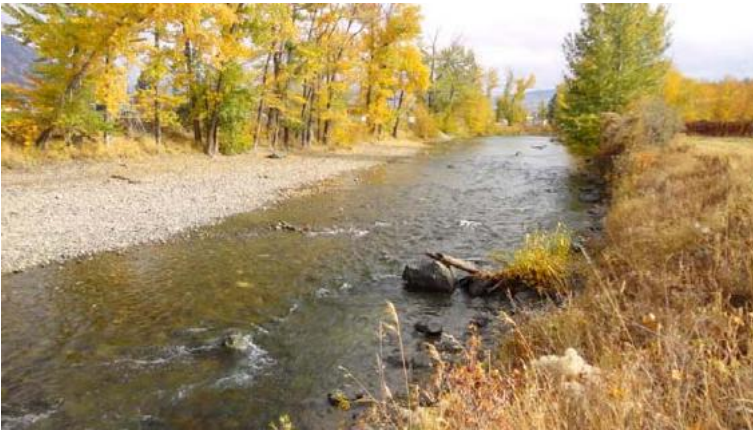
Photo 7: Coldstream River with riparian vegetation and gravel lateral bars.

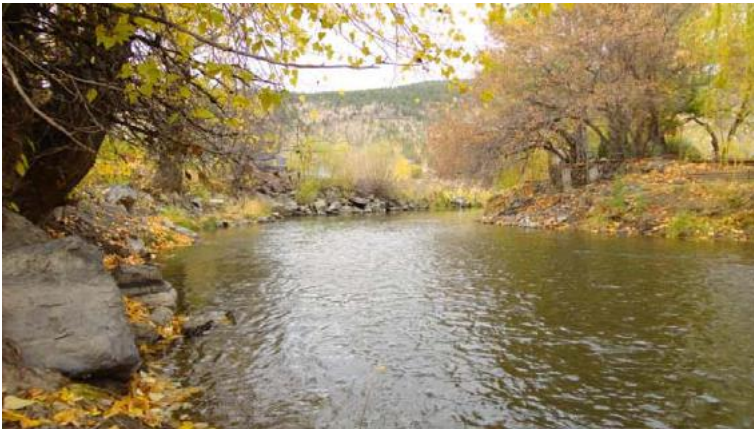
Photo 8: Coldwater River in west part of Merritt, showing bank armour and dikes.

Modern alluvial deposits are found along the rivers and streams (Fulton 1962; Bobrowsky *et al.* 2002) (Photos 7 - 14). The Coldwater River has active bedload transport and frequent cobble and sand lateral bars while the smaller Nicola River has minor bedload transport and tortuous-shaped meanders in its floodplain and less sediment transport and erosion. Late glacial fan deposits are present at the surface at stream mouths along the edge of the valley floor.

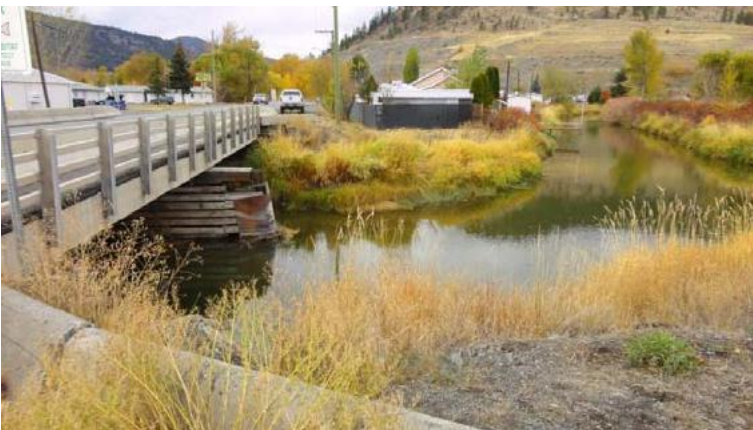
Photo 9: Nicola River in northeast part of Merritt showing road crossing, riparian area and straight channel reach.

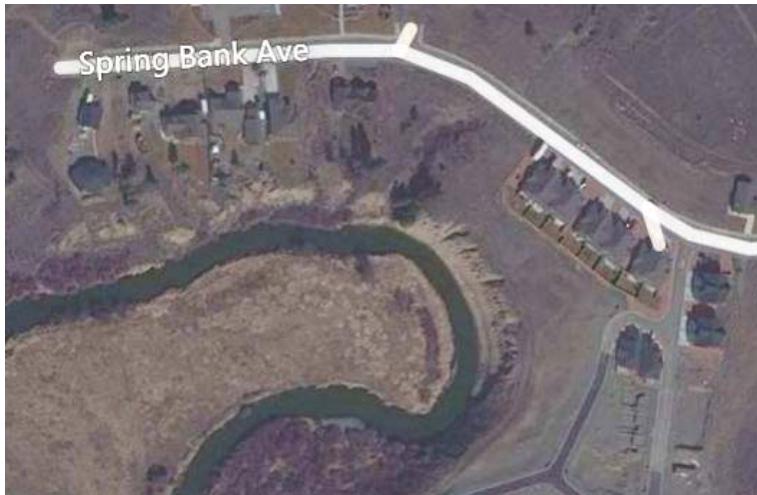
Photo 10: Orthoimage showing details of a Nicola River meander bend with bank erosion (left) and rilling (right), with recent residential development above. Stormwater conveyance and disposal must be carefully managed in such situations.. Bing Map image.

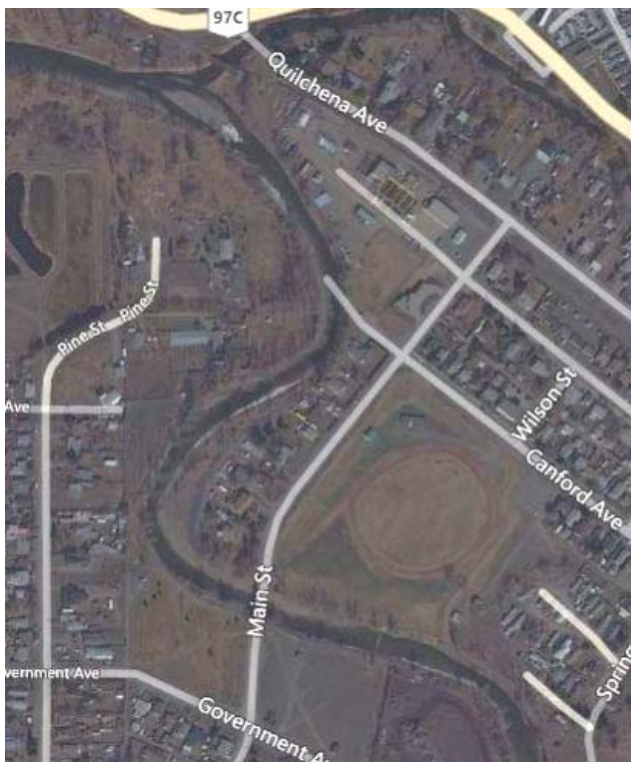
Photo 11: Bing Map image of west side of Merritt with confluence of larger Coldstream River (bottom) and smaller Nicola River (top). The circular park area may be a former coal mining area and is used for floodwater detention.

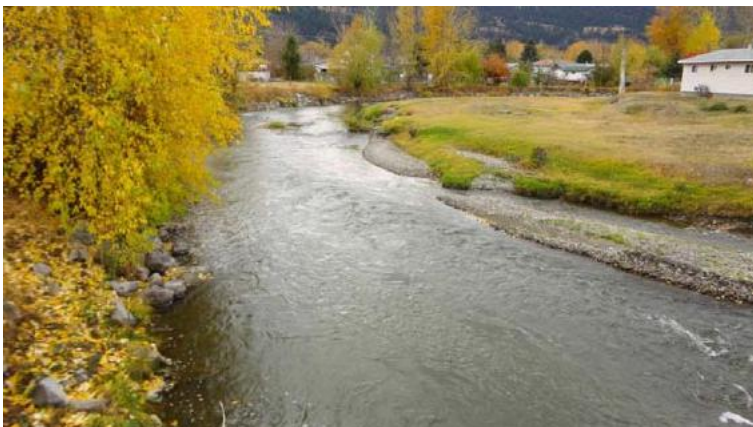
Photo 12: Coldstream River with residential buildings near channel.

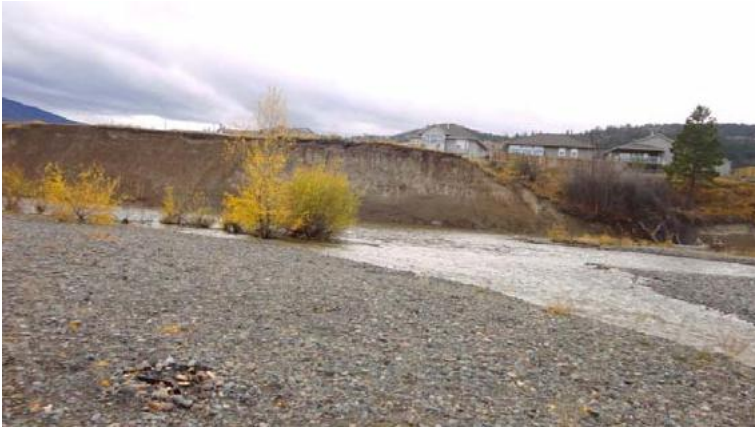
Photo 13: Coldstream River with steep banks in lacustrine sediment, near residential housing.

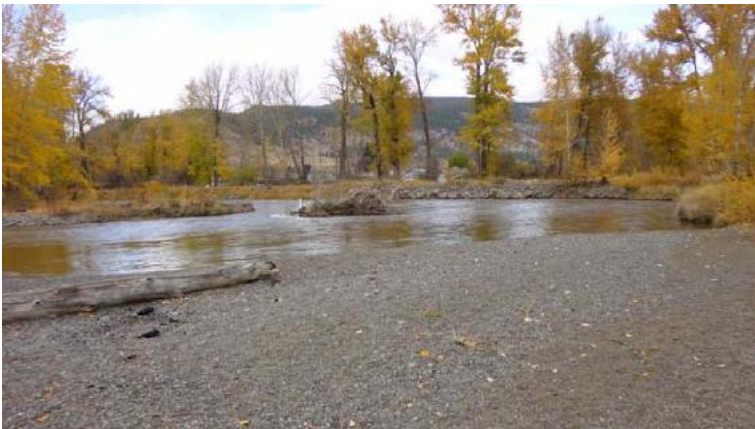
Photo 14: Coldstream River above Merritt with wider channel and gravel islands and bars.

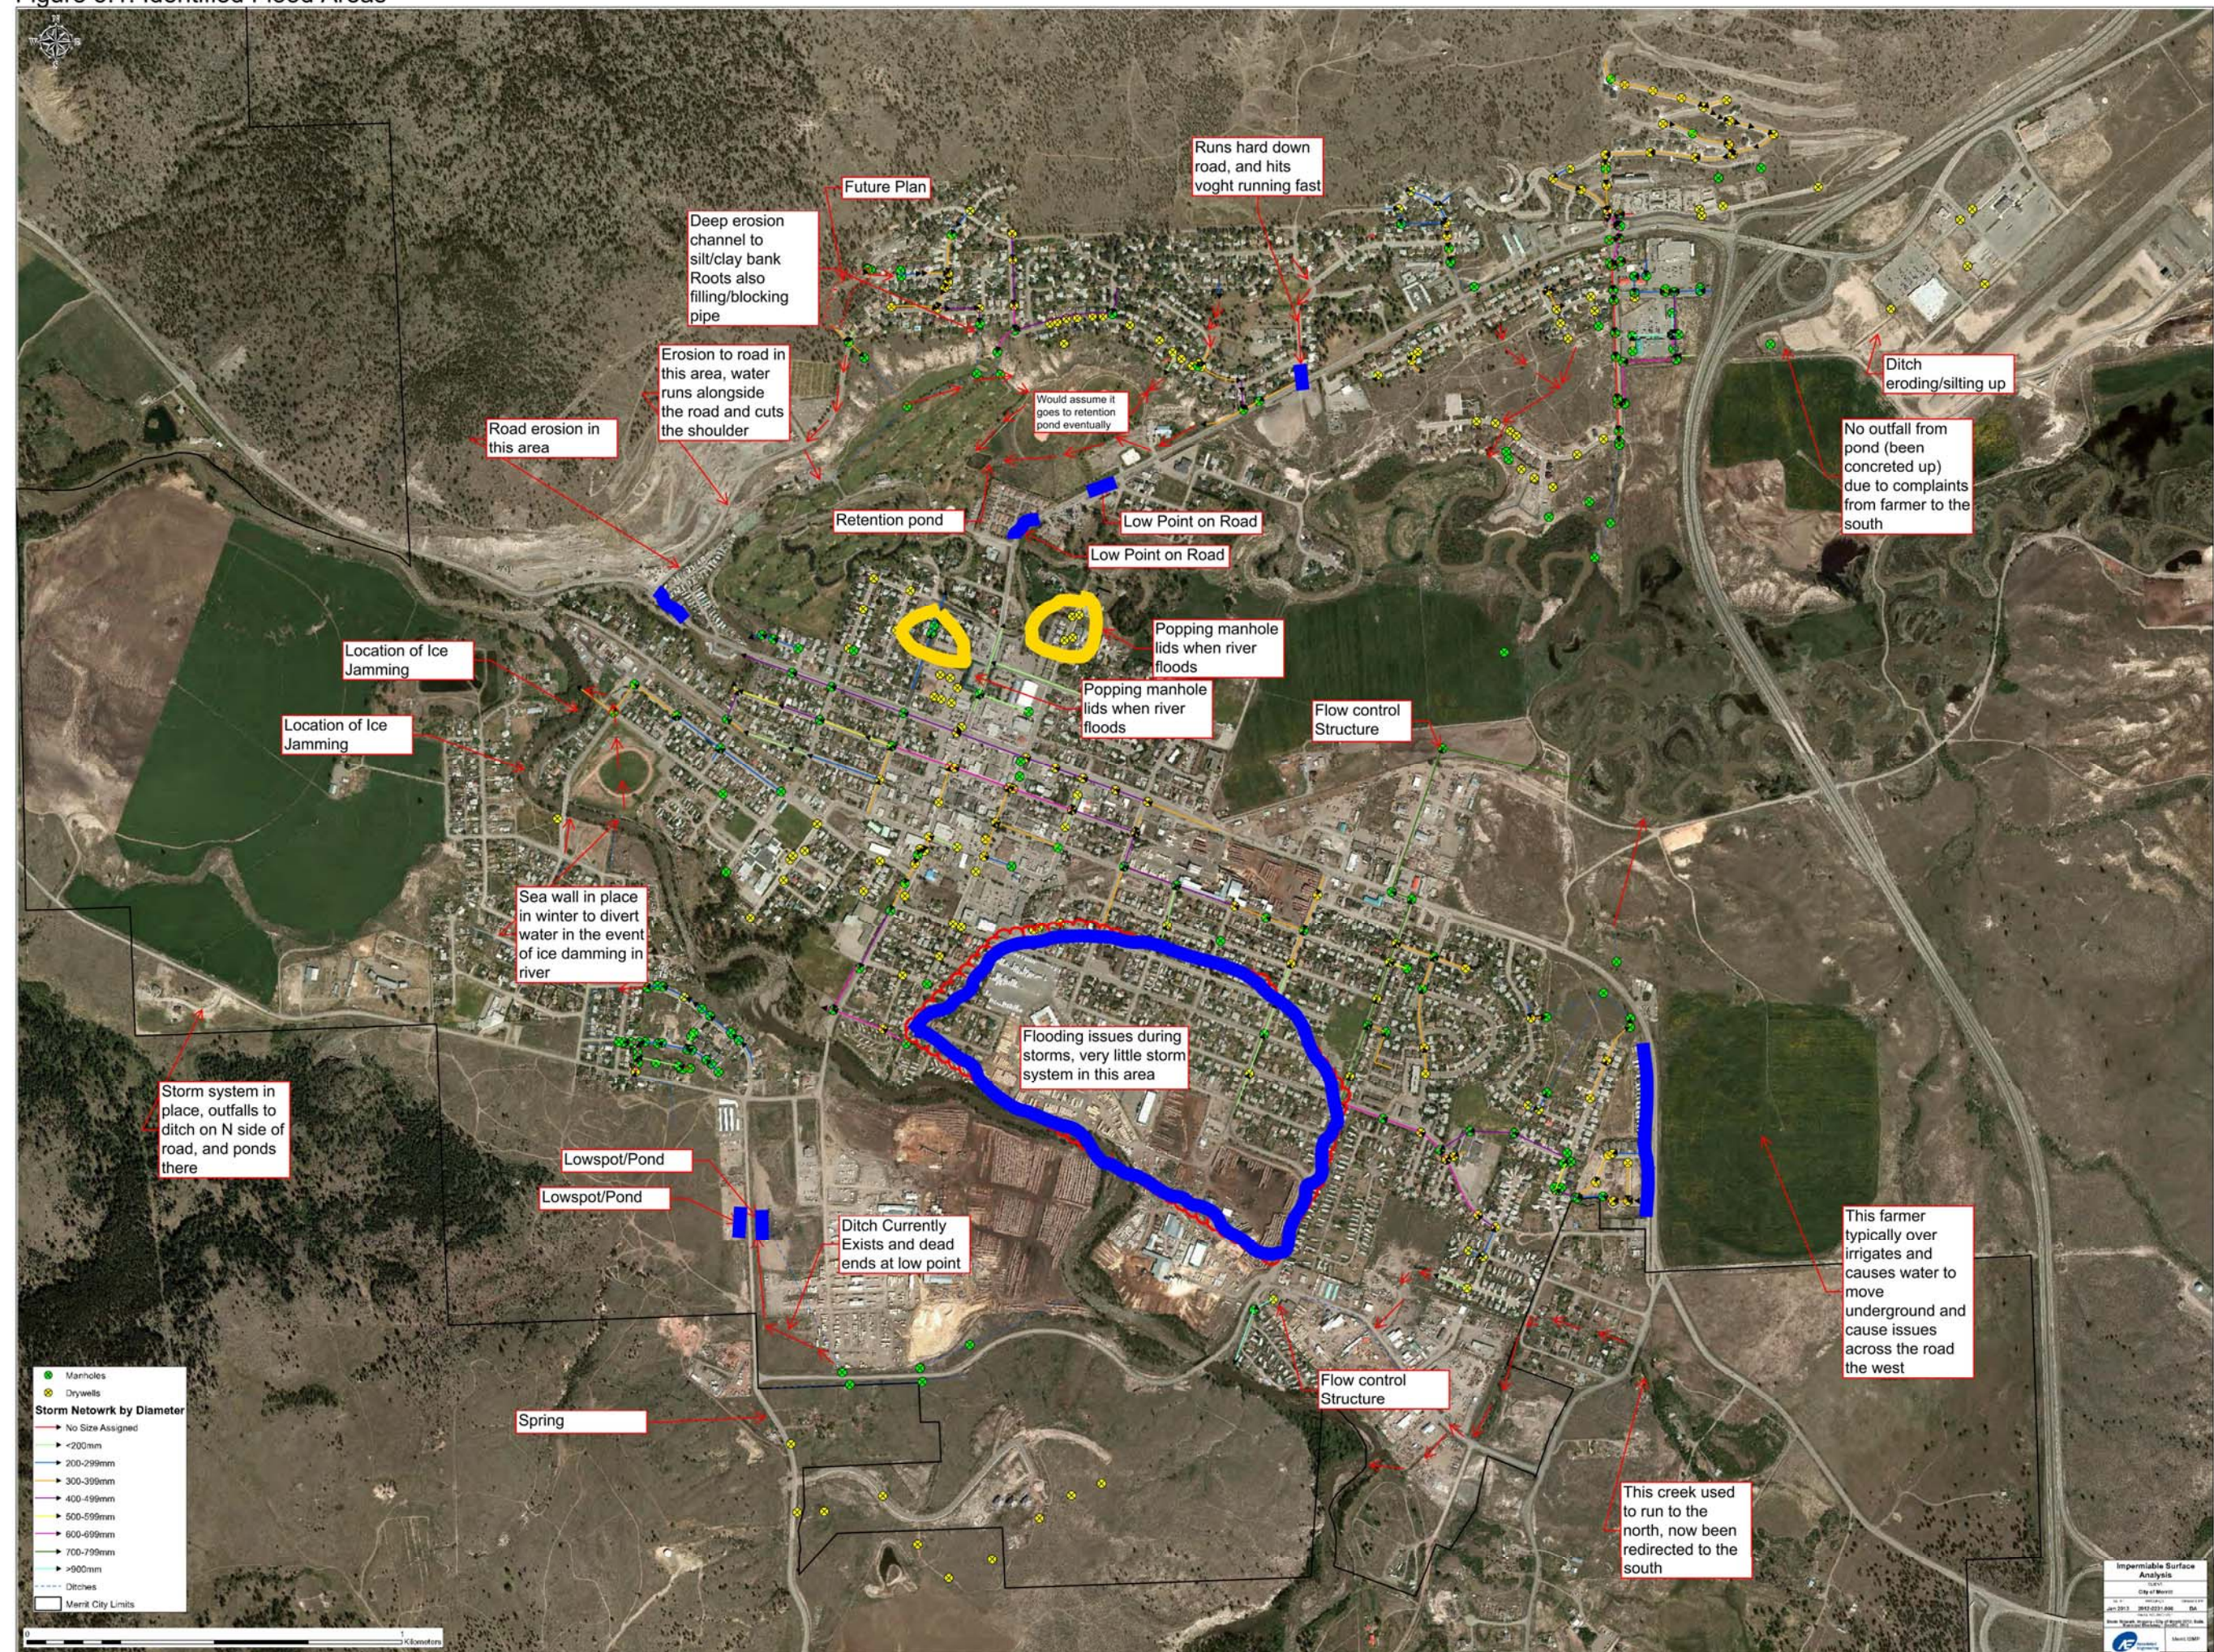
Figure 5.1: Identified Flood Areas

Model results were compared against anecdotal information collected via interviews with City Operations staff. The City does not maintain detailed records of all service call locations listing the magnitude and cause of the flooding issues. However, City staff was able to identify a number of “problem areas” (e.g. main downtown Merritt – north of Coldwater River) that experience chronic flooding. City staff also identified a number of “historic” flood events. **Figures 5.1** below summarizes the identified flood areas.

The base model assumes free outfalls at the system discharges to the Nicola and Coldwater Rivers. When the river outlets are modified to represent the 20-year flood level, the model results show increases in system flooding in the areas North of Merritt Avenue South of the Nicola River. These new flooding areas correlate well with the observed system performance as provided by City staff and summarized in **Figure 5.1**.

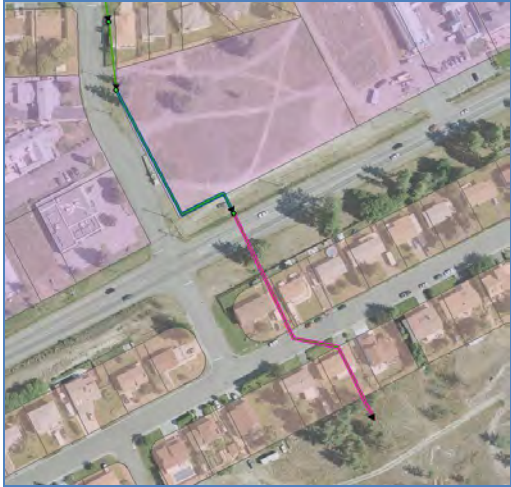
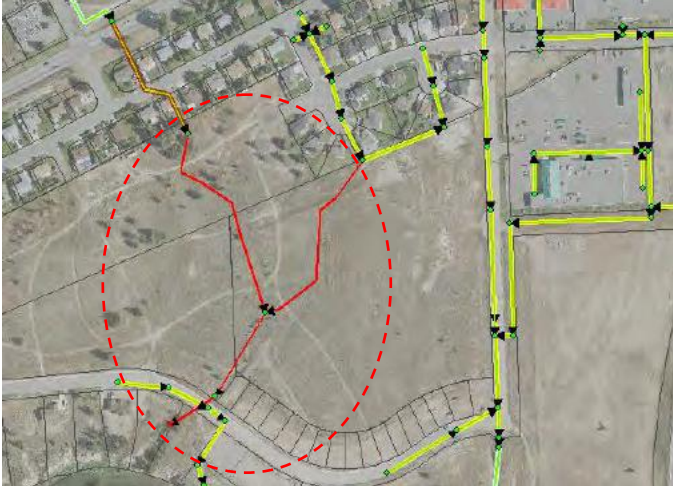
Issue #	Description	Assumption
1.	Missing downstream system: Reference Culvert ID: 35782

Add downstream ditch system to connect system to the Nicola River. Based on contour and orthophotos.

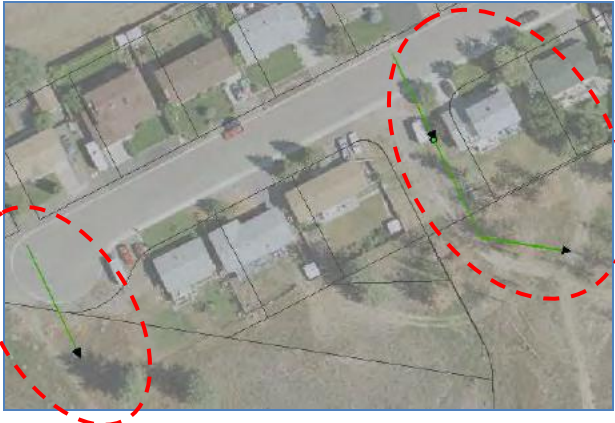
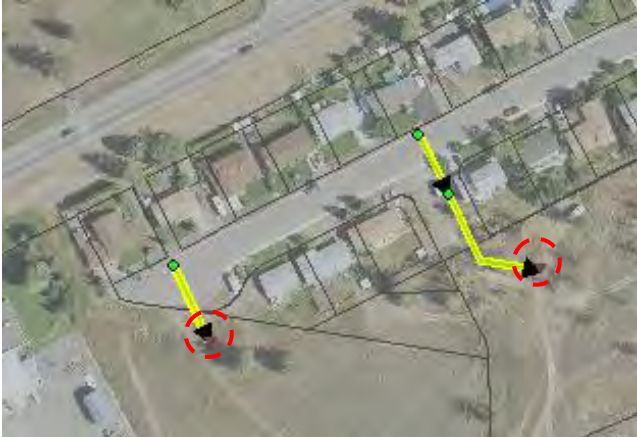
2.	Missing downstream system: Reference Stormmain ID: 4122, 4124

No apparent downstream system. Assume flow infiltrates into the ground. Add model outfalls.

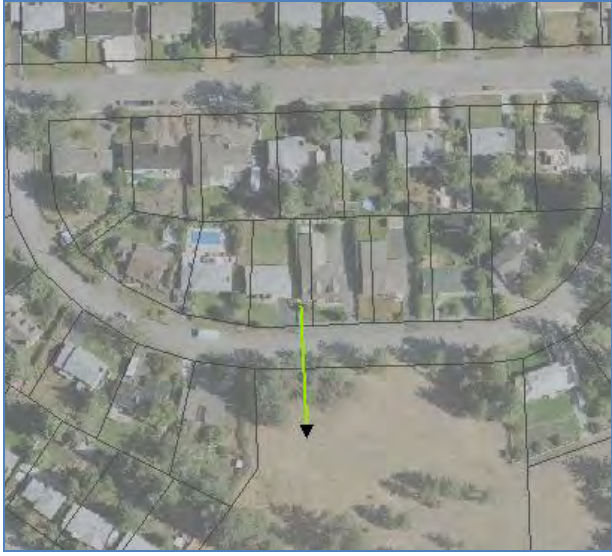
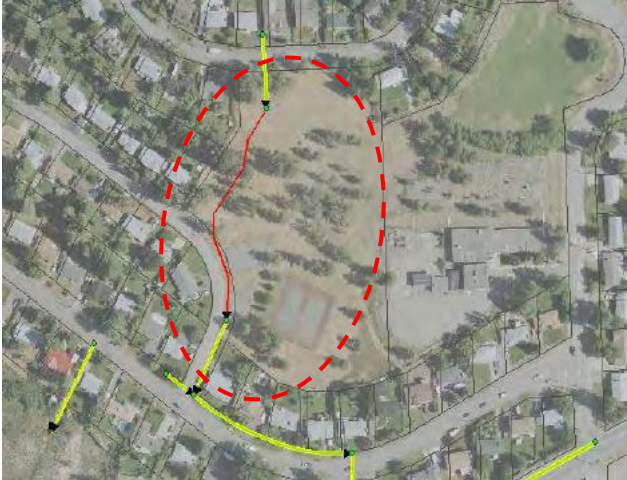
Issue #	Description	Assumption
3.	Missing downstream system: Reference Stormmain ID: 4193

Add ditch to join downstream system to the south. Based on site photos.

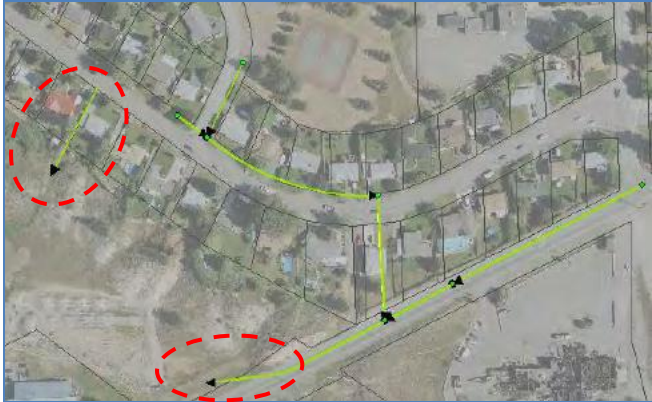
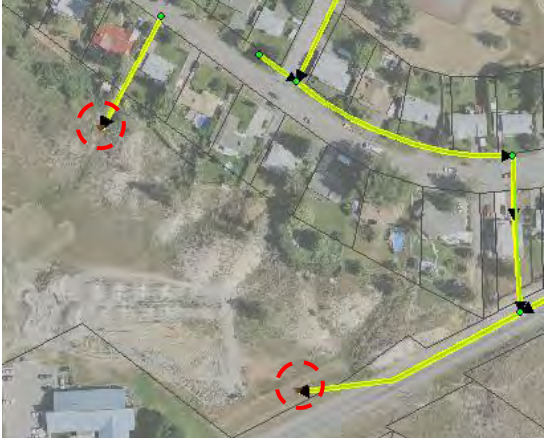
4.	Missing downstream system: Reference Stormmain ID: 4217, 4219

No apparent downstream system. Assume flow infiltrates into the ground. Add model outfalls

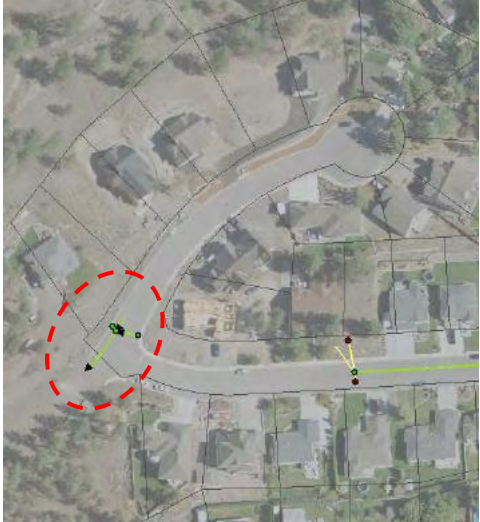
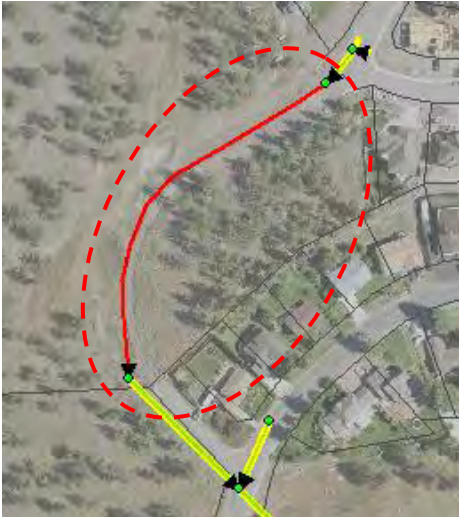
Issue #	Description	Assumption
5.	<p>Missing downstream system: Reference</p> <p>Stormmain ID: 36288</p>

<p>Add ditch to join system to the south. Based on orthophotos and site photos.</p>

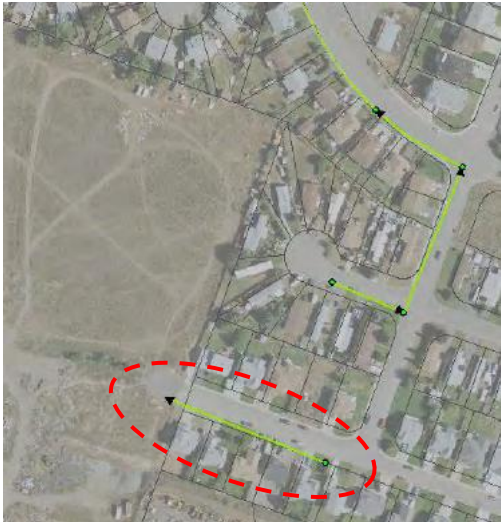
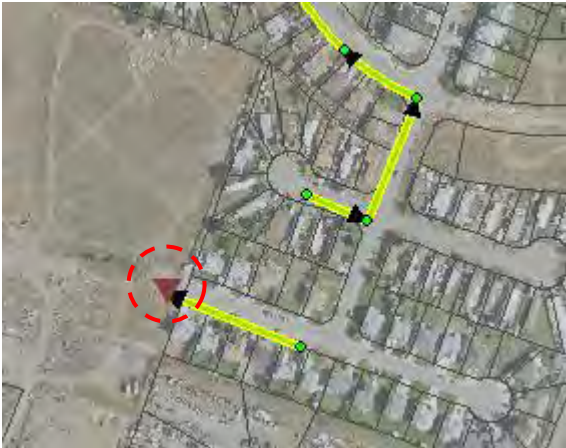
6.	<p>Missing downstream system: Reference</p> <p>Stormmain ID: 4188</p>

<p>No apparent downstream system. Assume flow infiltrates into the ground. Add model outfall.</p>

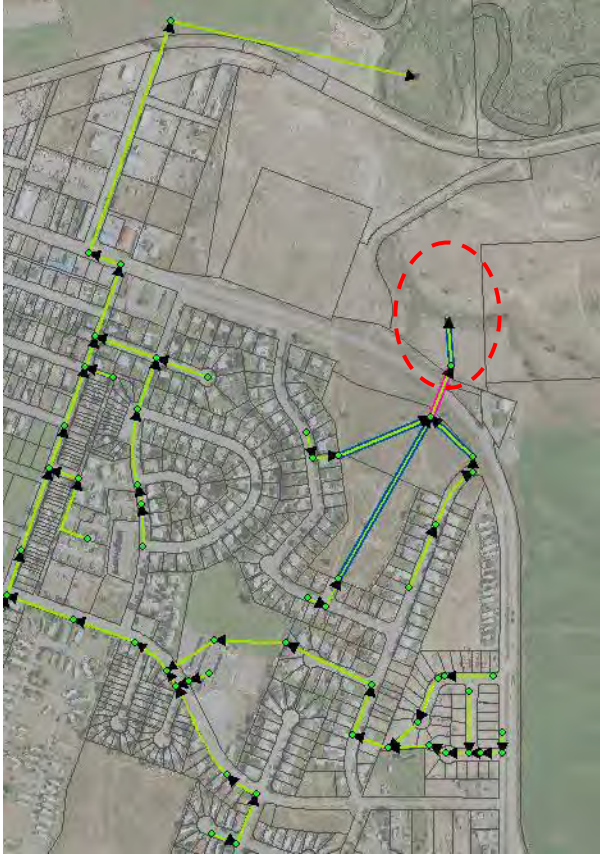
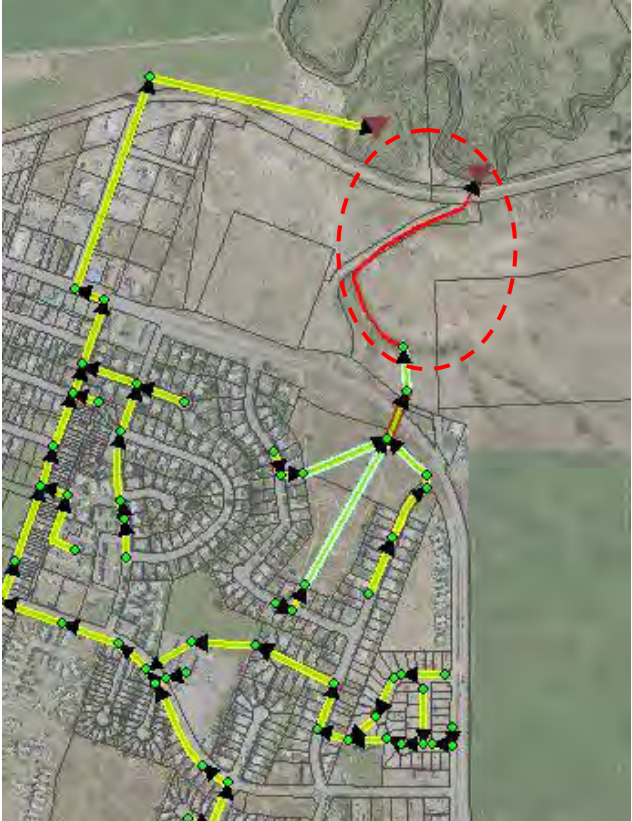
Issue #	Description	Assumption
7.	<p>Missing downstream system: Reference Ditch ID: 35794</p>

<p>Add downstream ditch system to connect system to the Coldwater River. Based on contour and orthophotos.</p>

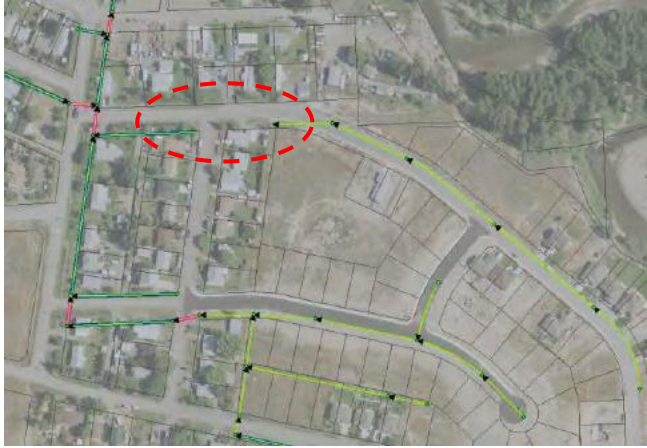
Issue #	Description	Assumption
8.	Missing downstream connection: Reference Stormmain ID: 36339

Add ditch and culvert. Based on site photos.  
9.	Missing downstream connection: Reference Culvert ID: 36219  	Add downstream ditch system to connect system to the Coldwater River. Based on site photos.

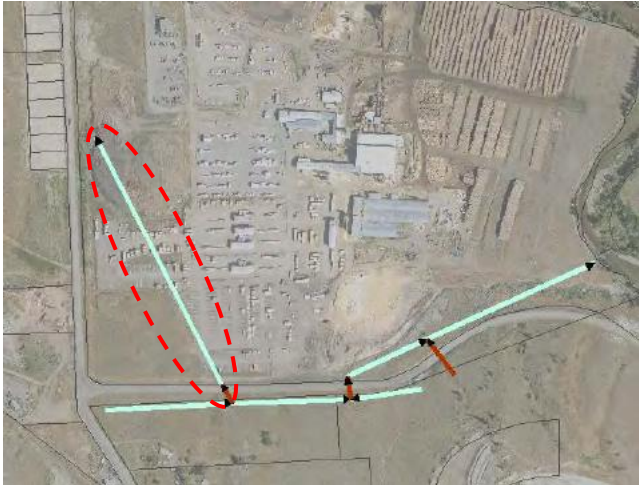
Issue #	Description	Assumption
10.	<p>Missing downstream connection: Reference Ditch ID: 34218. Reference Culvert ID: 36224</p>

<p>To exclude circled ditch and culvert from the model. Based on site photos.</p>
