Trans Canada Trail — Linking Communities Initiative Recreational Route Study — Merritt To Brookmere

Final Report

Friday, 2nd June, 2000

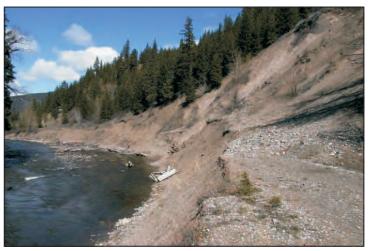
(May, 2000) a major deterrent to through traffic. Although there are indications of foot traffic and a rudimentary trail across it, the Coldwater River is cutting away at the base and the uphill clay and gravel slope is unstable.

Fig. 7. Washout and landslide near KM 2.2. Viewed from the south. (Date: 2000-04-24—By: Murphy Shewchuk.)

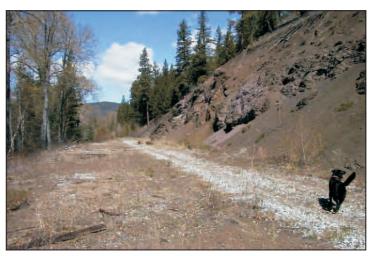
Fig. 8. The KVR right-of-way near KM 2.5 on the Patchett - Kingsvale section. (Date: 2000-04-24 — By: Murphy Shewchuk.)

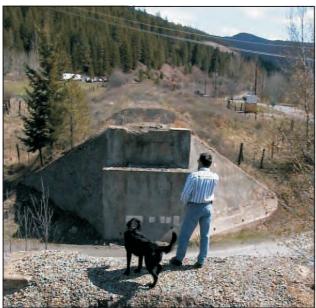
Fig. 10. Voght Creek Bridge abutments at KM 9.4. (Date: 2000-04-24 — By: Murphy Shewchuk.)

9.0 to 9.5 km	Create suitable access routes from the railway grade to Coldwater Road to bypass the missing bridge over Voght Creek and the Coldwater Road.

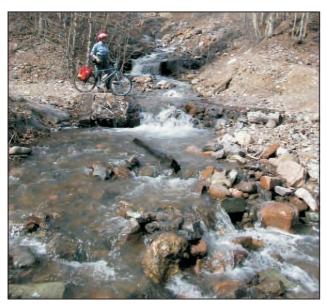
Fig. 11. "Salt Creek" near Brodie - KM 21.2. (Date: 2000-04-18 — By: Murphy Shewchuk.)

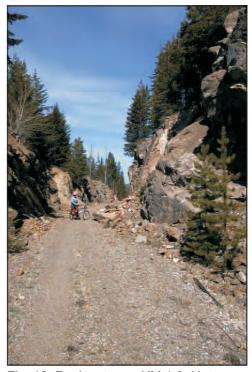
Fig. 12. Rock cut near KM 1.9. Note cyclist near centre of photograph. (Date: 2000-04-18 — By: Murphy Shewchuk.)

The right-of-way goes through a rock cut at KM 1.9. Some of the material may be suitable for remedial work elsewhere along the route. There are several culverts near KM 3.5 that will require cleaning and/or replacement. There are also three wooden bridges along the route at KM 3.76, KM 5.21 and KM 5.45. These will require decking and handrails for maximum safety. As this is a high snow area, the design should take snow load into consideration. Brush is encroaching on the grade in numerous places. The cuttings could serve to stabilize the bank in several locations including the washouts near Juliet.

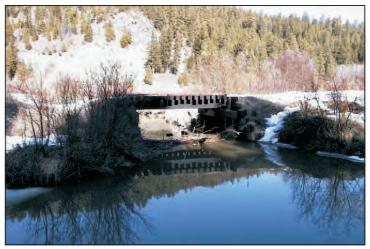
Condition: (2000-04-04) Rotting curbs and dry ties. Some debris and large rocks near upstream entrance. May prompt beaver dam construction.

Fig. 13. Note debris build-up upstream from bridge. (Date: 2000-04-02 — By: Murphy Shewchuk.)

Work: Curbs to be replaced. Decking and handrails to be installed. Channel could be cleared to minimize future problems.

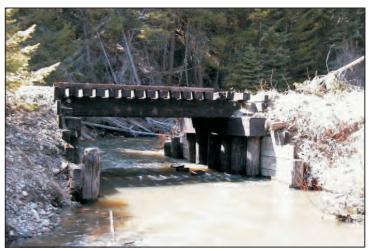
Condition: (2000-04-04) Rotting curbs and dry ties.

Fig. 14. Channel curves before and after bridge. Beaverdam upstream from bridge.

Work: Curbs to be replaced. Decking and handrails to be installed.

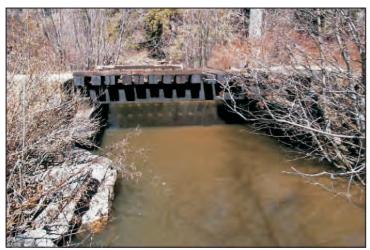
Fig. 15. Brook Creek Bridge # 3. View from upstream side. (Date: 2000-04-26 — By: Murphy Shewchuk.)

Description: Wooden bridge 16 ft (5 metres) long. Bridge deck approximately 8 ft (2.5 metres) above creek bed.

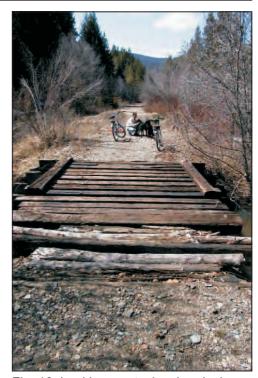
Fig. 16. Looking west, showing deck and KVR RoW.

Condition: Brush growing in around bridge. Downstream channel is packed with brush. Ties missing at east end of bridge.

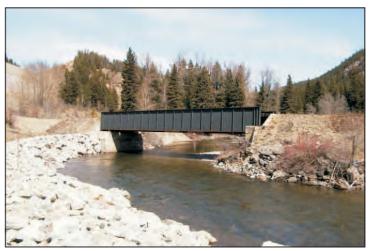
Condition: Some cracked ties. Otherwise in good condition.

Fig. 17. Coldwater Bridge # 1 (Brodie) looking north. (Date: 2000-04-18 — By: Murphy Shewchuk.)

Work: Curbs to be replaced. Decking and handrails to be installed.

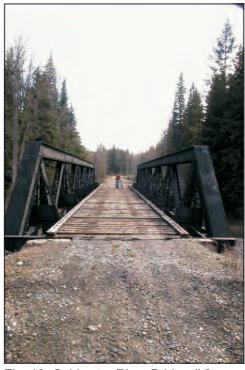
Condition: Good condition. Steel work requires paint.

Fig. 18. Coldwater River Bridge # 2. (Date: 2000-04-26 — By: Murphy Shewchuk.)

Work: Curbs to be replaced. Decking and handrails to be

installed.

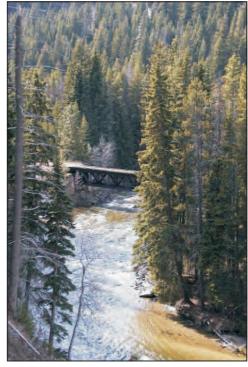
Condition: Some cracked ties. Otherwise in good condition.Work: Curbs to be replaced. Decking and handrails to be

Fig. 19. Coldwater River Bridge # 3. (Date: 2000-04-18 — By: Murphy Shewchuk.)

installed.

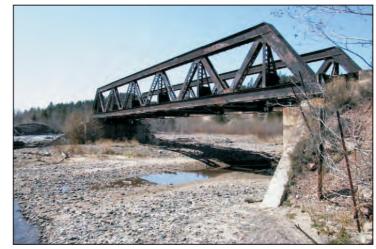
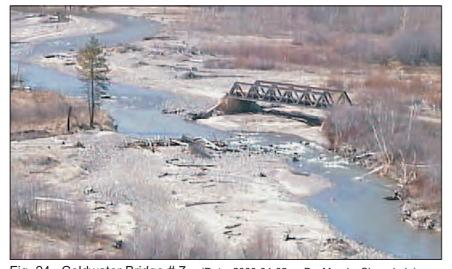
Condition: South approach washed out -- Coldwater River bypasses bridge.

Fig. 23. Coldwater Bridge # 7. (Date: 2000-04-19 — By: Murphy Shewchuk.)

Fig. 24. Coldwater Bridge # 7. (Date: 2000-04-02 — By: Murphy Shewchuk.)

Work: Due to numerous washouts and other conflicts, this bridge is not part of the recommended trail system.

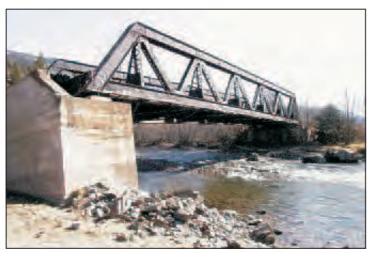
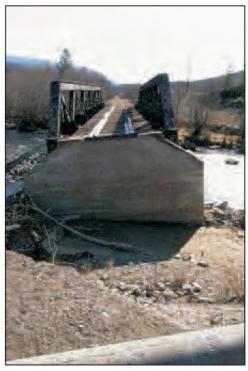
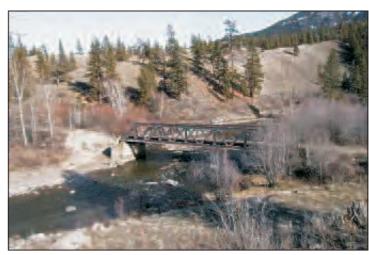
Fig. 25. View from downstream at north side of bridge. (Date: 2000-03-30 — By: Murphy Shewchuk.)

Fig. 26. View from railway RoW from north side of bridge. Date: 2000-03-30 — By: Murphy Shewchuk.)

Description: Steel frame bridge approximately 115 ft (35 metres) long. Bridge deck approximately 20 ft (6 metres) above Coldwater River bed.

Fig. 27. View from hillside on southwest side of bridge looking northeast toward Coldwater Road. Date: 2000-03-30 — By: Murphy Shewchuk.)

Work: Curbs to be replaced. Decking and handrails to be installed. Ties to be replaced.

Note: Due to numerous washouts and other conflicts, this bridge is not part of the recommended trail system.

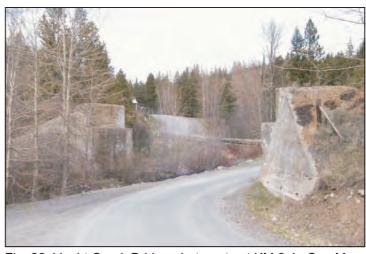
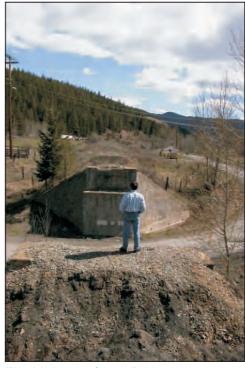
Description: Bridge has been removed due to restricted clearance and planned Coldwater Road re-alignment.

Fig. 28. Voght Creek Bridge abutments at KM 9.4. See Map 8 on page 25. (Date: 2000-04-02 — By: Murphy Shewchuk.)

Fig. 29. Voght Creek Bridge abutments at KM 9.4. See Map 8 on page 25. (Date: 2000-04-02 — By: Murphy Shewchuk.)

Work: An access route around the missing bridge will have to be constructed. The map below shows two options. The northern option through Lot 607 would allow access to the Coldwater Road north of the anticipated re-alignment. Access through the Trans Mountain Pipe Line right-of-way may be a short-term solution.

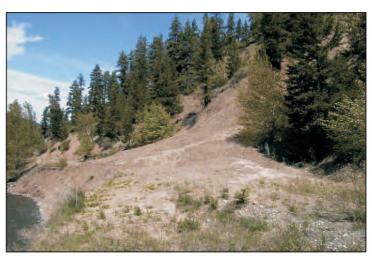
This mud "fan", according to Bill Strande, has been a recurring problem that has plagued the railway for years. It appears to be due to an accumulation of run-off water above the RoW and subject to movement in spring or after a heavy rain. It is also being undermined by the Coldwater River in flood years.

Fig. 30. Mudslide area approximately 0.6 km south of Patchett Road. (Date: 2000-05-24 — By: Murphy Shewchuk.)

The solution here may be to allow it to build and "groom" the surface periodically to make it easier to traverse.

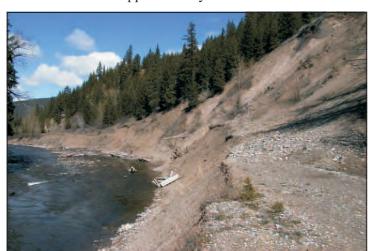
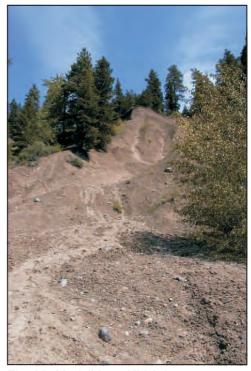
Mudslide and Washout: KM 2.2

This combination mudslide/washout at KM 2.2 is likely the most significant on the route between Patchett and Brodie. The Coldwater River has removed approximately 100 metres of railbed on a wide

Fig. 31. Mudslide/washout at KM 2.2 looking north. (Date: 2000-04-24 — By: Murphy Shewchuk.)

Fig. 32. Mudslide at KM 2.2. (Date: 2000-05-24 — By: Murphy Shewchuk.)

curve and could remove more during the next major flood. The clay and gravel hillside above (east) of the washout has slowly eroded into several relatively shallow gullies which continue to erode during spring runoff and rain or windstorms.

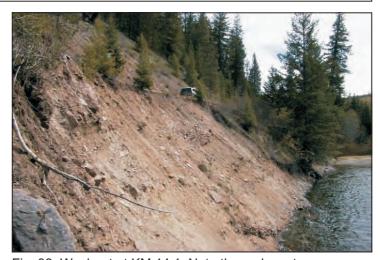
Washout: KM 14.1

Fig. 33. Washout at KM 14.1. Note the rocky outcrops near the base. (Date: 2000-05-08 — By: Murphy Shewchuk.)

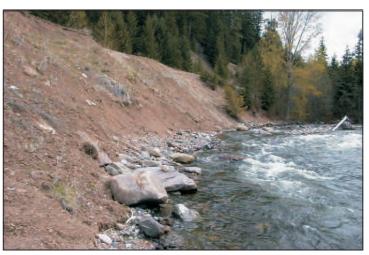
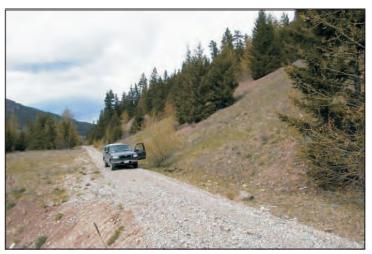
Fig. 34. Washout at KM 14.9. Note the growth starting on the embankment. (Date: 2000-05-08 — By: Murphy Shewchuk.)

Fig. 35. Washout at KM 14.9. Note the embankment above the right-of-way. (Date: 2000-05-08 — By: Murphy Shewchuk.)

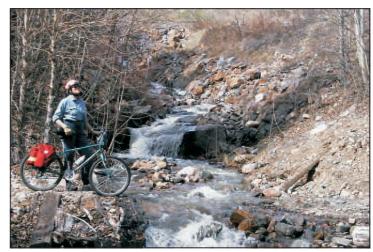
(N 49° 49.03′ W 120° 56.09′)

Fig. 36. Salt Creek, near Brodie. (Date: 2000-04-18 — By: Murphy Shewchuk.)

As with the mudslide near Patchett Road, the solution here may be to periodically "groom" the fan and allow it to build and stabilize. It does not appear to be undermined by the Coldwater River.

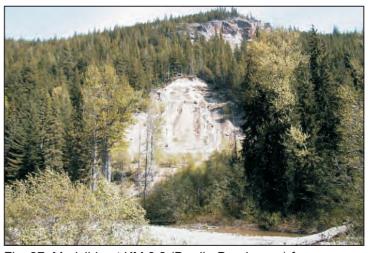
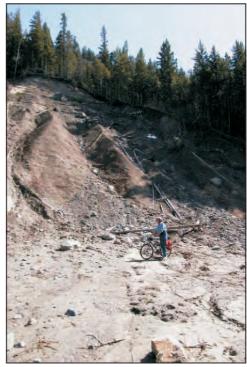
The first problem area is a mudslide at KM 0.8. The 100-metre-wide fan of the slide has spread across the right-of-way, however it doesn't pose a significant hazard to self-propelled traffic. A land slump has split the right-of-way diagonally at KM 0.9. This may have been caused by a blocked culvert saturating the rail grade. The culvert has been cleaned out and the land appears stable. It is not being undermined by the Coldwater River.

Fig. 37. Mudslide at KM 0.8 (Brodie-Brookmere) from across Coldwater River. (Date: 2000-05-24 — By: Murphy Shewchuk.)

Fig. 38. Mudslide at KM 0.8 (Brodie-Brookmere). Note cyclist on the right-of-way near the centre of the slide. (Date: 2000-04-18 — By: Murphy Shewchuk.)

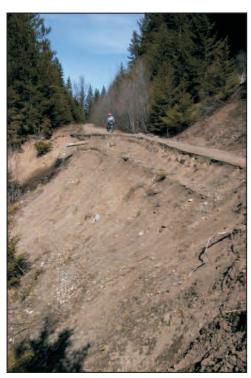
Land subsidence: KM 0.9

Fig. 39. Land slump or subsidence at KM 0.9.

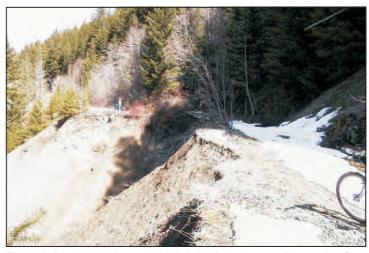
A major washout has occurred at KM 1.2. The Coldwater River has undermined the bank and the feeder creek has contributed to the problem. A trail has been cut around the washout at grade level, but remedial work will have to be done for long-term stability. Engineering advice should be sought here.

Fig. 40. Major washout at KM 1.2. Note the cyclist on the far side of the washout and that trail goes through trees in the middle right of the photograph.
