## **CITY OF MERRITT**

### **2015 MERRITT BRIDGE INSPECTION REPORT**

**Issued: December 15, 2015**

**WATSON ENGINEERING LTD.**

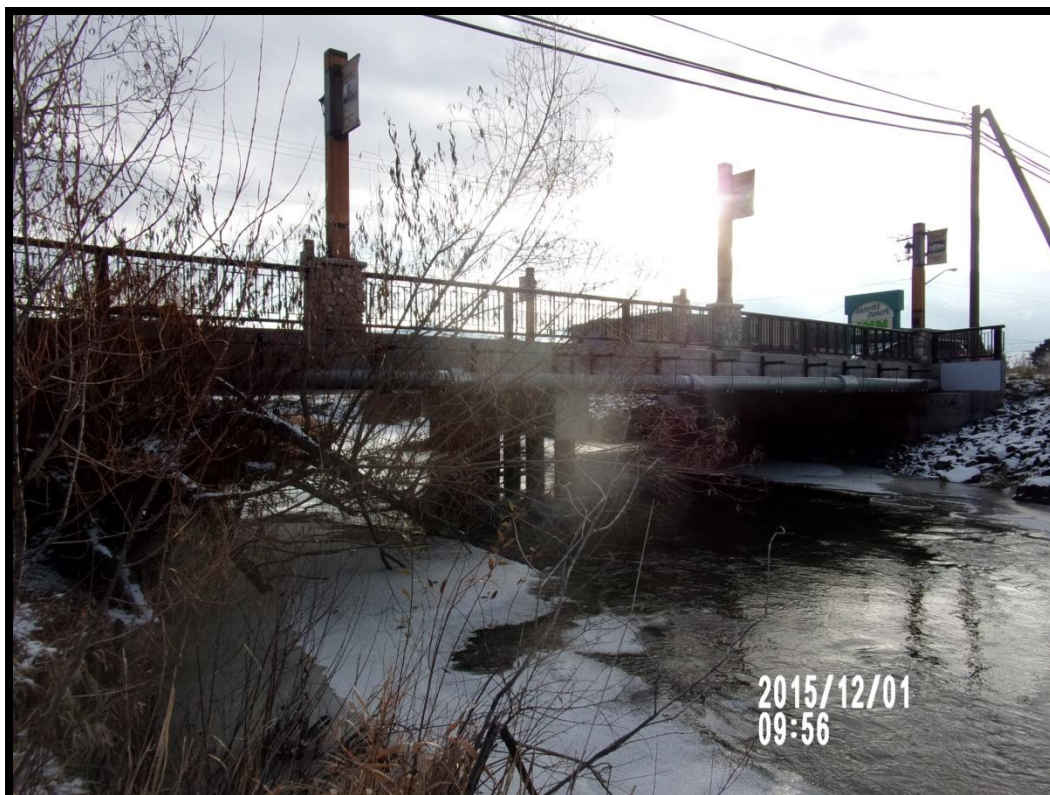
Photo #03. View Of Structure From West Bank Upstream.

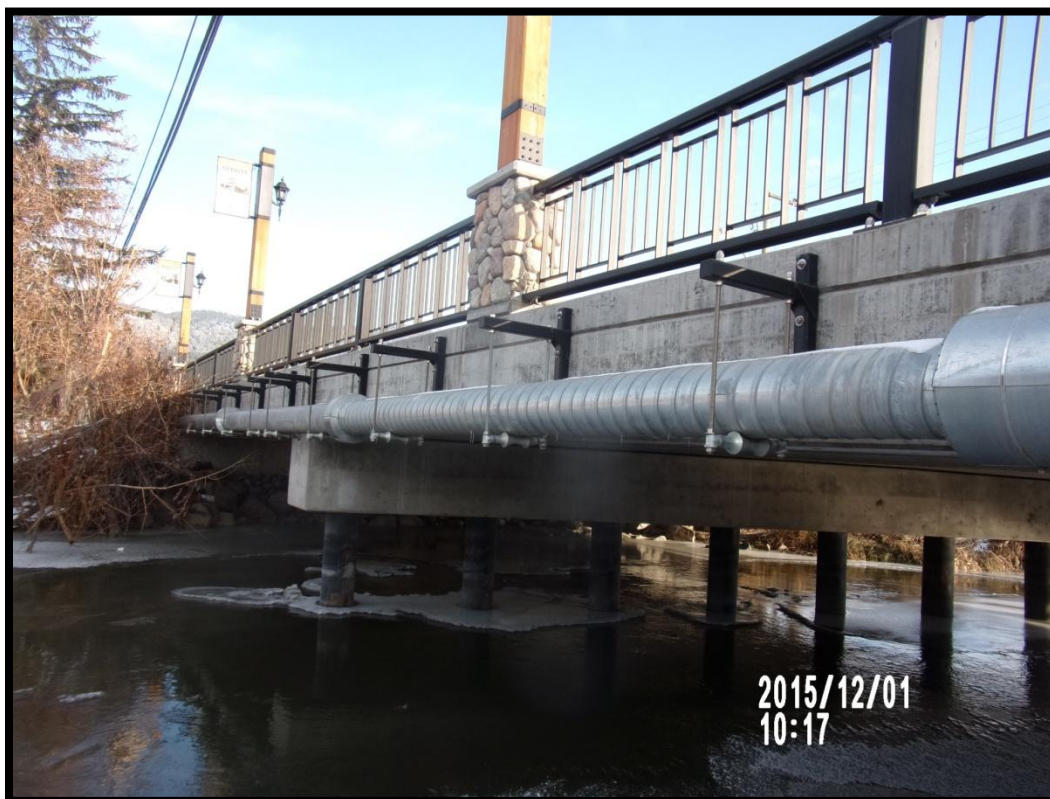
Photo #04. View Of Structure From West Bank Downstream.

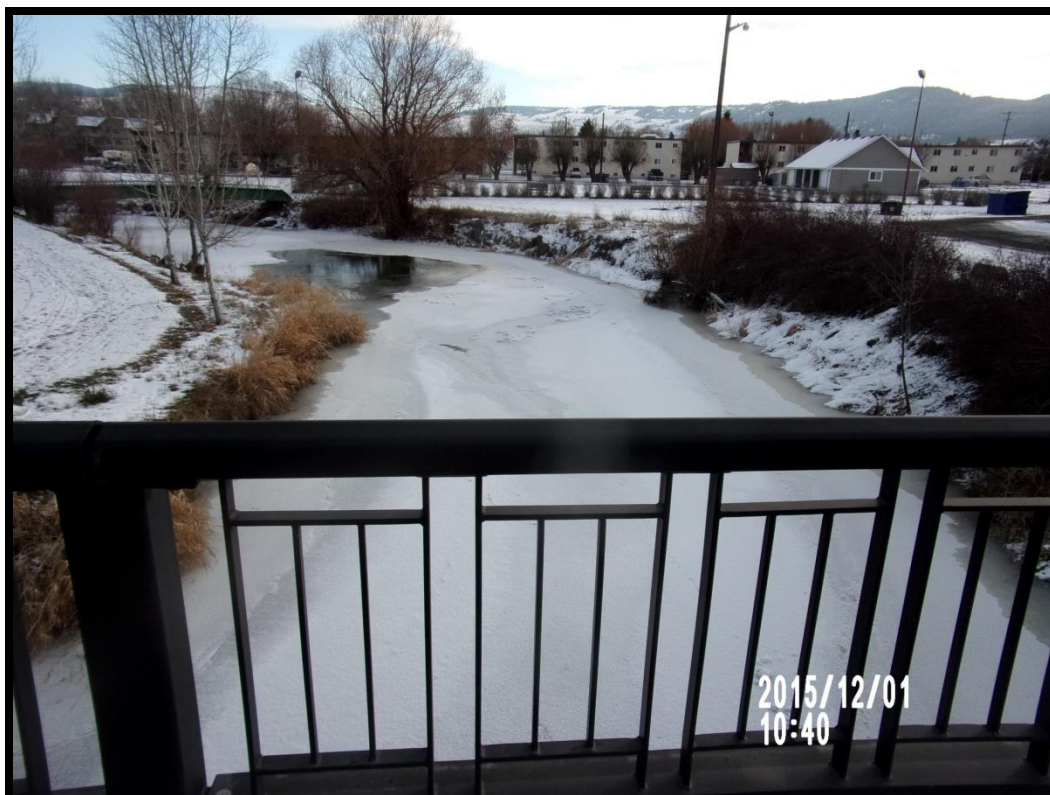
Photo #05. View Upstream.

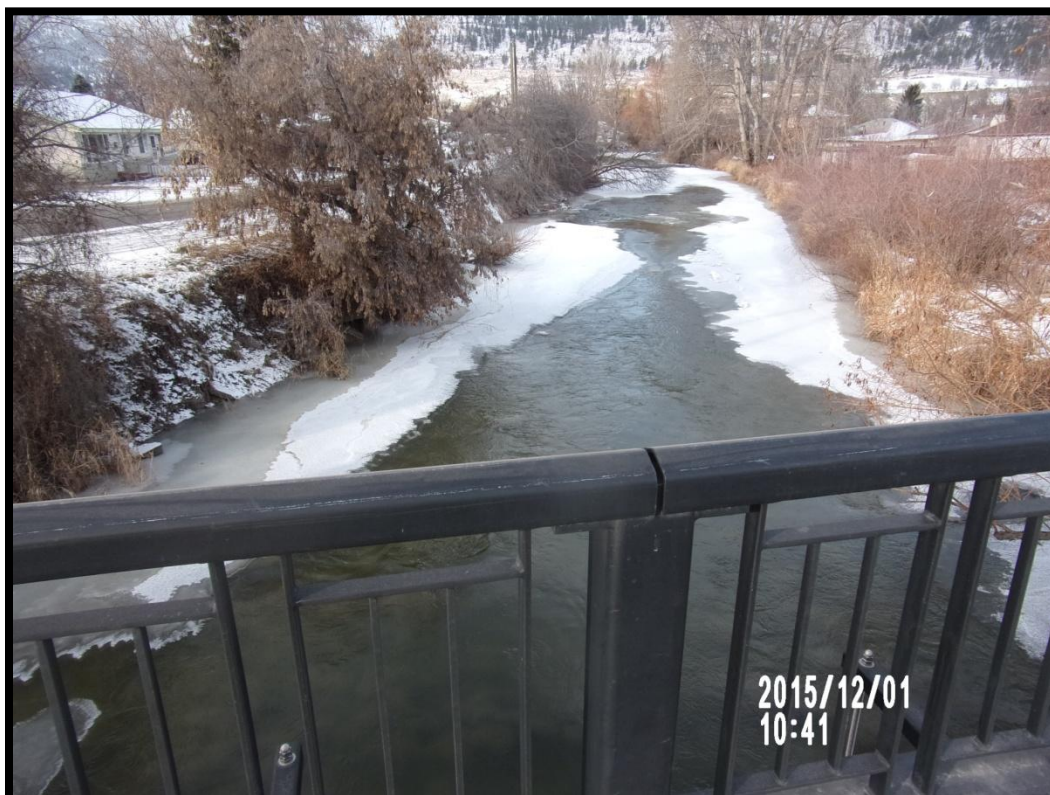
Photo #06. View Downstream.

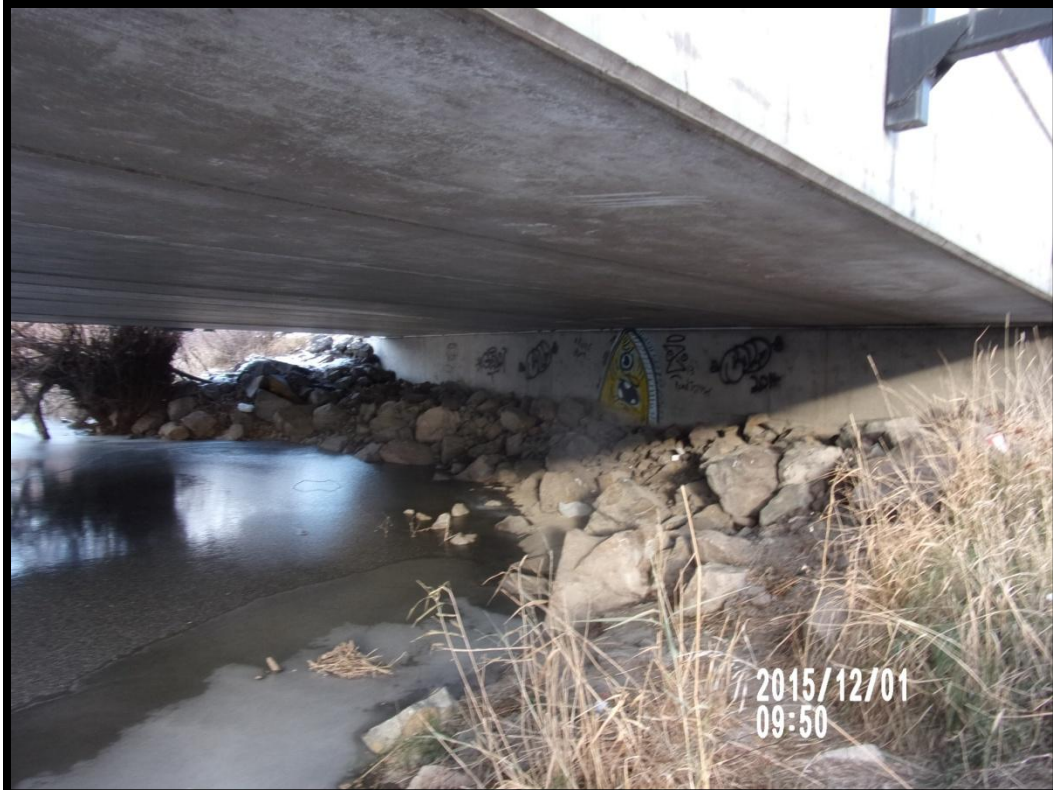
Photo #7. Rip Rap On East Abutment.

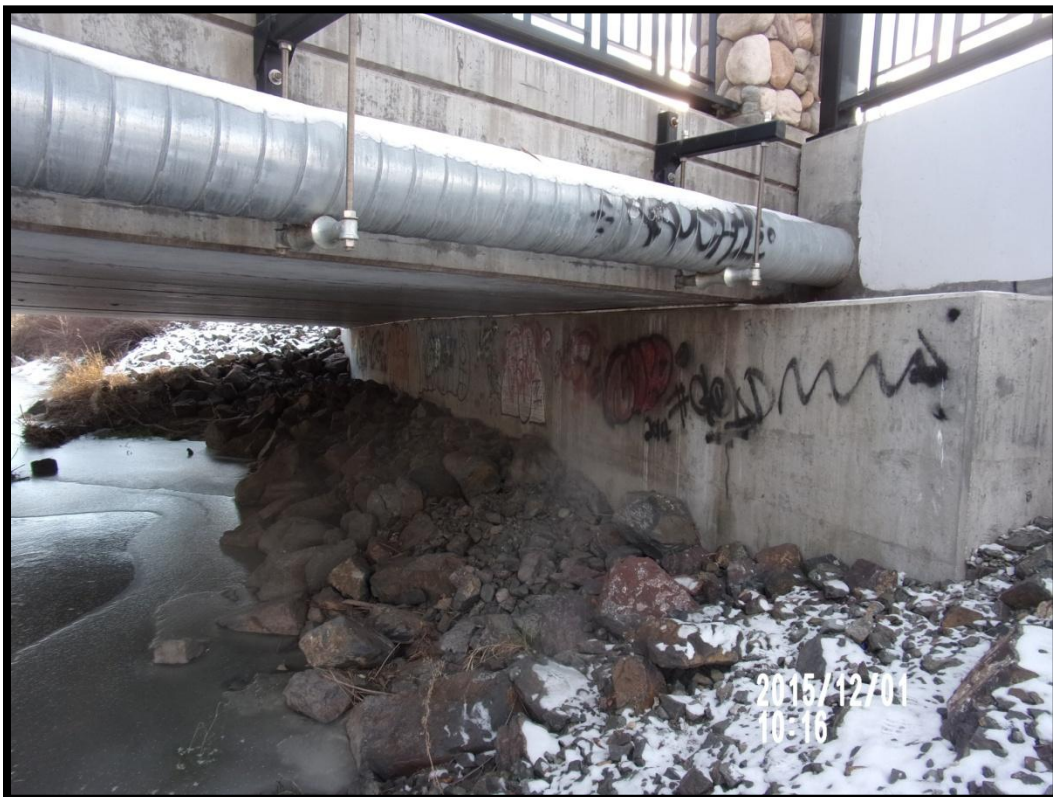
Photo #8. Rip Rap On West Abutment.

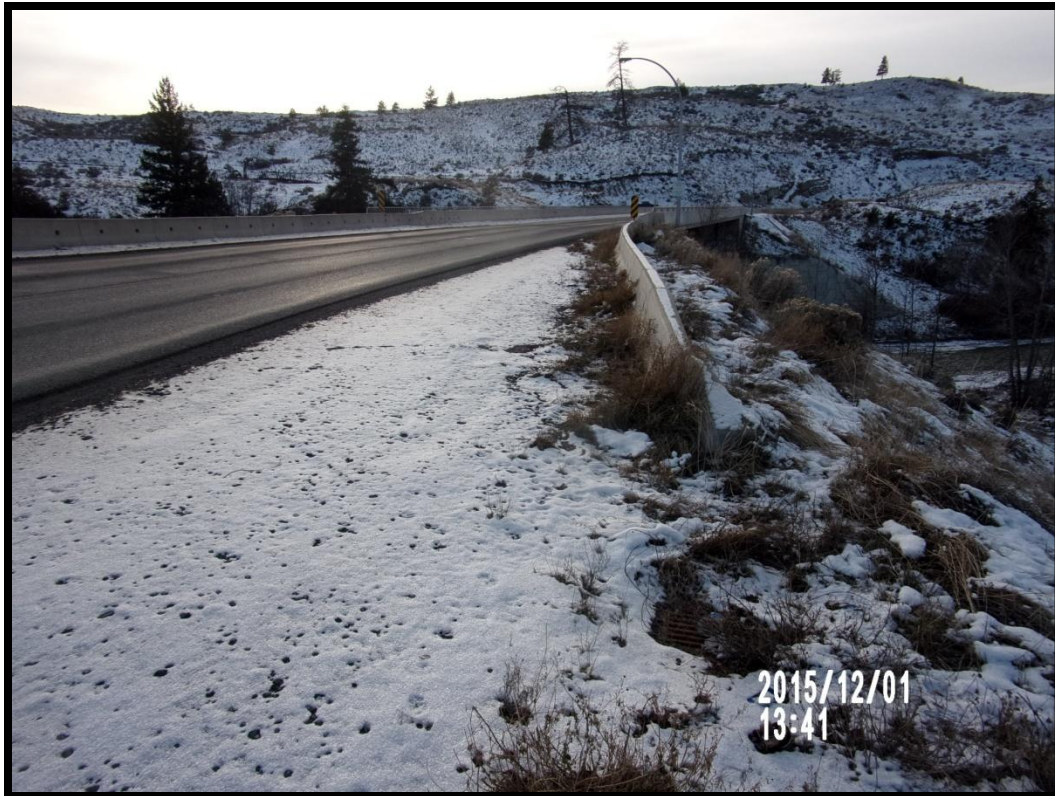
Photo #01. View Of Structure From North Approach.

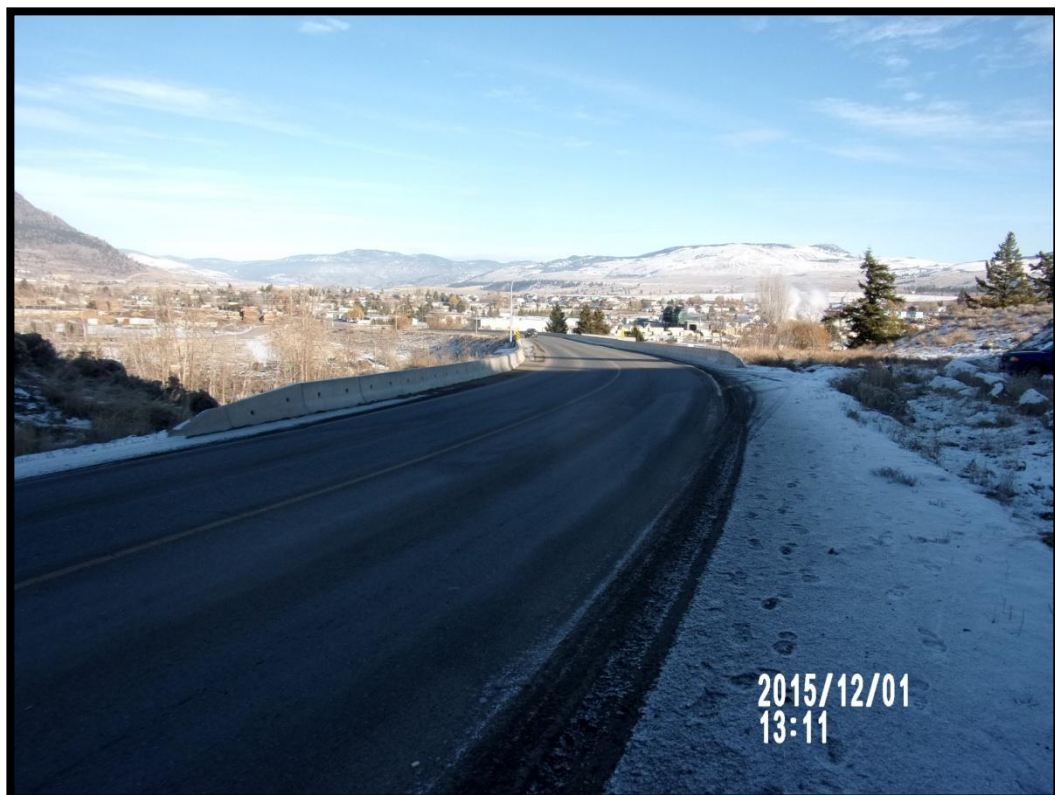
Photo #02. View Of Structure From South Approach.

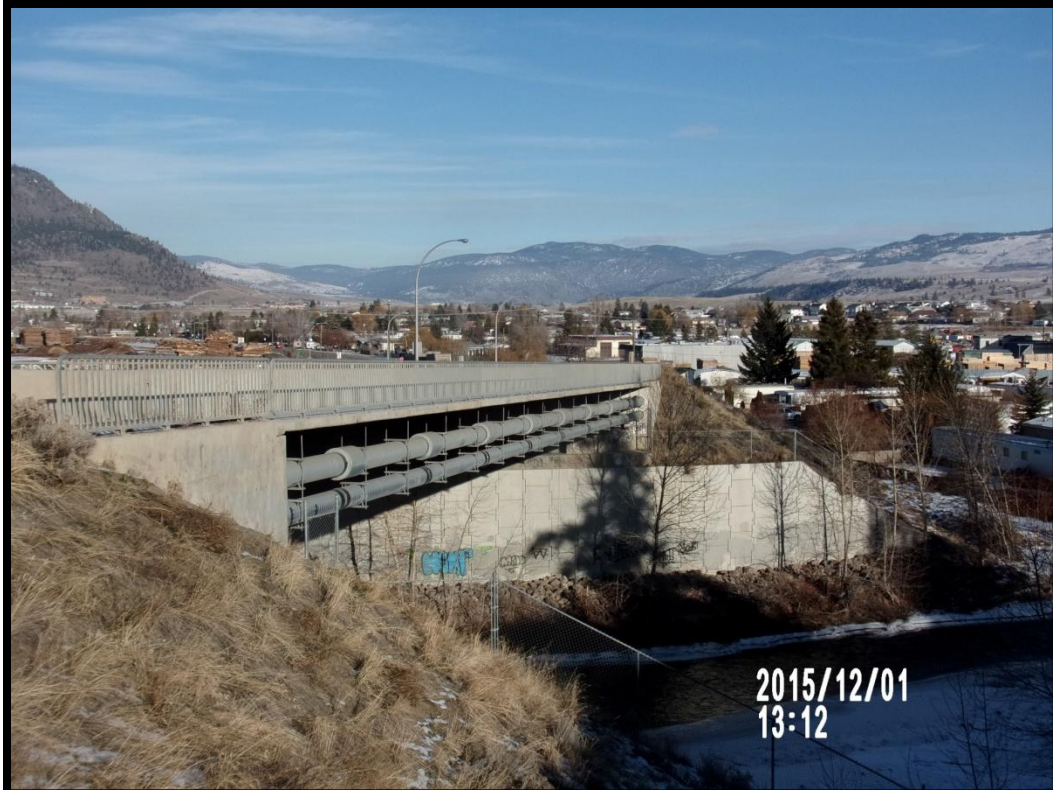
Photo #03. View Of Structure From West Bank Upstream.

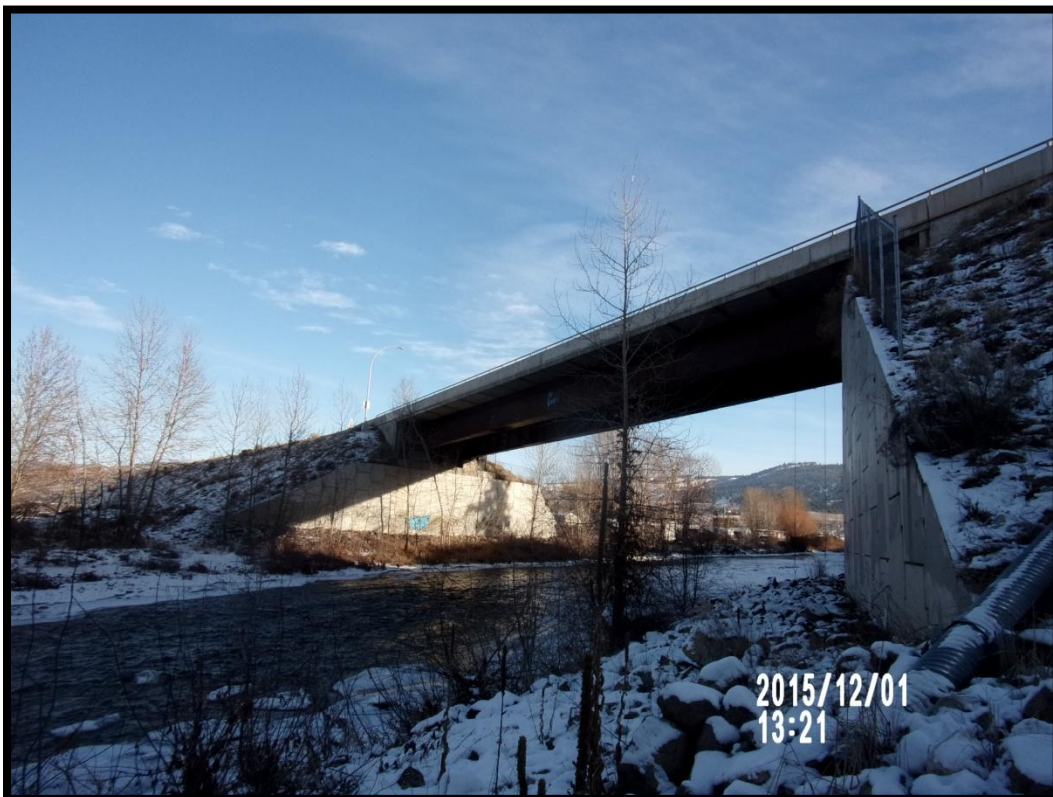
Photo #04. View Of Structure From West Bank Downstream.

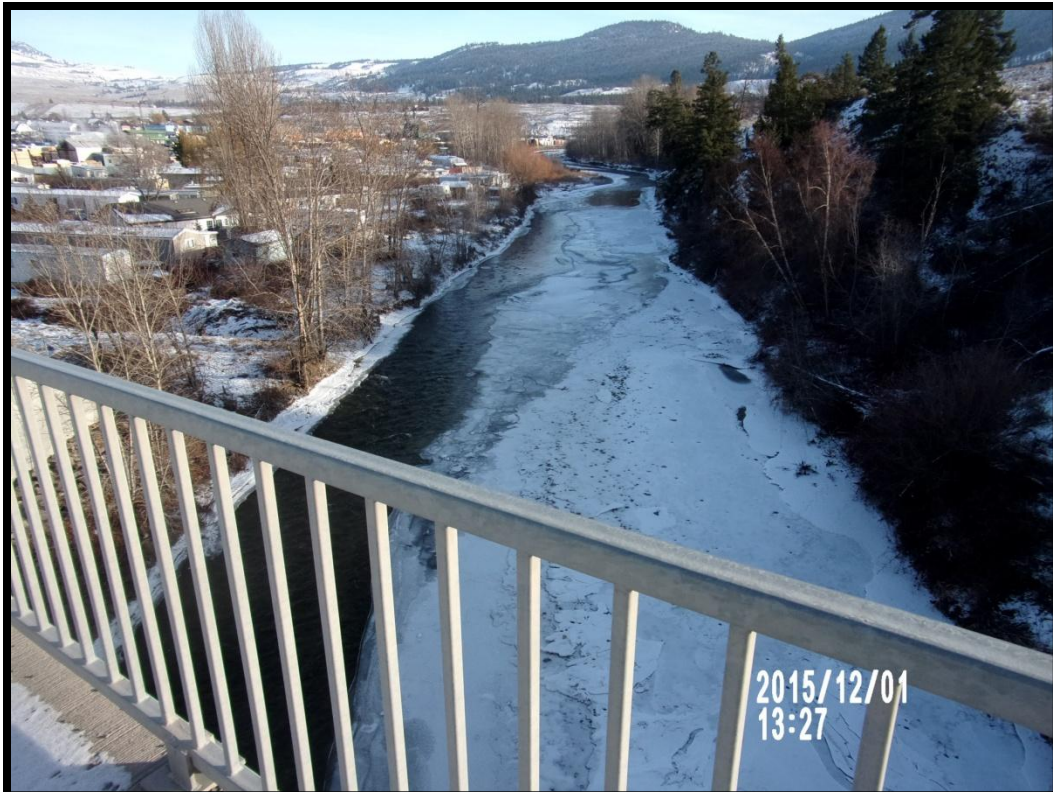
Photo #05. View Upstream.

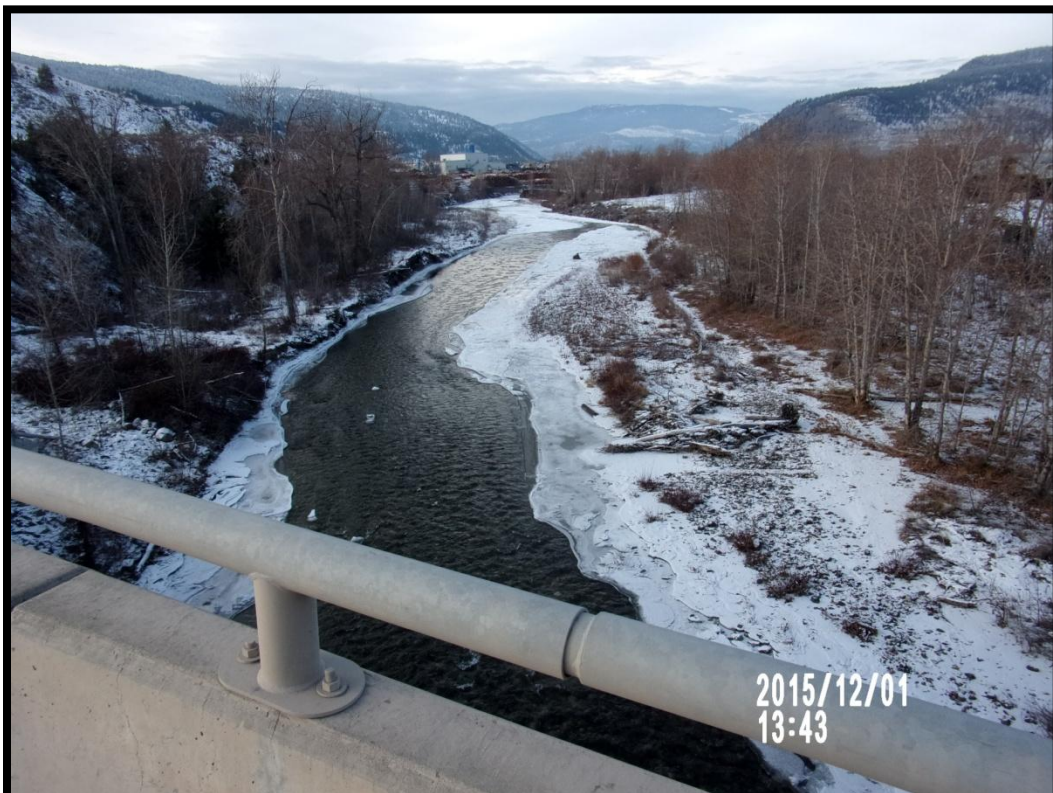
Photo #06. View Downstream.

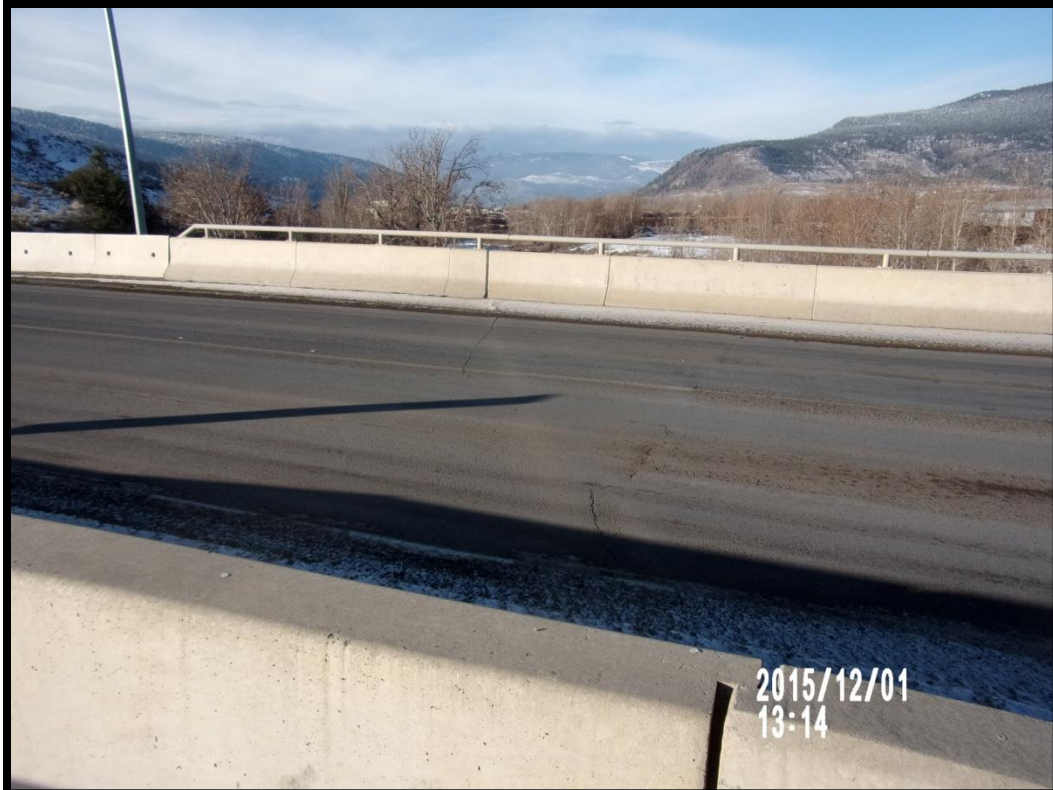
Photo #07. South Abutment Joint.

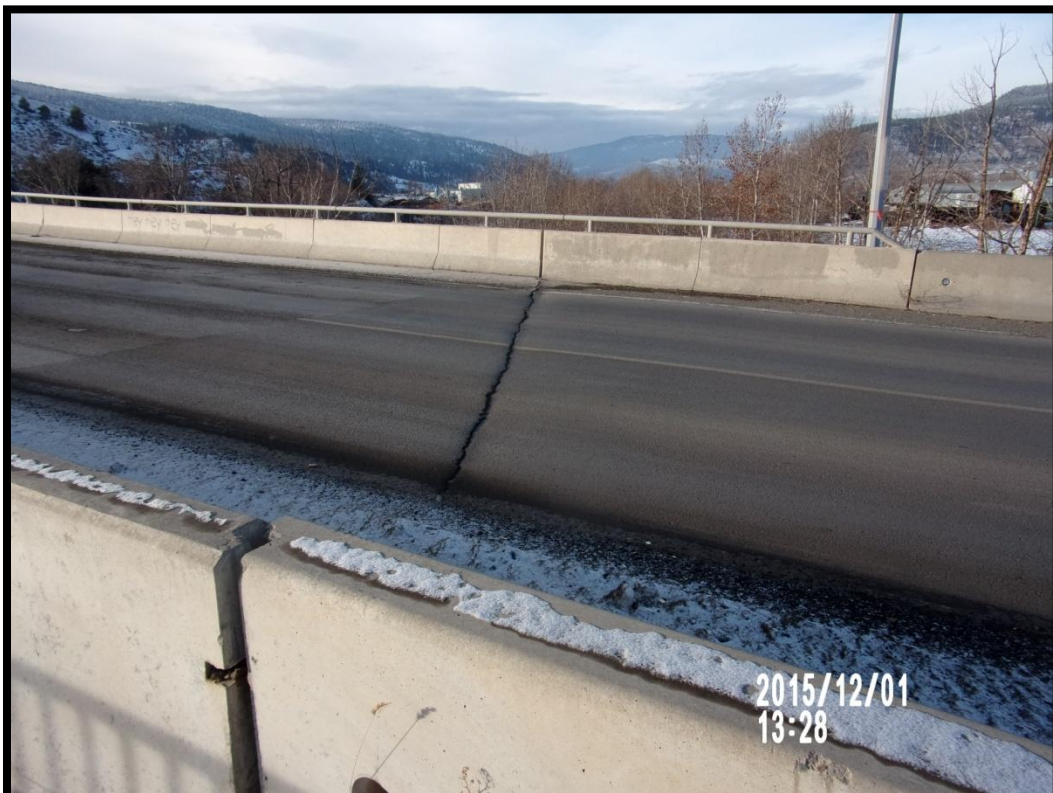
Photo #08. North Abutment Joint.

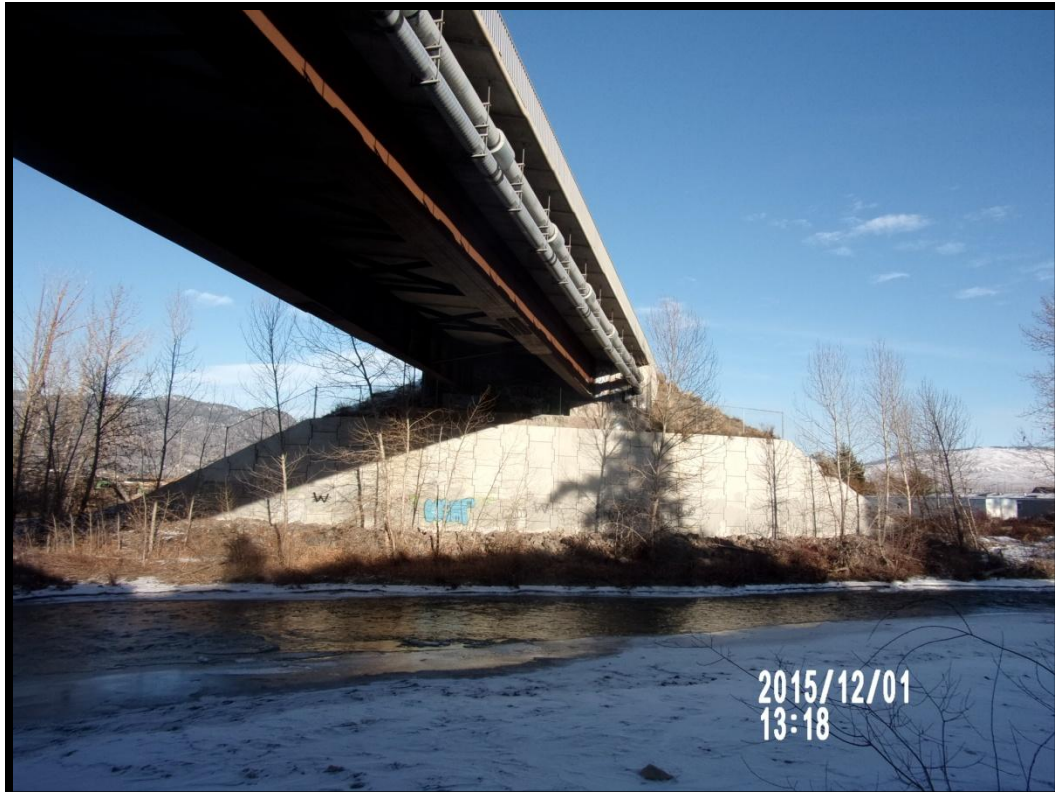
Photo #09. North Abutment And MSE Wall.

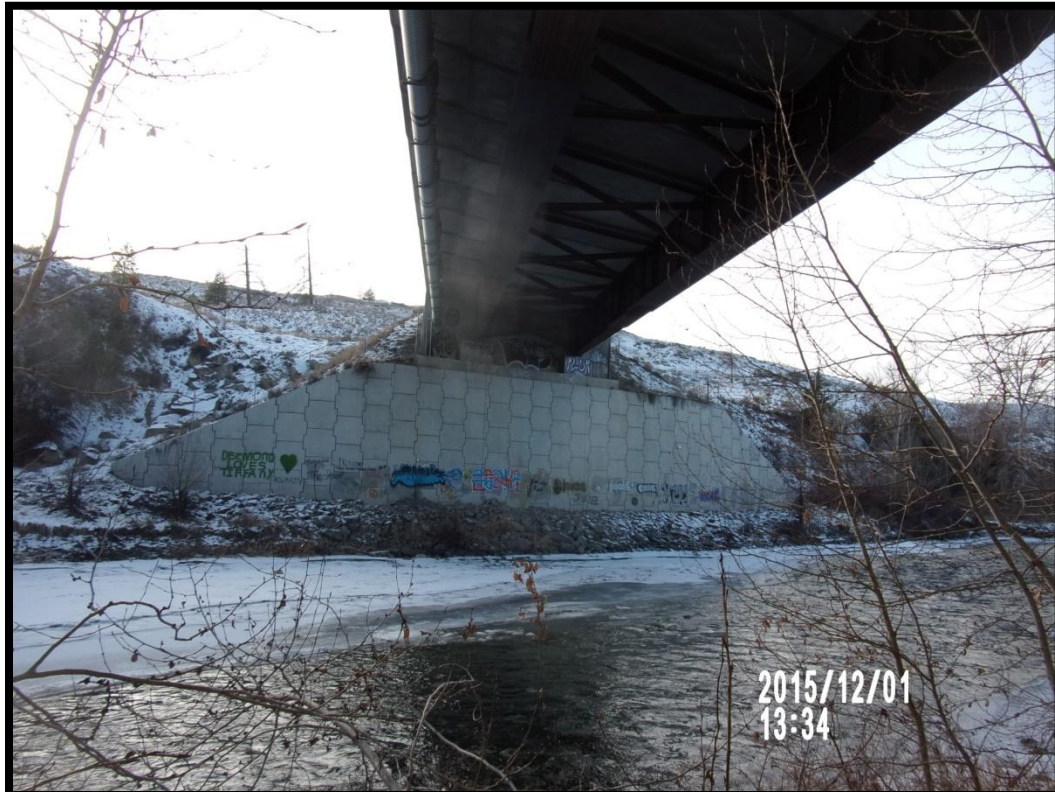
The overall structure is in good condition. The South Approach downstream slope was repaired in 2013 and remains in good condition. There is a tendency for road debris to accumulate on the roadway side of all barriers causing drainage problems as the catch basins fill. The roadway should be cleaned periodically. The slopes adjacent to the wing walls are eroding and accumulating and pushing against the chain link fence on top of the MSE wall. There is vandalism damage to the chain link fencing at the abutments and bearings allowing access to the bearing seats and top of MSE wall. This poses a potential liability as there is a long drop from the bearings to the rip rap below with risk of injury. The amount and location of graffiti has increased dramatically since the 2008 inspection. Some graffiti is located on the steel girders in mid bridge span.

Photo #10. South Abutment And MSE Wall. Note Steel Diaphragms And Graffiti.

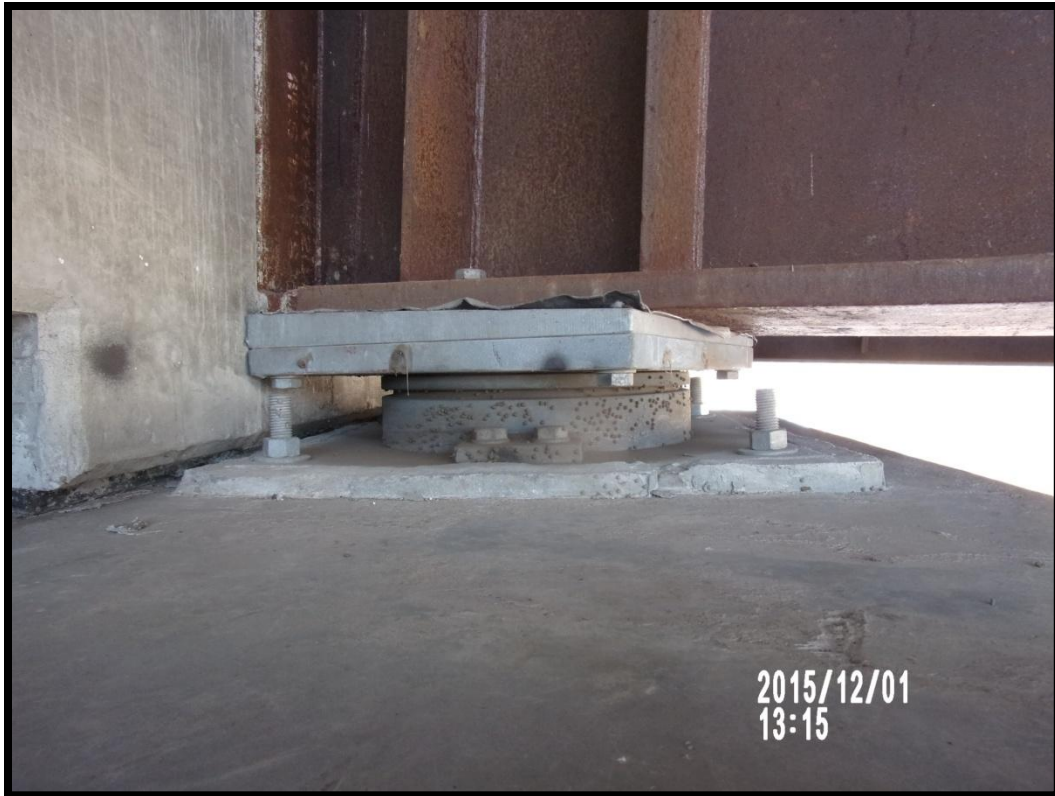
Photo #11. South Abutment Bearing Seat.

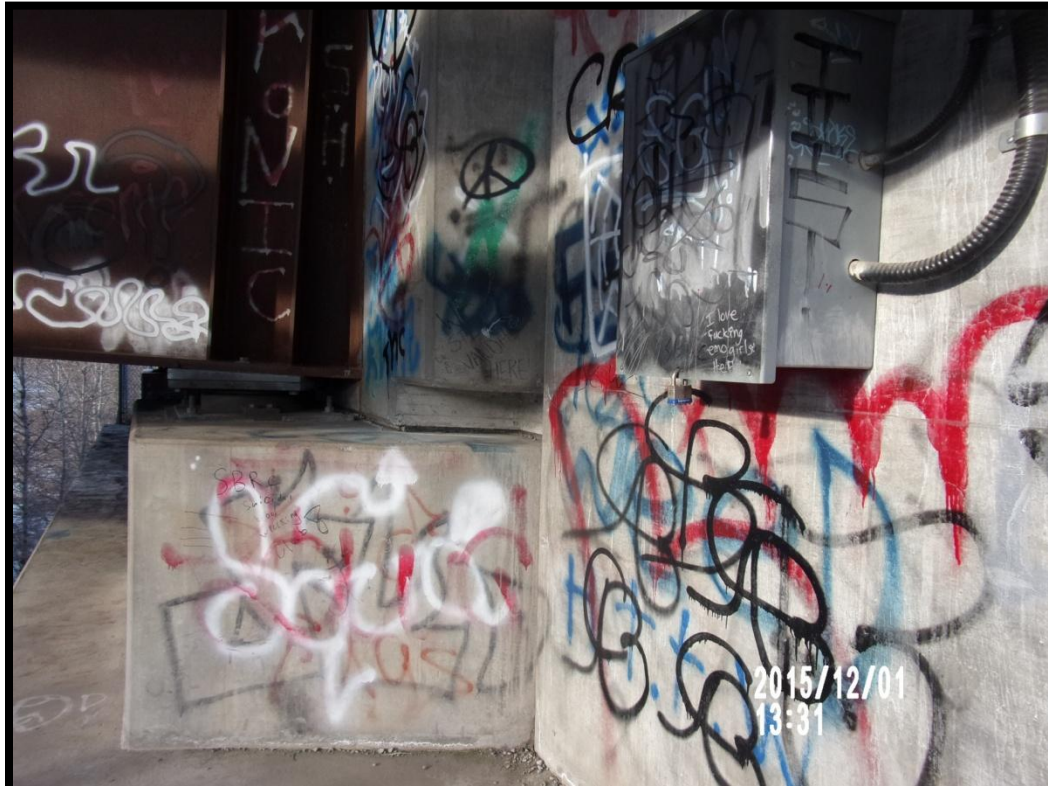
Photo #12. North Abutment Bearing Seat. Note Graffiti.

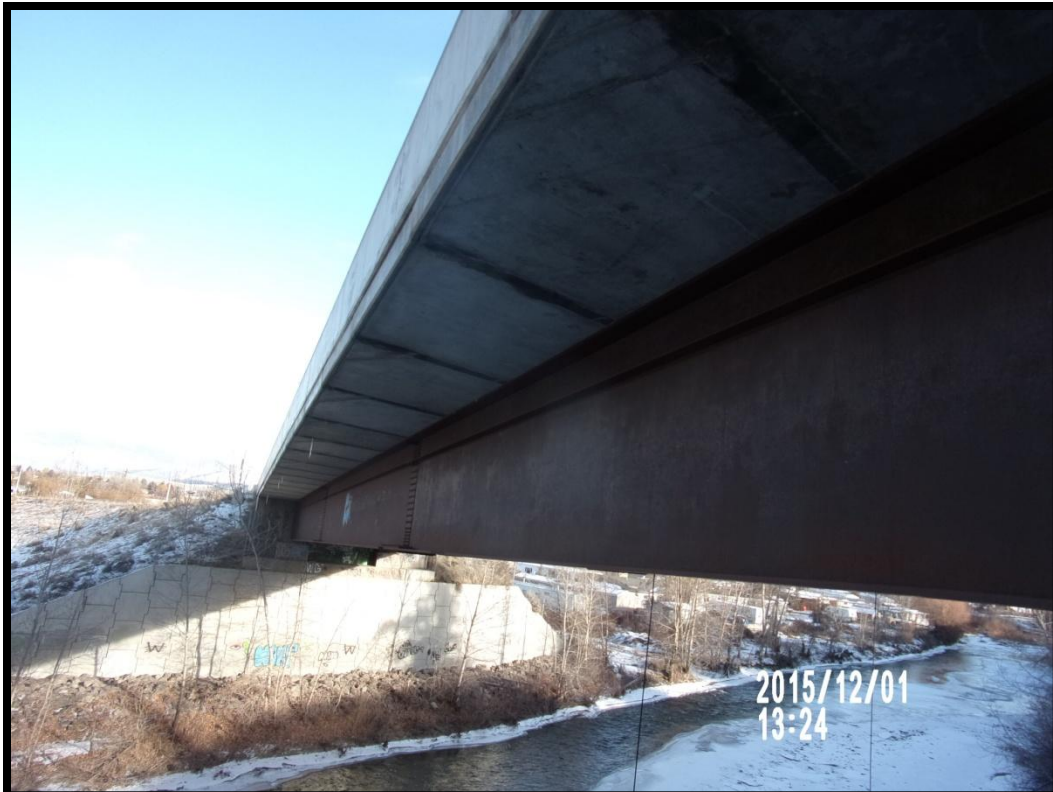
Photo #13. Steel Girders And Precast Concrete Deck Panels.

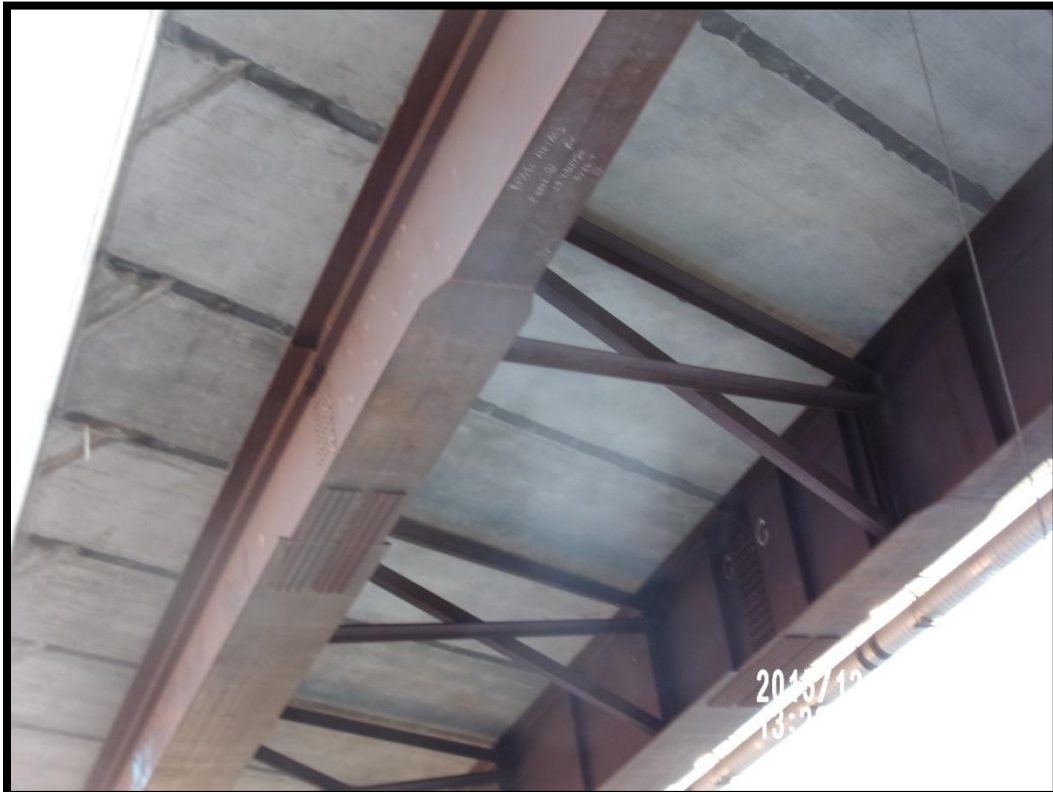
Photo #14. Detail Of Steel Girder, Steel Diaphragm And Underside Of Precast Concrete Deck Panels. Note: Cable.

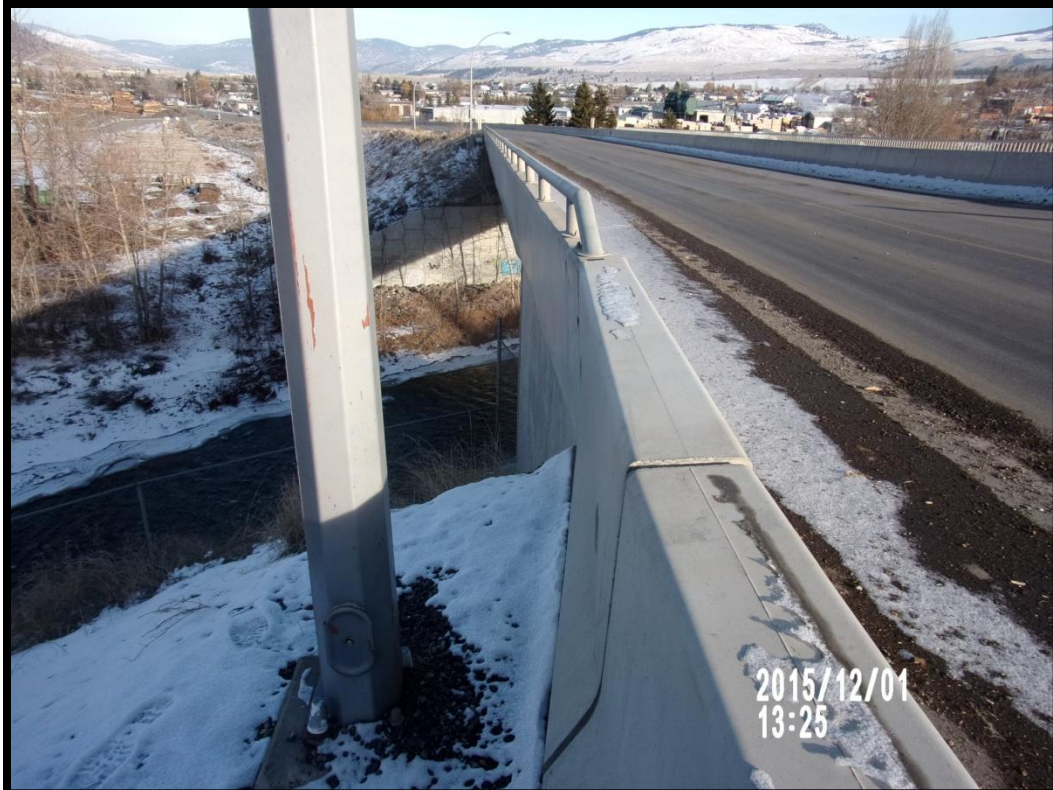
Photo #15 Downstream Parapet And Railing From South Abutment.

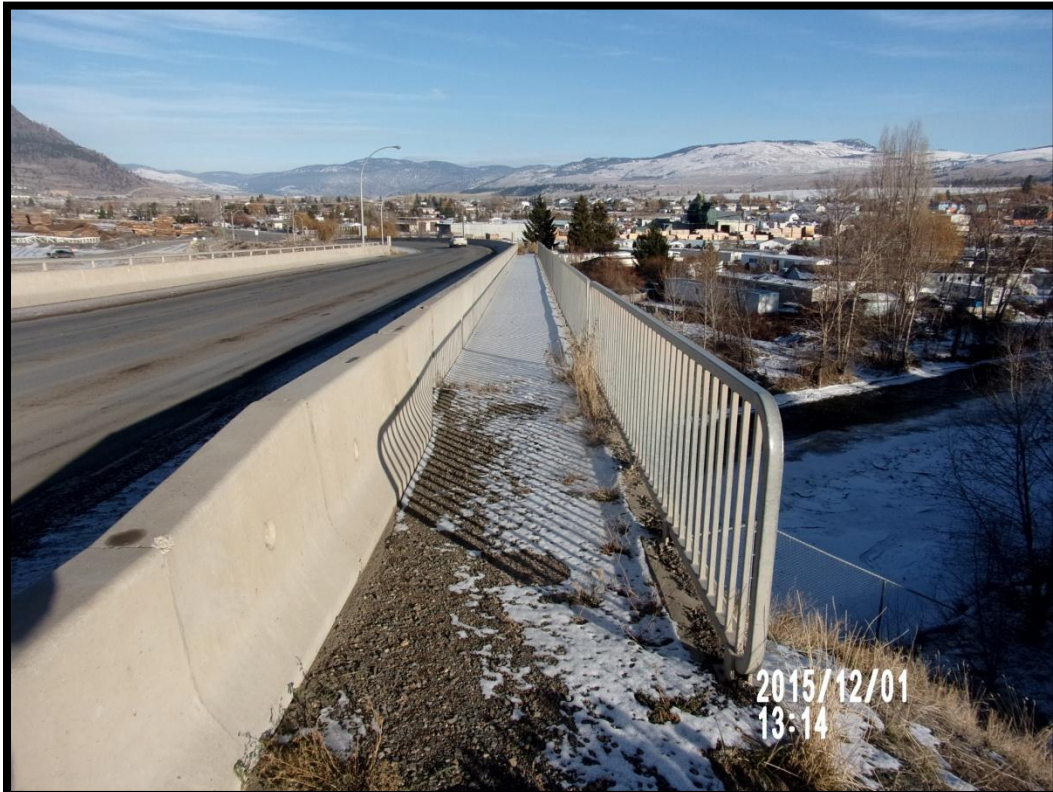
Photo #16. Upstream Parapet And Pedestrian Railing From South Abutment.

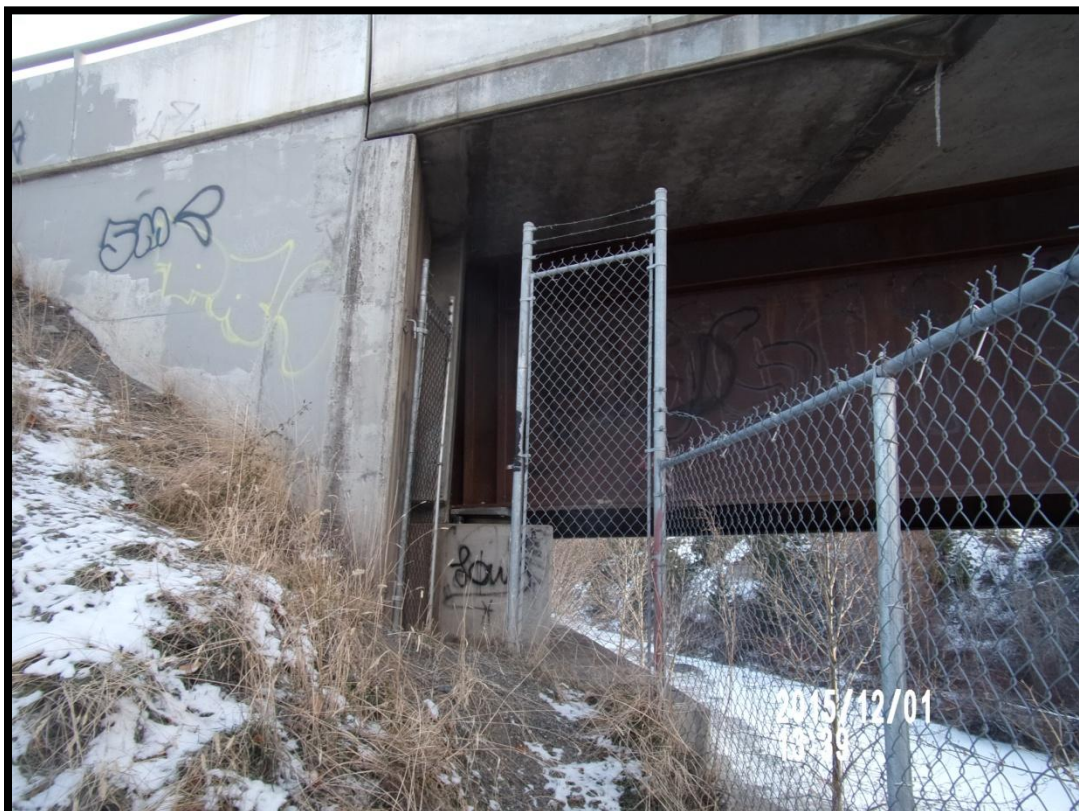
Photo #18. Upstream North Abutment. Note Gate Open.

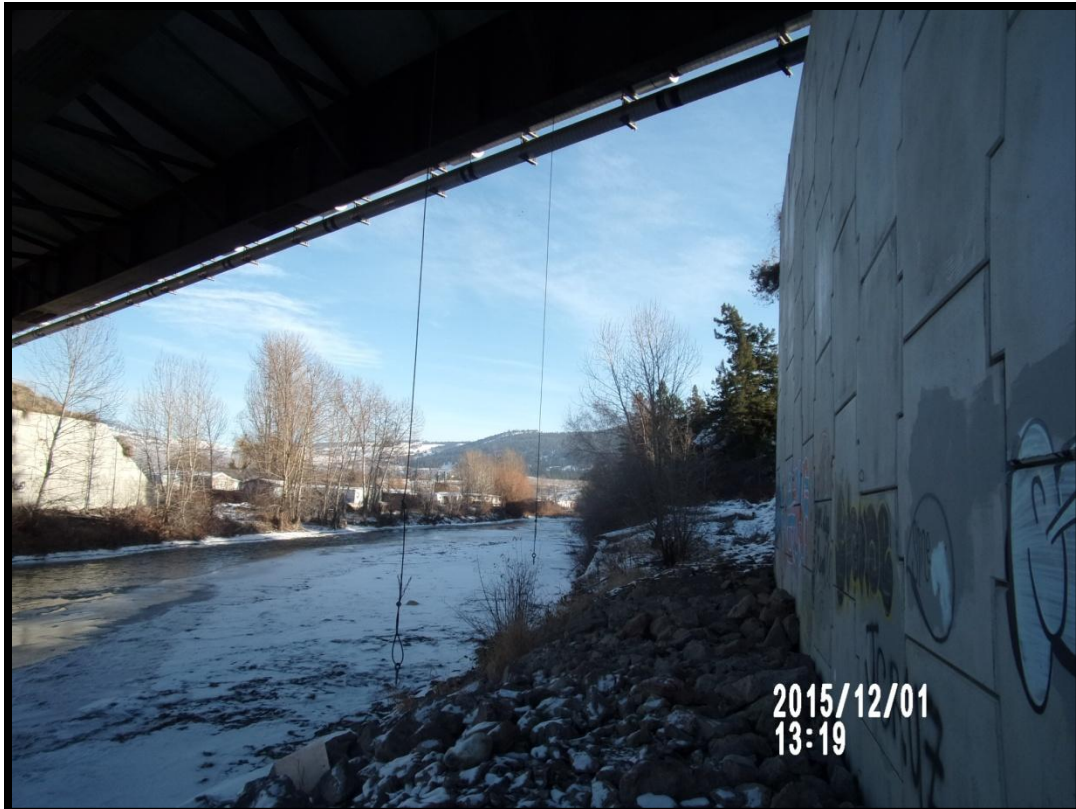
Photo #19. South Bank. Note: Cables Within Reach From Ground.

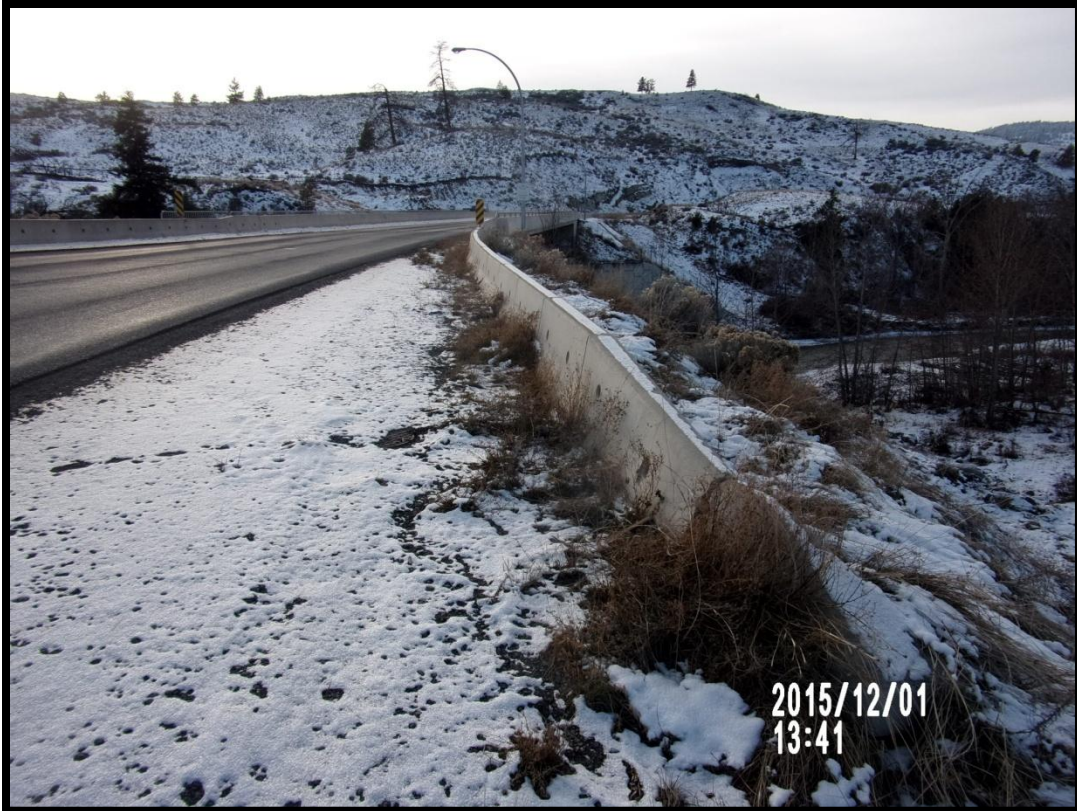
Photo #23. Downstream North Approach. Note: Accumulated Road Debris And Choked Catch Basin.

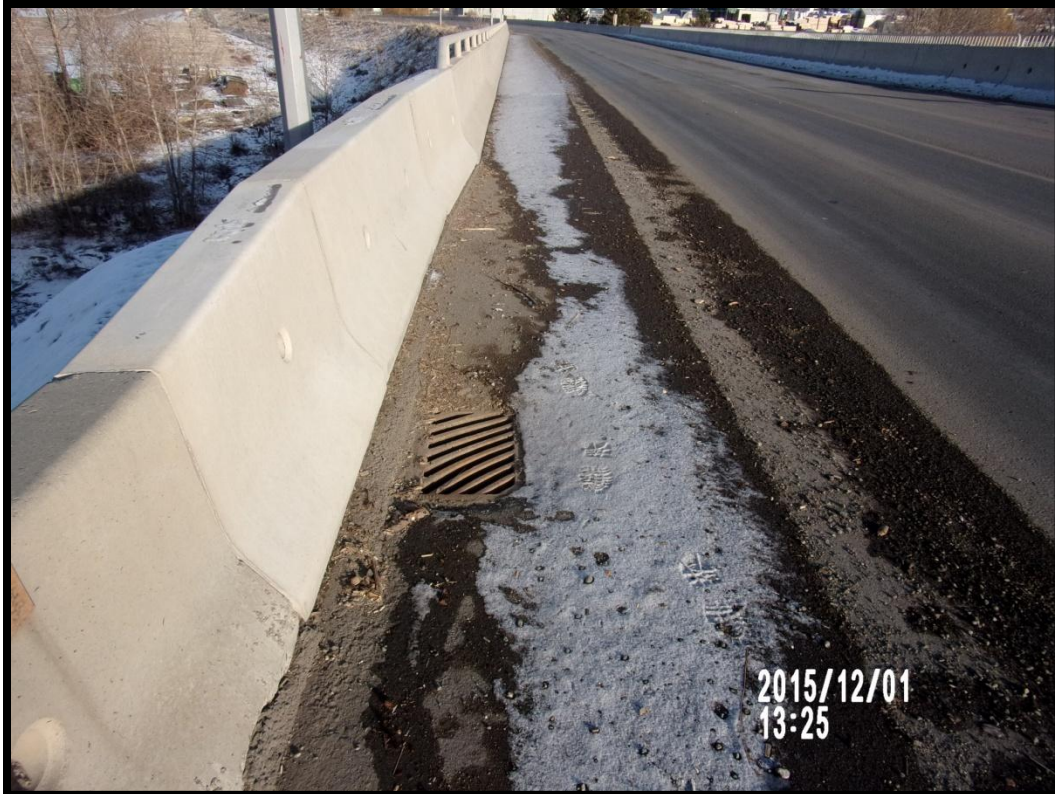
Photo #25. Downstream South Approach Catch Basin. Note: Found Filled With Debris.

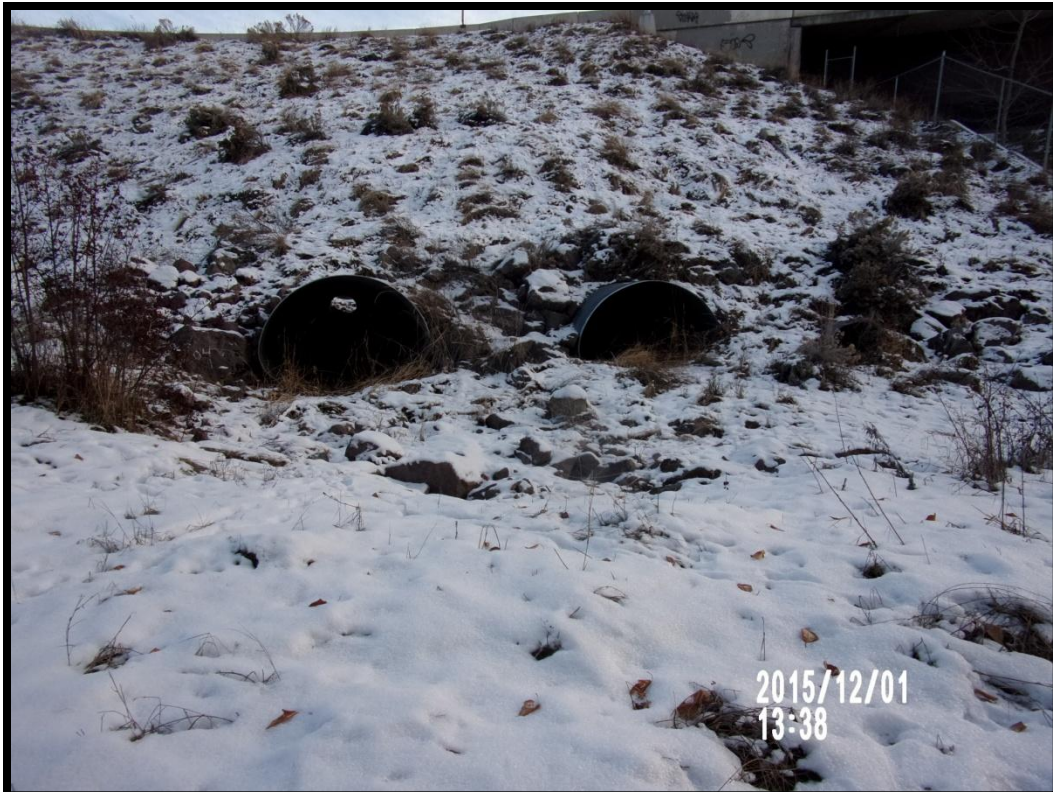
Photo #27 Culverts Under Downstream North Approach Fill.
