## **CITY OF MERRITT**

### **2015 MERRITT BRIDGE INSPECTION REPORT**

**Issued: December 15, 2015**

**WATSON ENGINEERING LTD.**

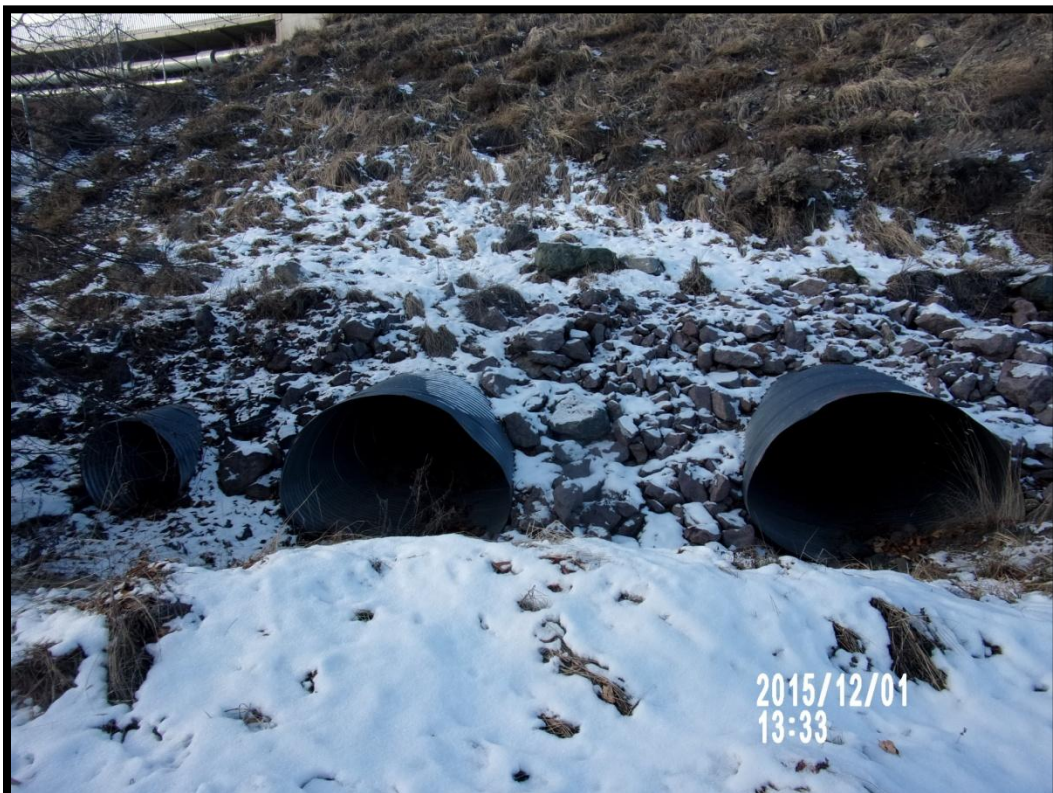
Photo #28 Culverts Under Upstream North Approach Fill.

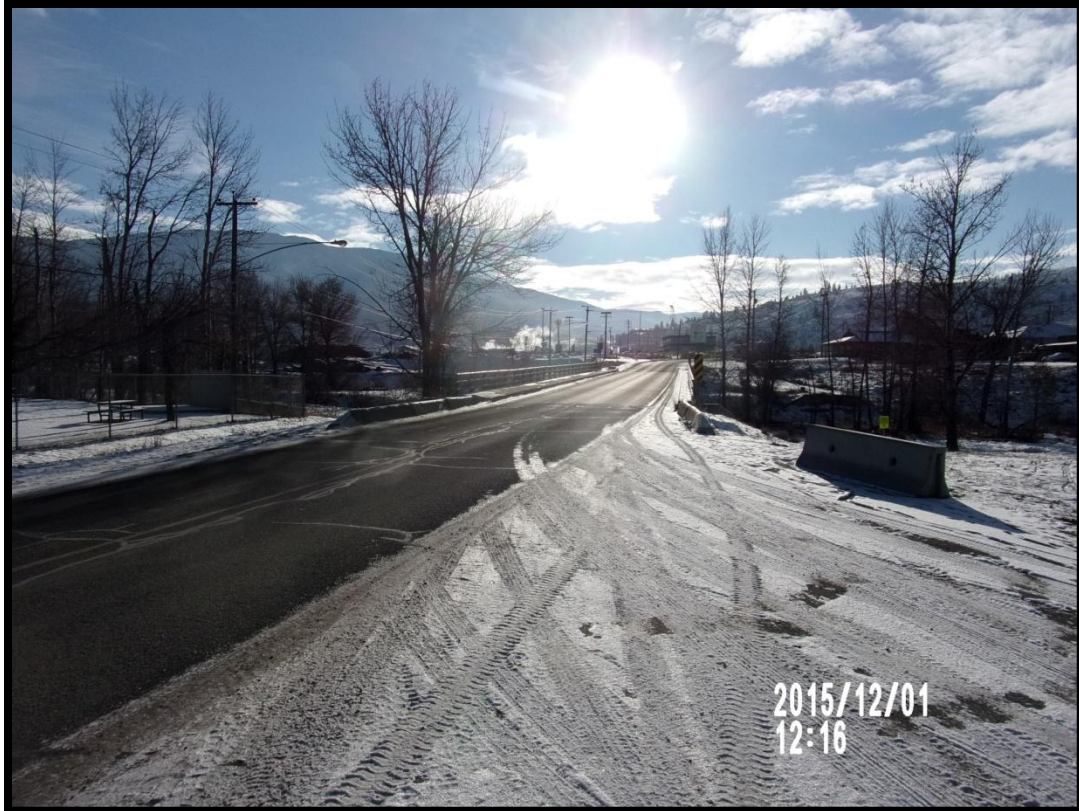
Photo #01. View Of Structure From East Approach.

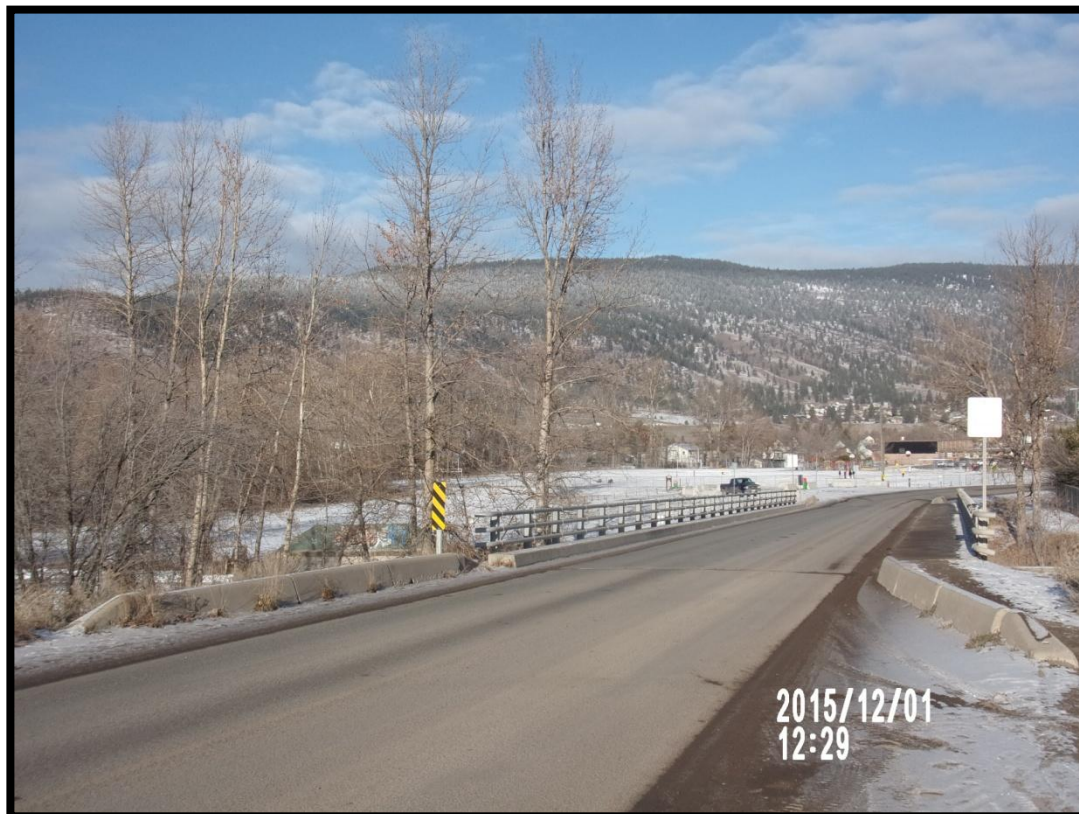
Photo #02. View Of Structure From West Approach.

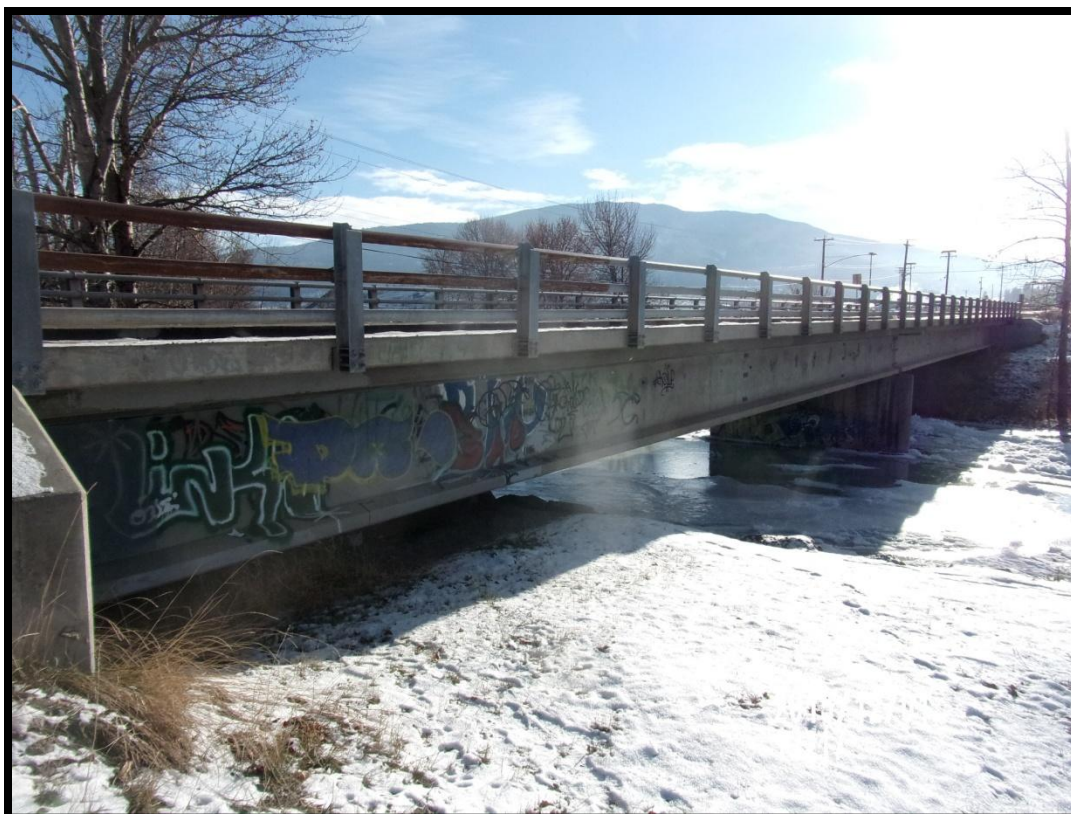
Photo #03. View Of Structure From East Bank Downstream.

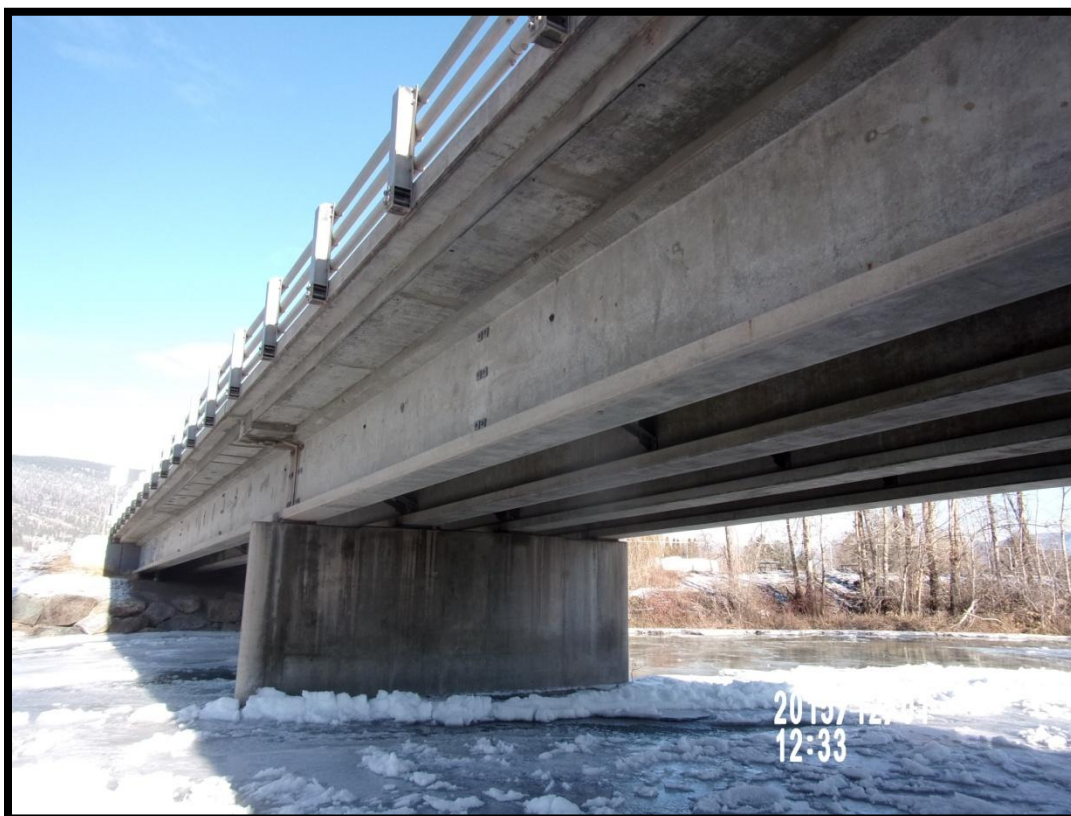
Photo #04. View Of Structure From West Bank Downstream.

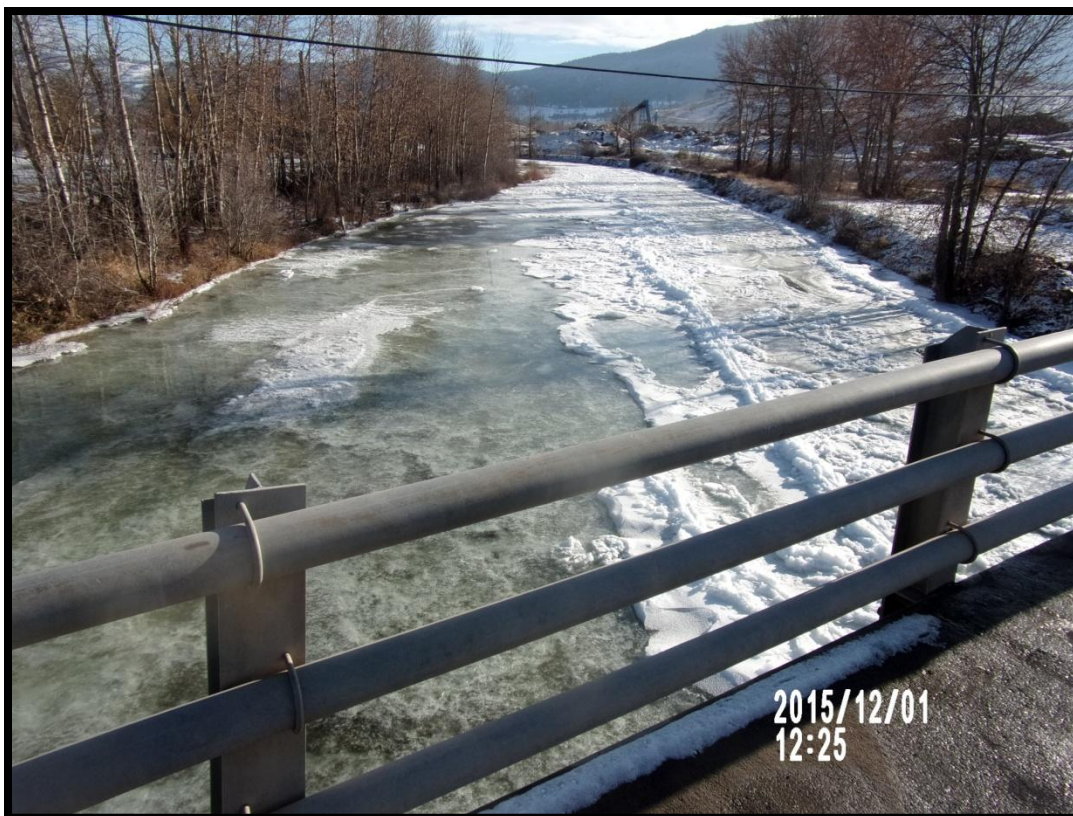
Photo #05. View Upstream.

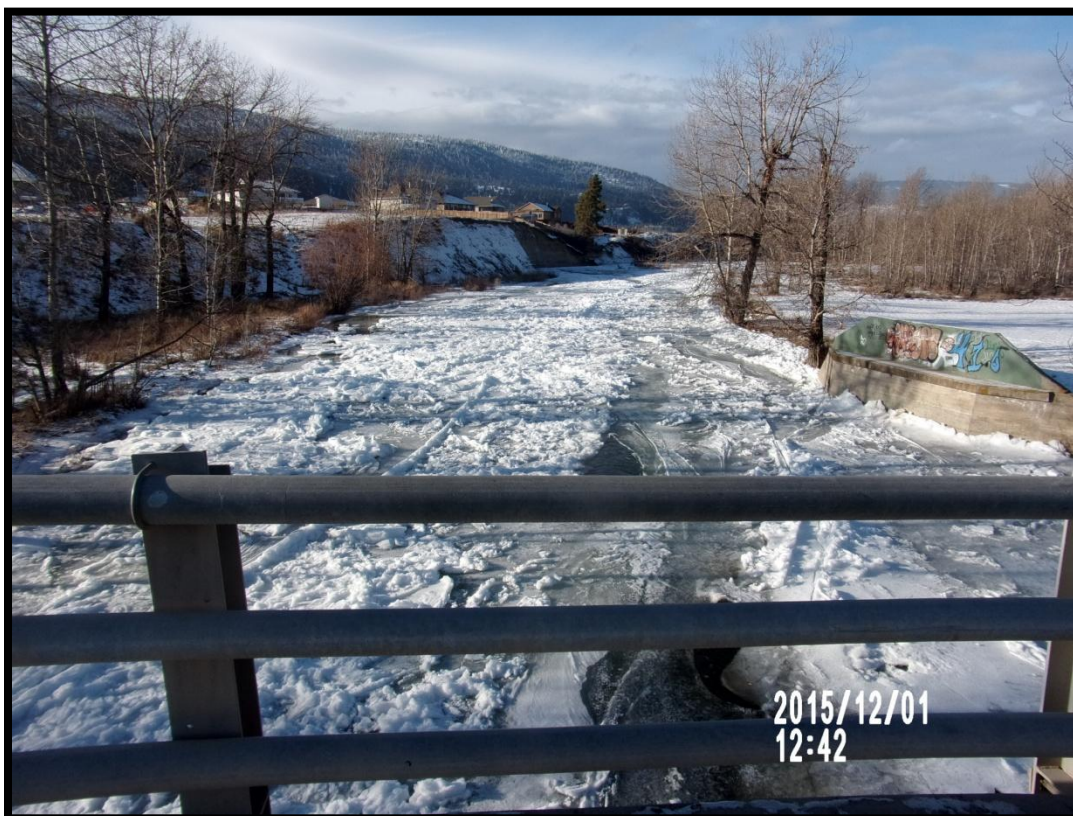
Photo #06. View Downstream.

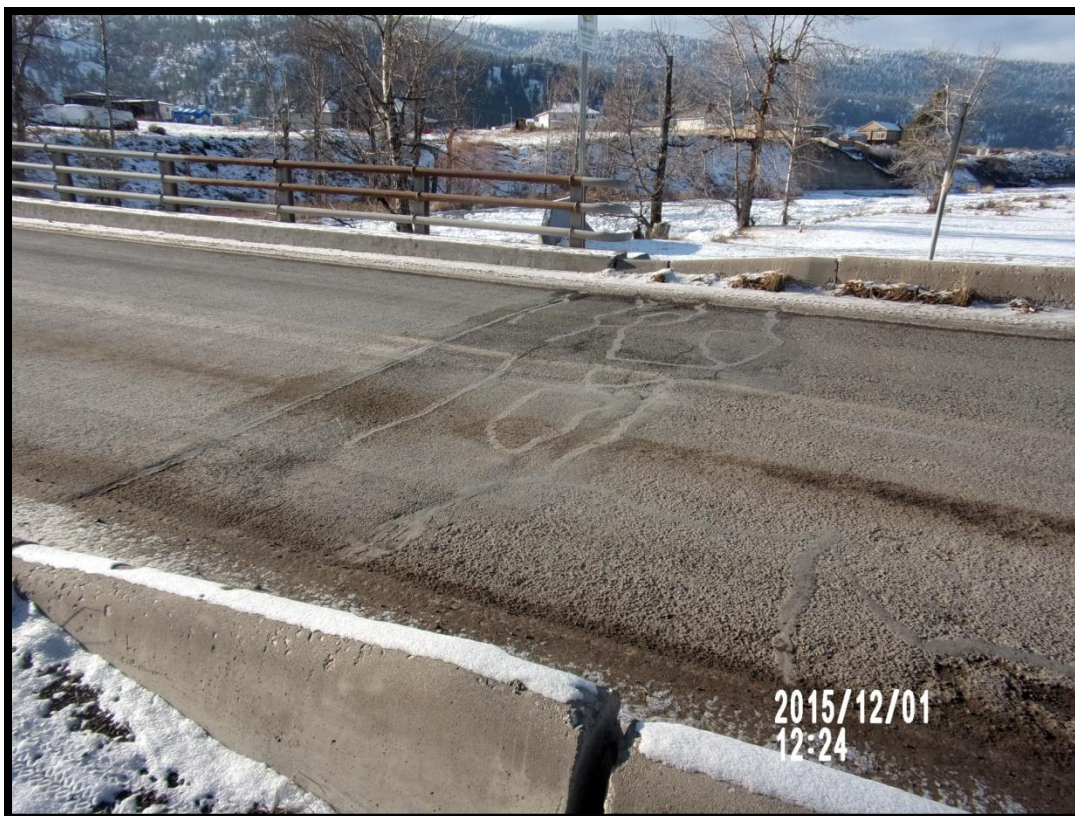
Photo #07. West Abutment Joint.

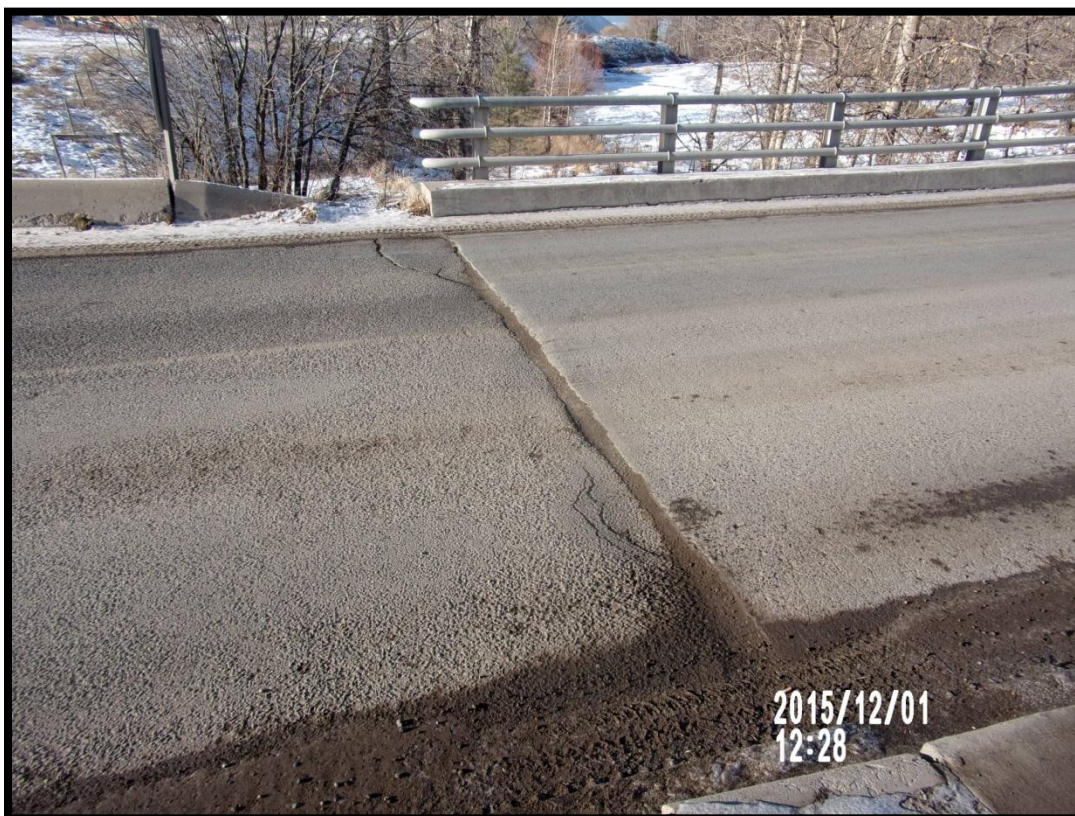
Photo #08. West Abutment Joint.

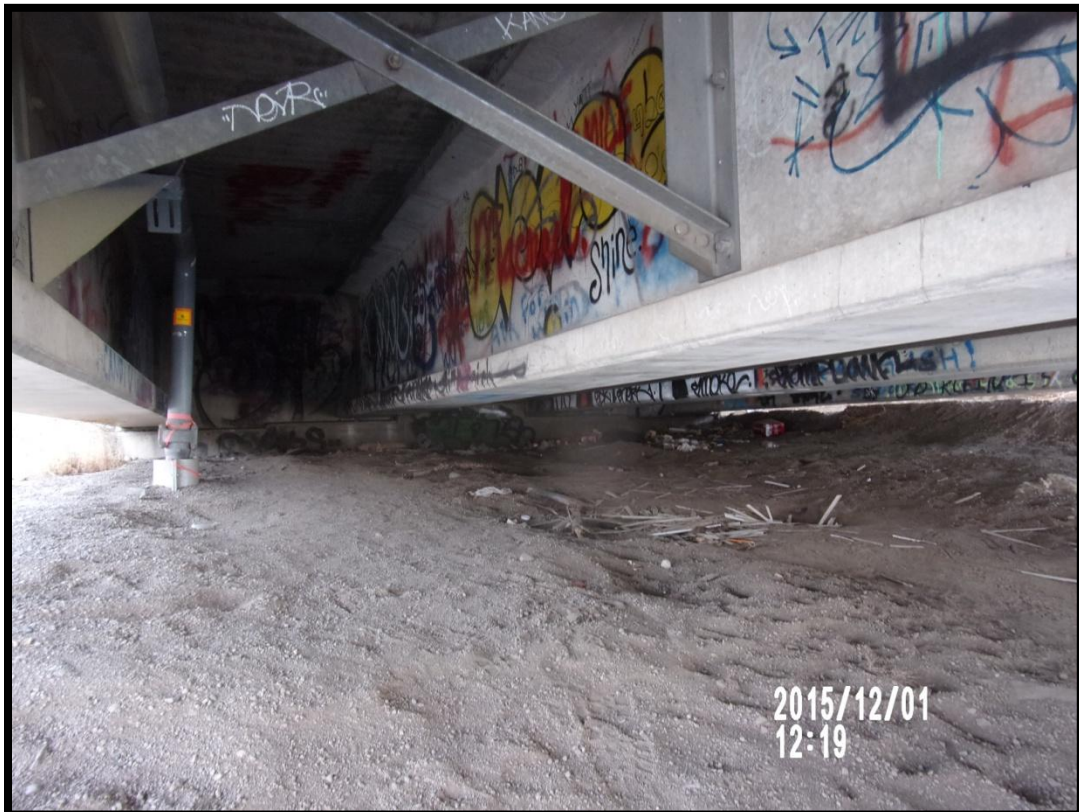
Photo #09. Downstream Girders And East Abutment With Gasline.

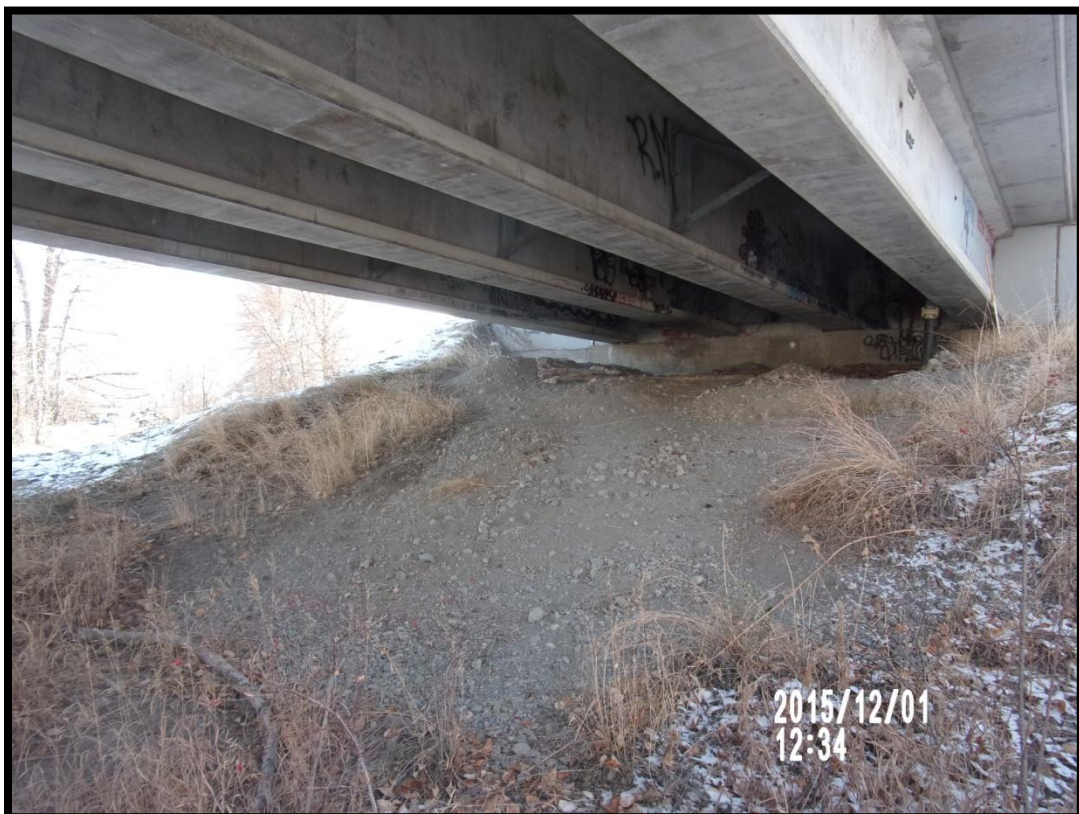
Photo #10. Girders And West Abutment.

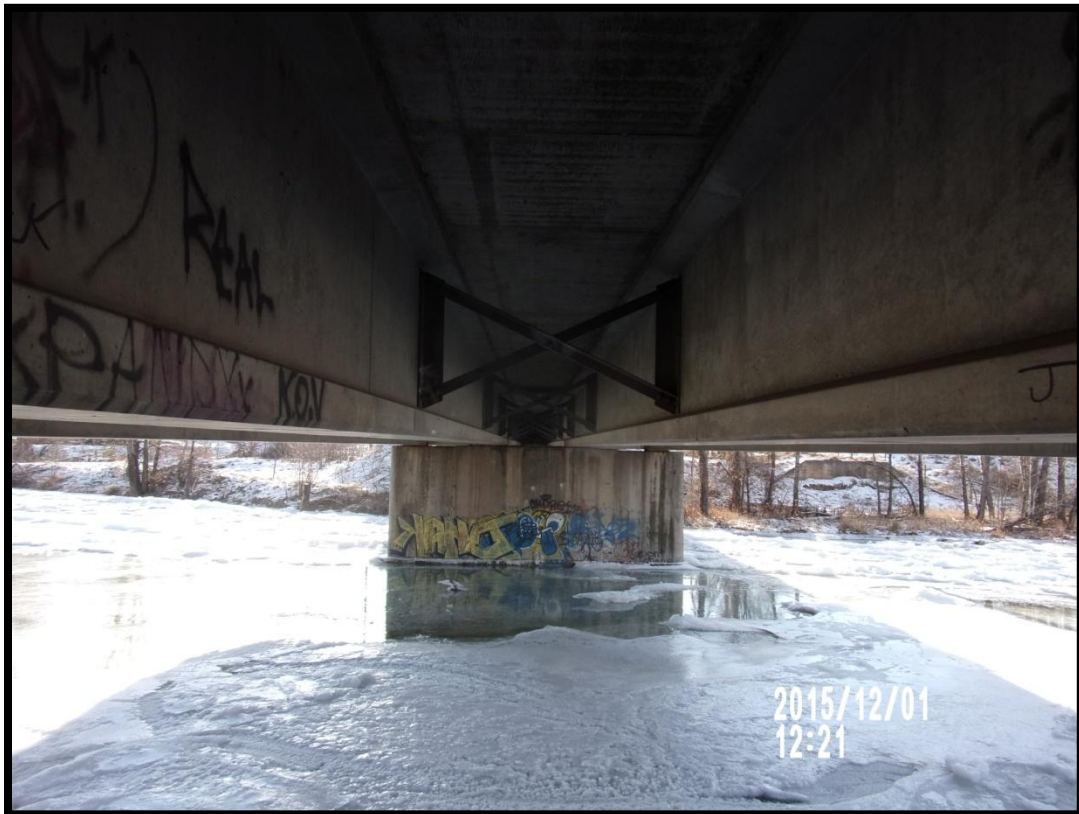
Photo #11. Centre Pier From East Abutment.

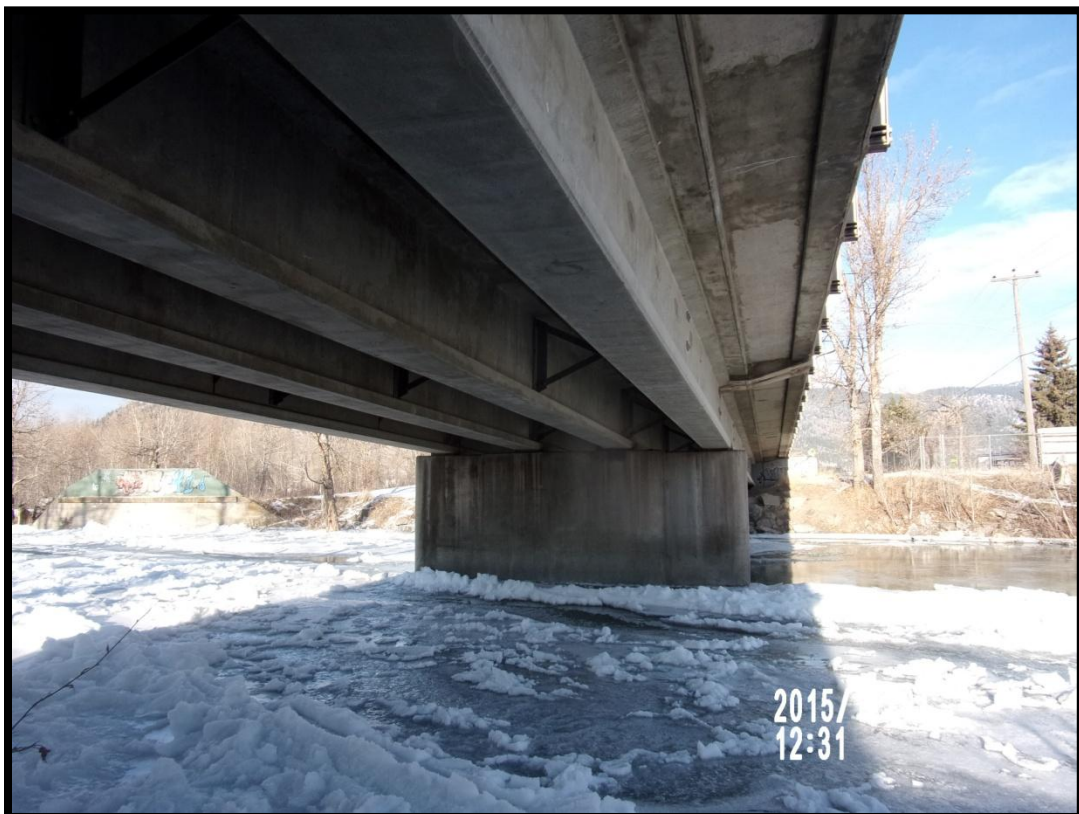
Photo #12. Centre Pier And Girders From West Abutment.

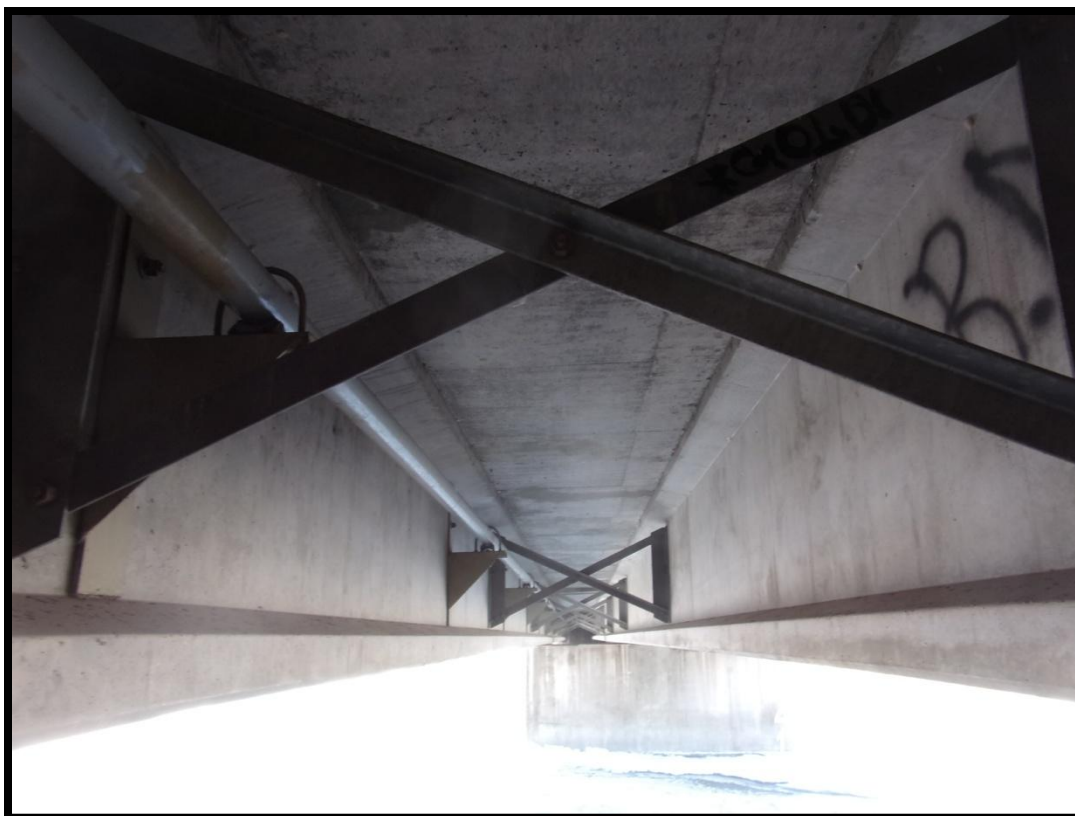
Photo #13. Steel Diaphragms.

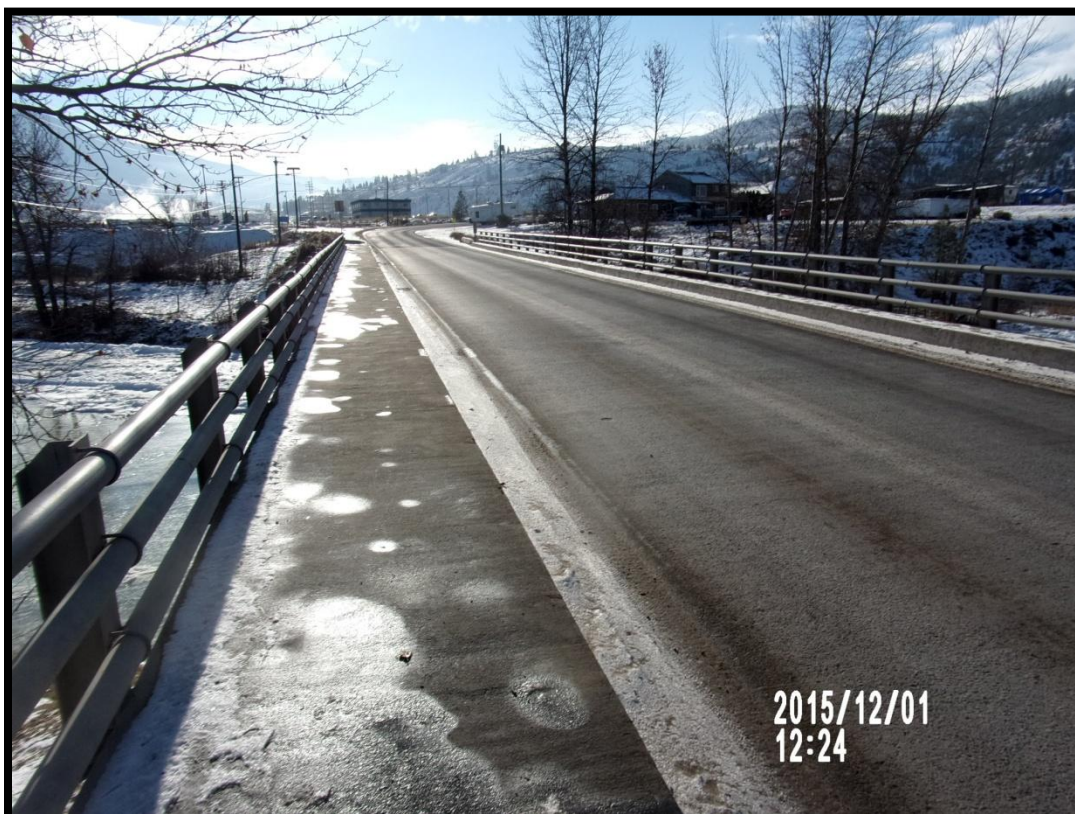
Photo #14 Sidewalk On Bridge.

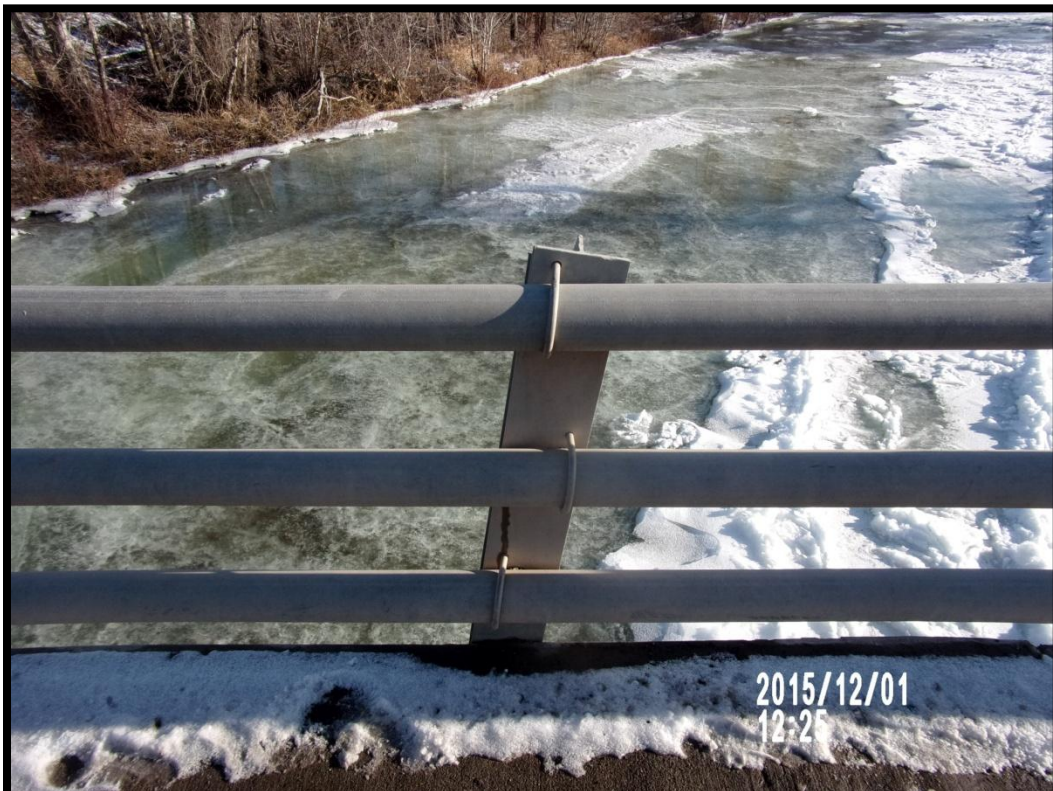
Photo #18. Railing At Upstream West Abutment. Note: Bent Post

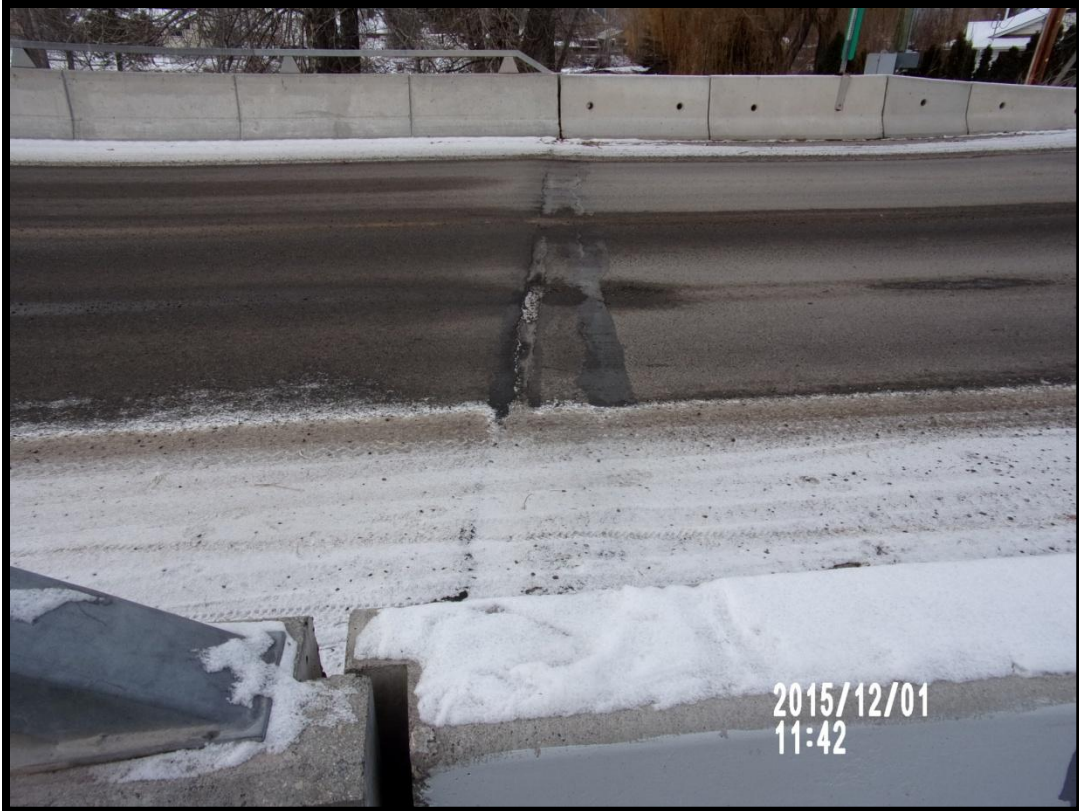
Observations	Recommendations
Bridge Rail Type: Condition:	MoT Standard Steel Parapet Railing. Good.	
Bridge Parapet Type: Condition:	CIP Concrete MoT Spec. Good. Original Sealed Expansion Joints Deteriorating.	Re-Seal Expansion Joints.
Pedestrian Rail Type: Height: Condition:	MoT Standard Steel Sidewalk Fence. 1.2m Good. Railing Base Broken Off At SW Wing Wall. Repaired.	
Sidewalk/Bicycle Path Location: Type: Condition:	Upstream Side Asphalt. Good. Settlement At Both Ends Creating Elevation Difference Between Approach And Bridge Deck.	
Curb Location: Type: Condition:	None.

Photo #08. West Pier Joint.

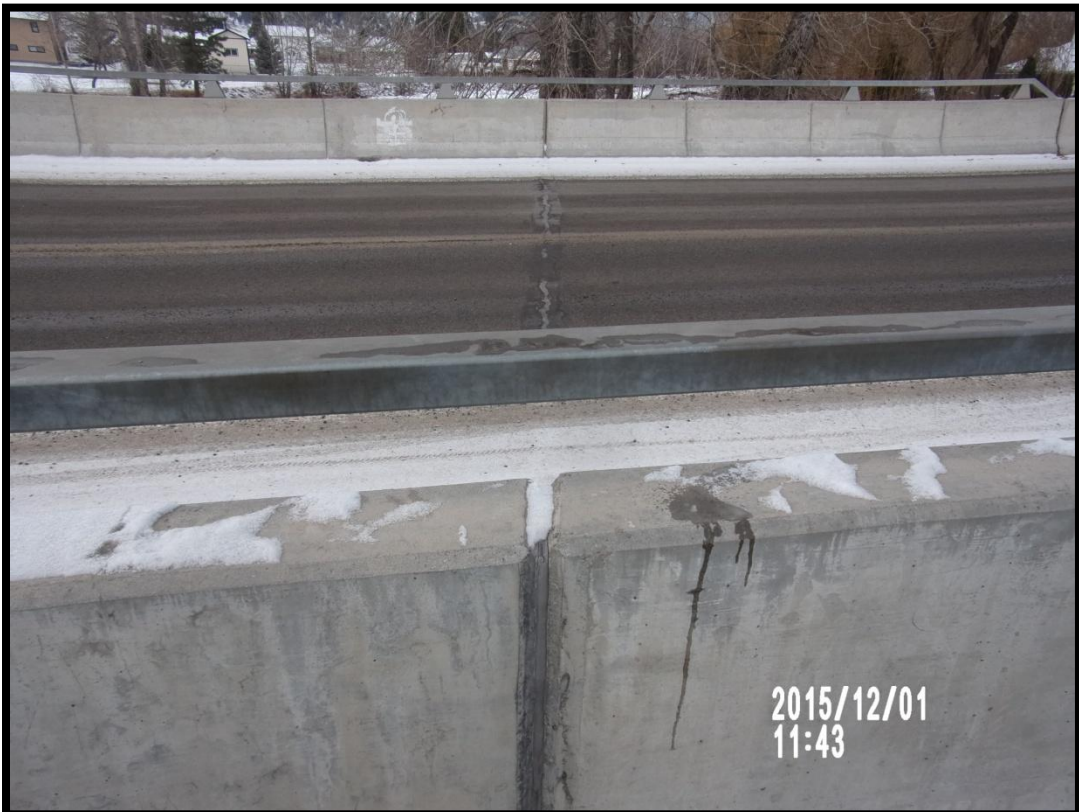
Photo #09. West Abutment Joint.

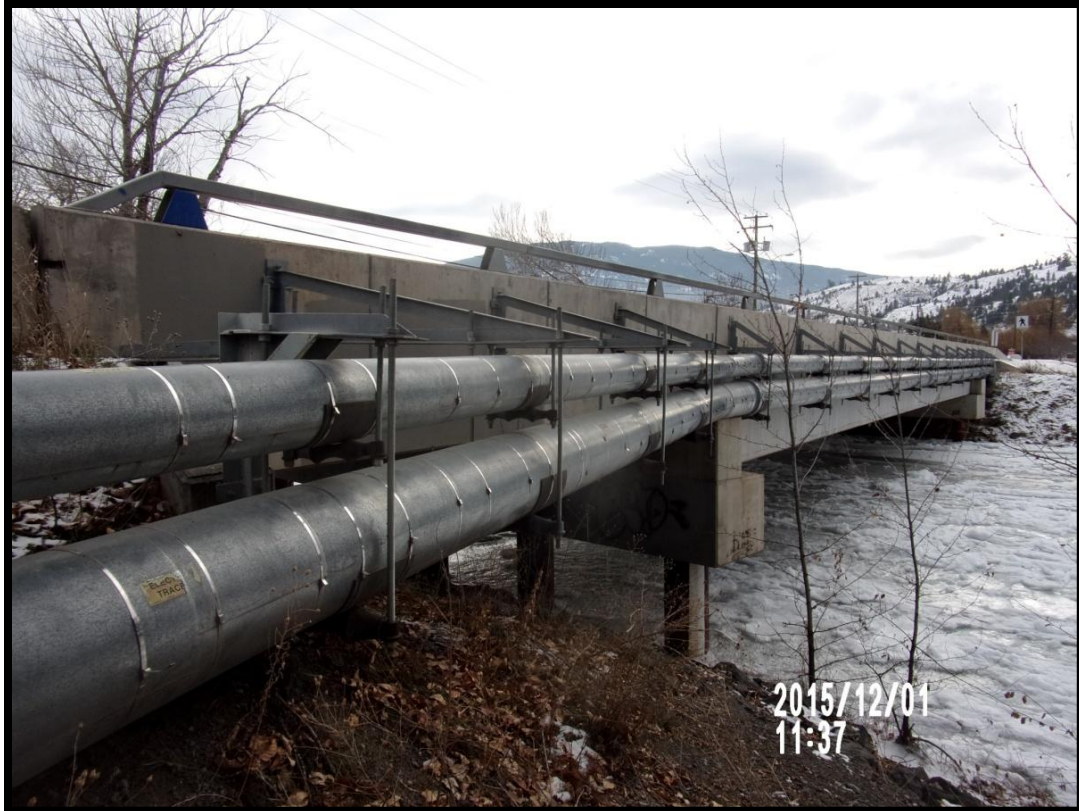
Photo #14. Waterline Near Mid-Span. Note: Missing Pipe Insulation Joint And Deterioration Of Insulation.

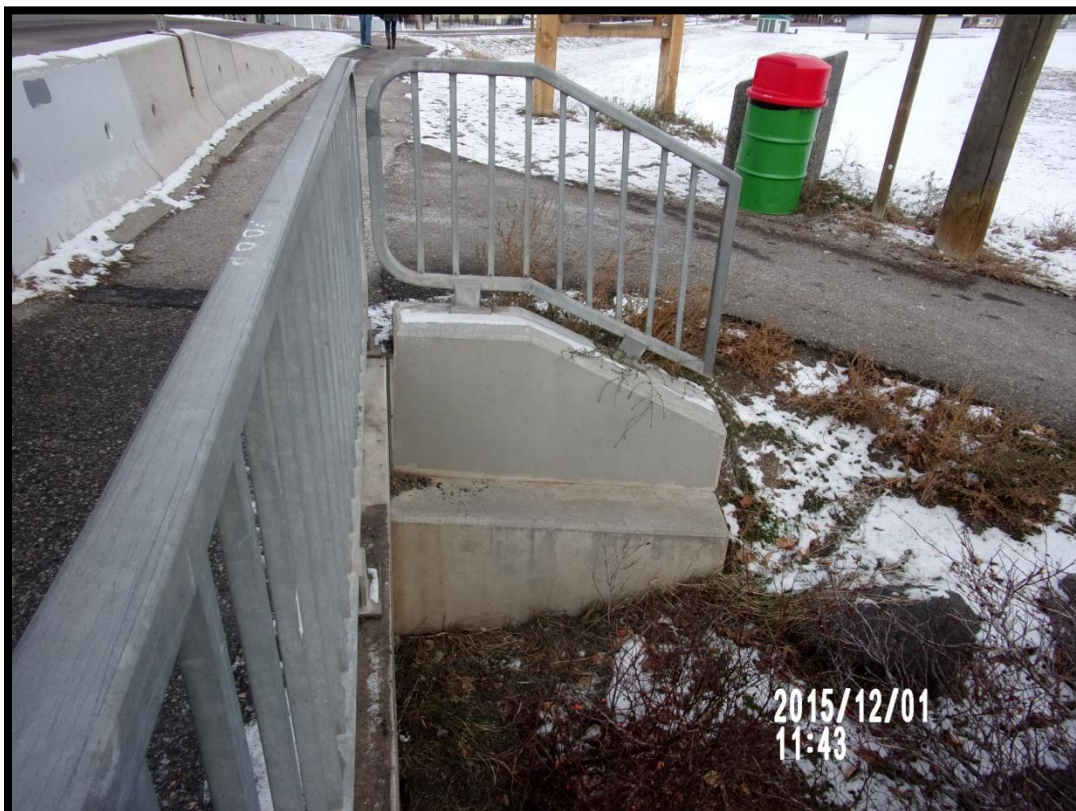
Photo #17 Sidewalk At West Wing Wall. Note: Damage To Wing Wall And Repositioned Rail Base.

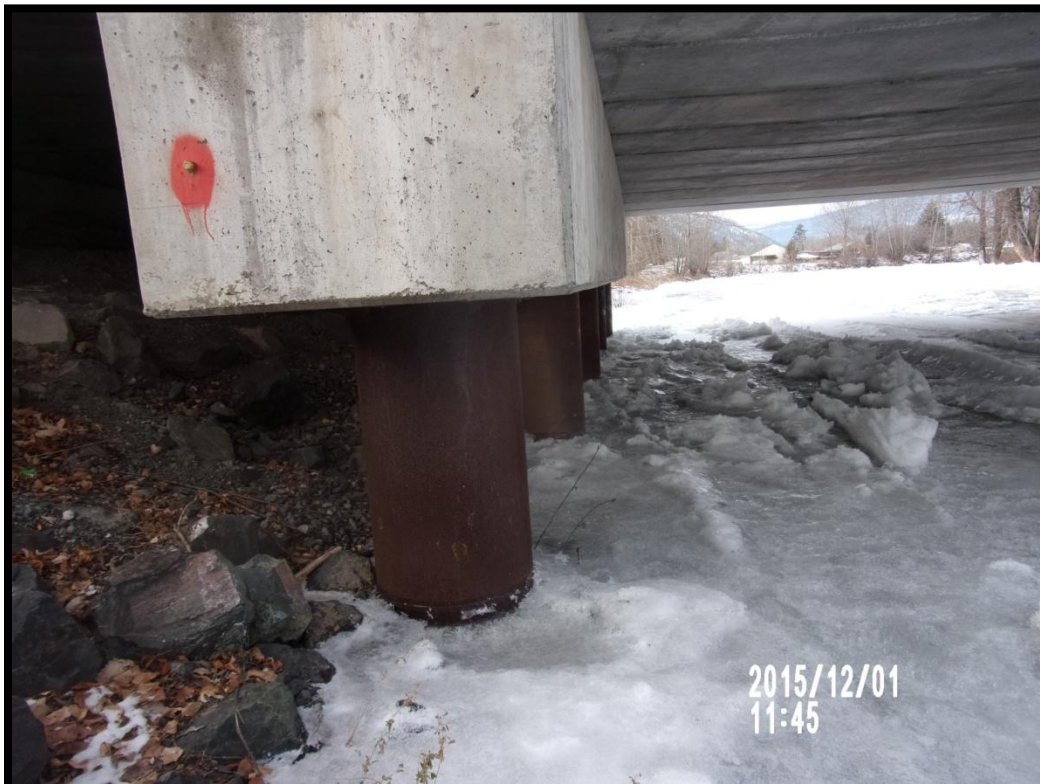
Photo #18. West Pier.

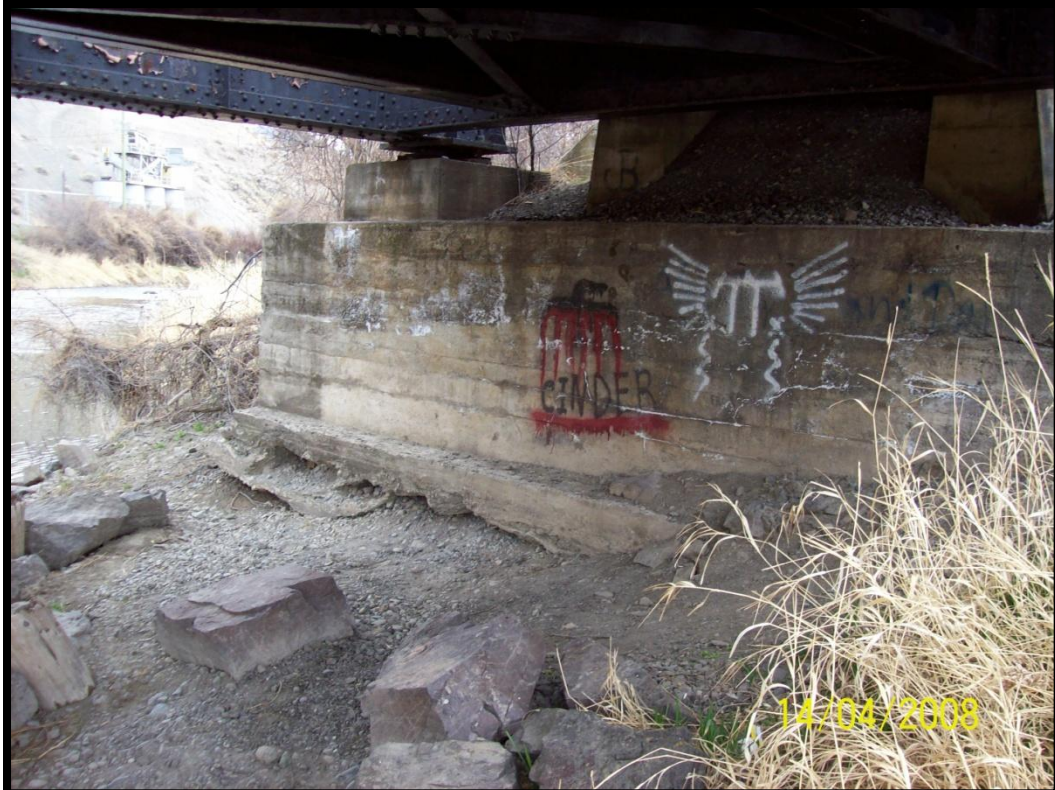
Photo #10. Detail Of South Abutment Undermining. Note Exposed Original Timber Piling 2008 Inspection.

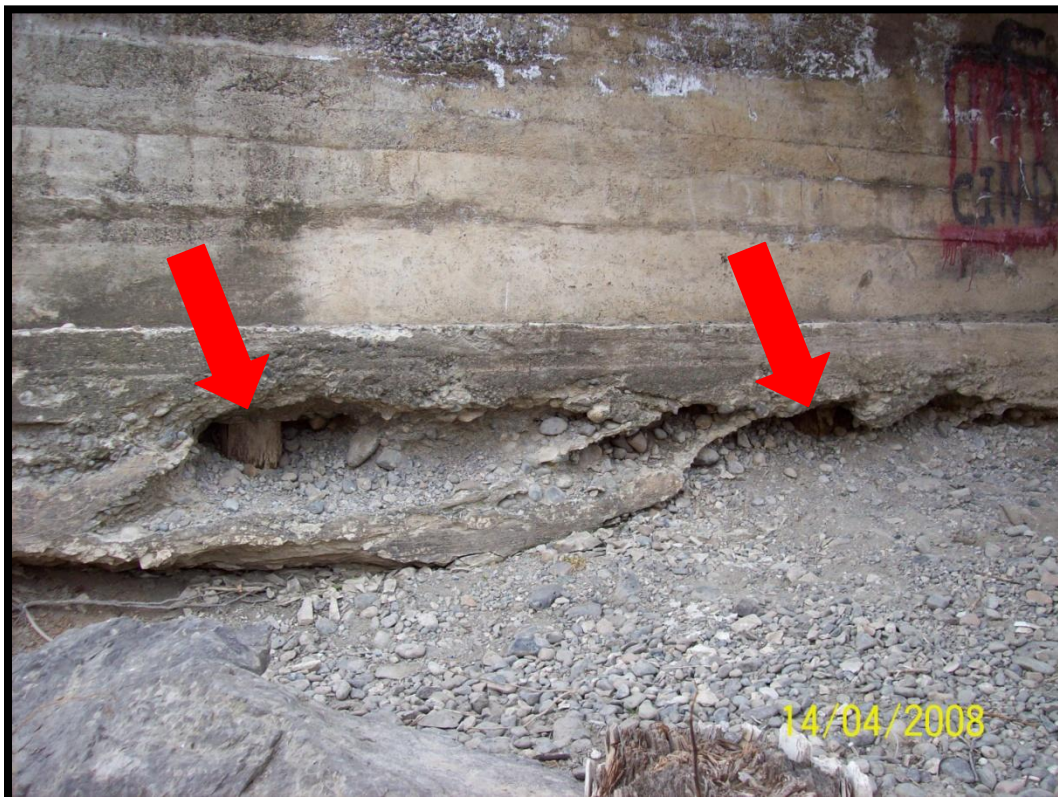
Photo #11. Underside Of Bridge.

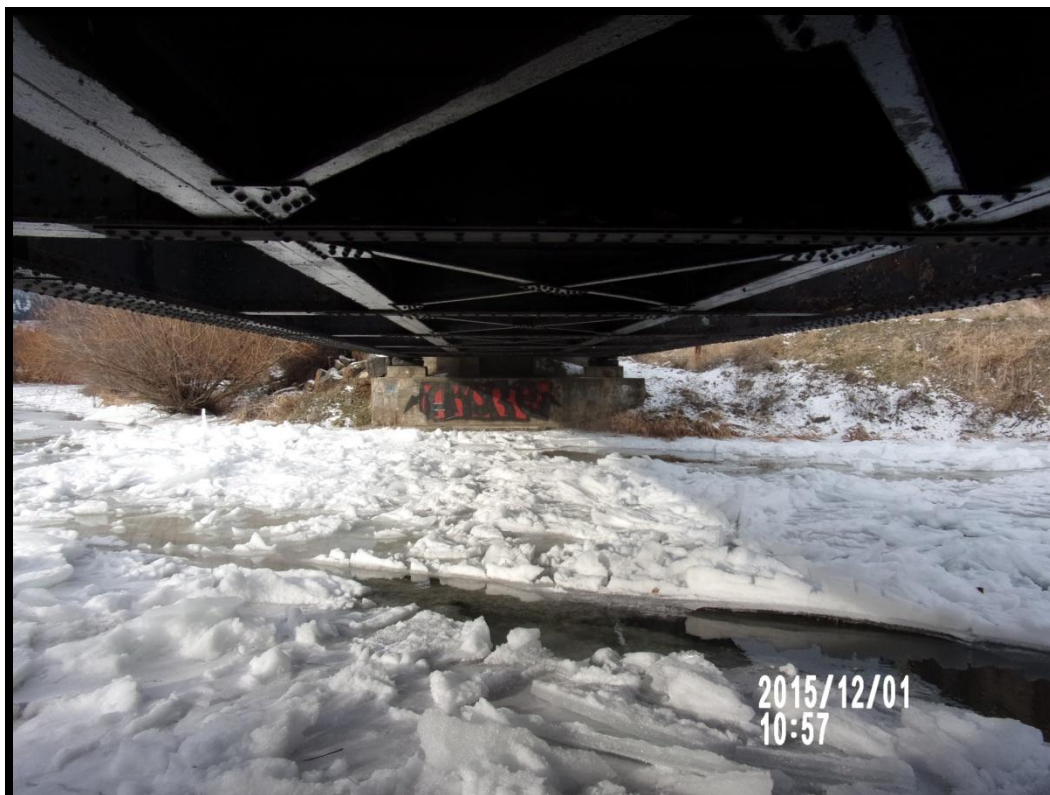
Photo #12. Upstream Plate Girder. Note: Peeling Paint.

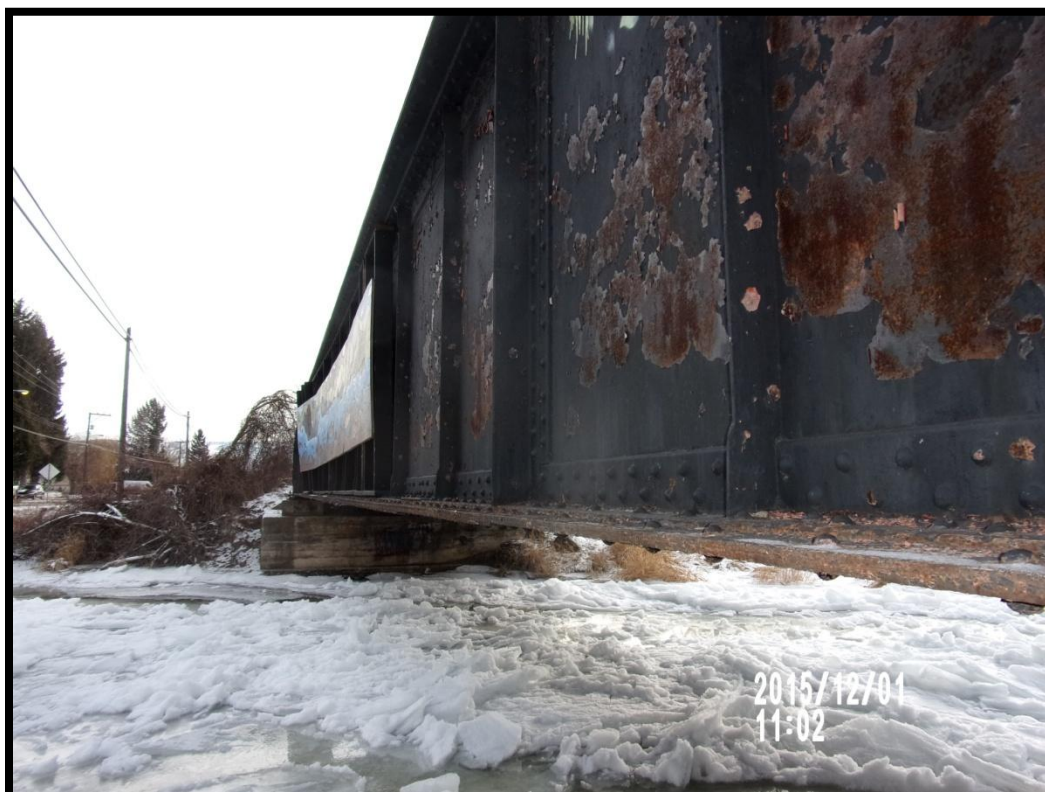
Photo #13. View Upstream.

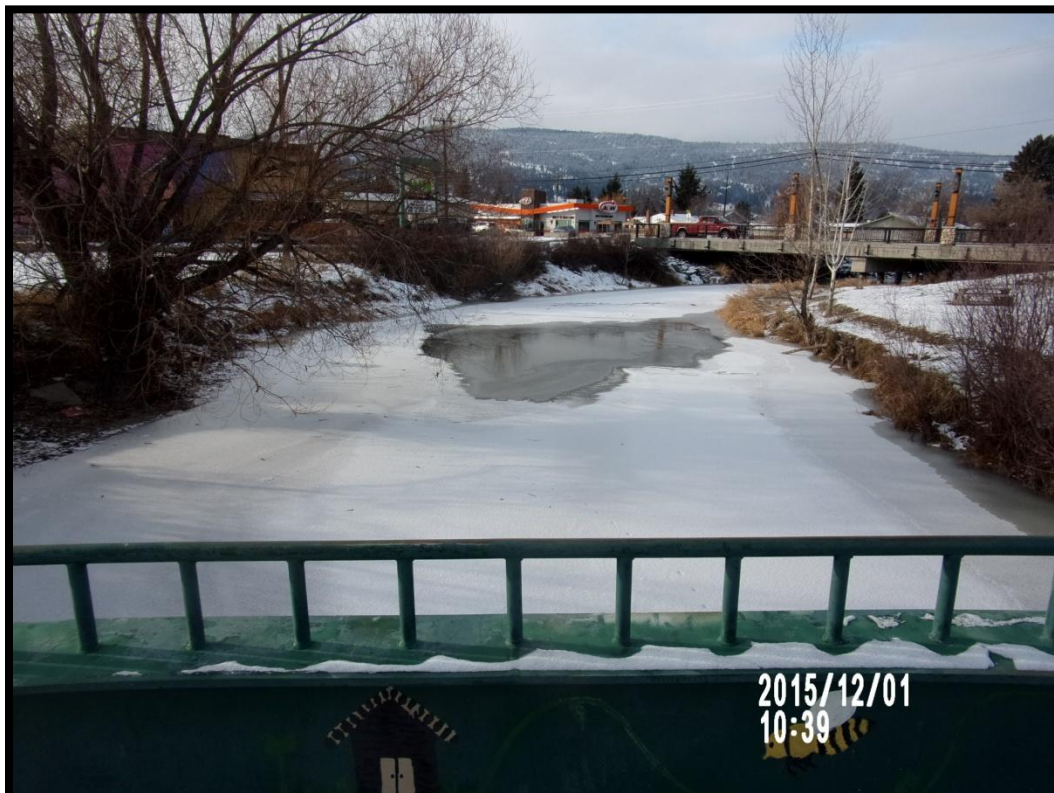
Photo #06. View Downstream.
