## **CITY OF MERRITT**

### **2015 MERRITT BRIDGE INSPECTION REPORT**

**Issued: December 15, 2015**

**WATSON ENGINEERING LTD.**

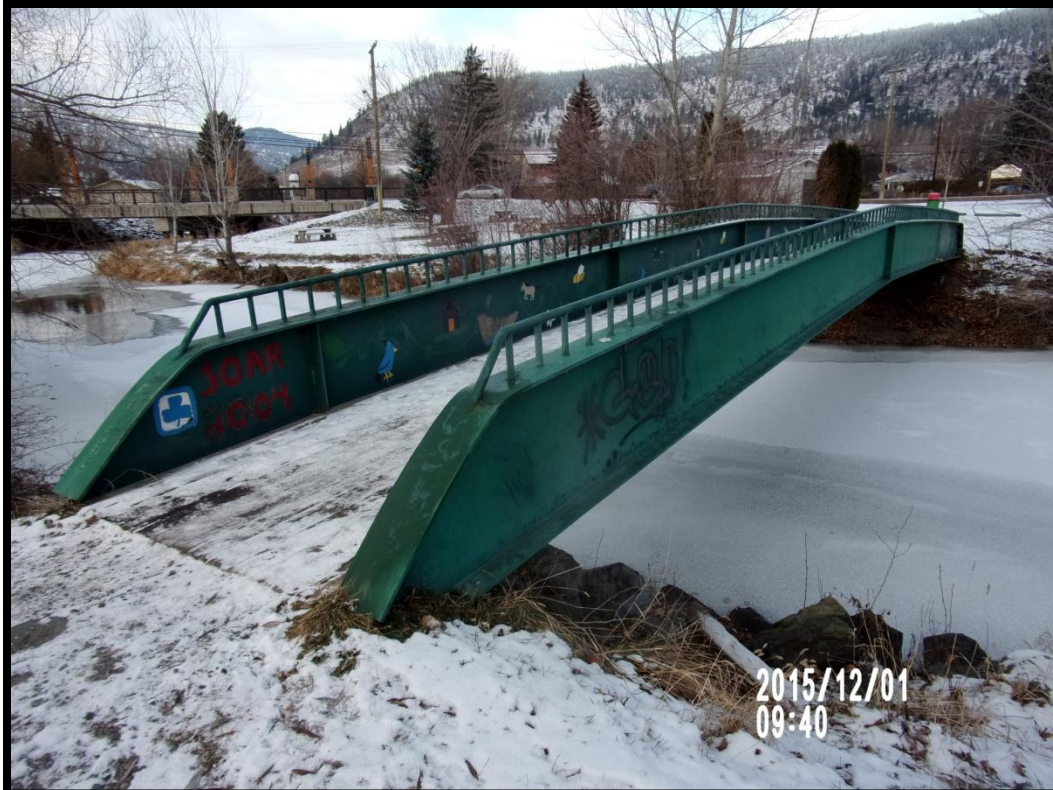
Photo #07. Bridge And Hand Railing.

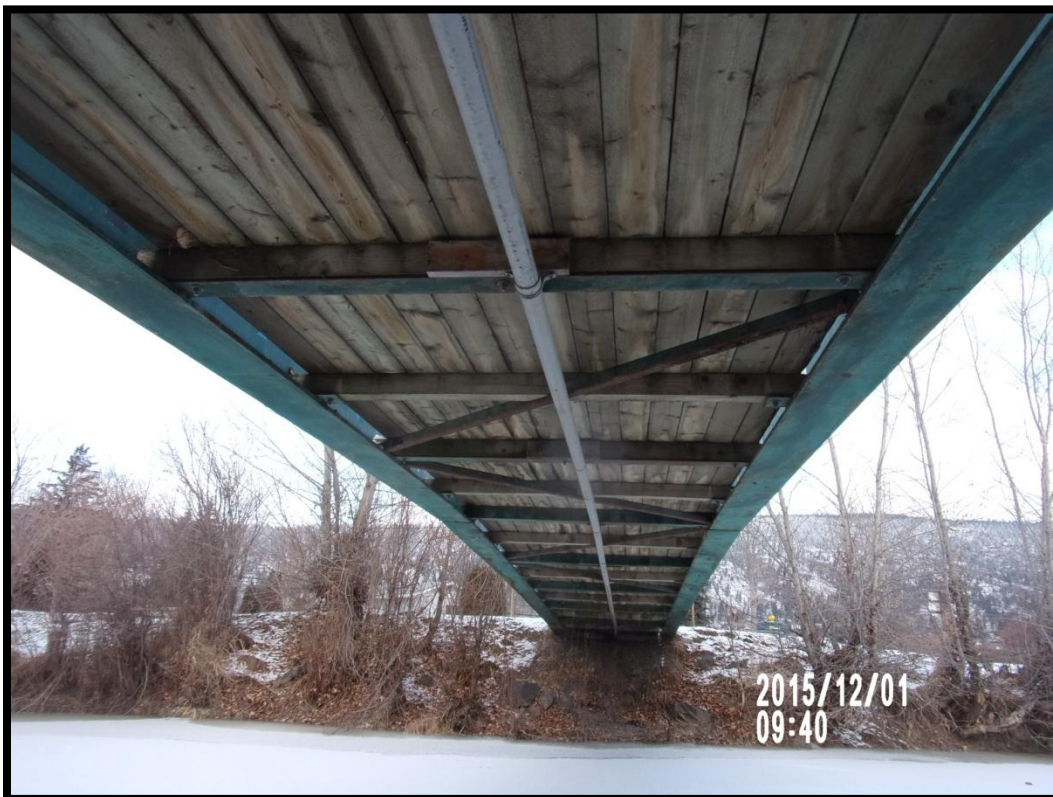
Photo #08 Underside Of Deck And South Abutment.

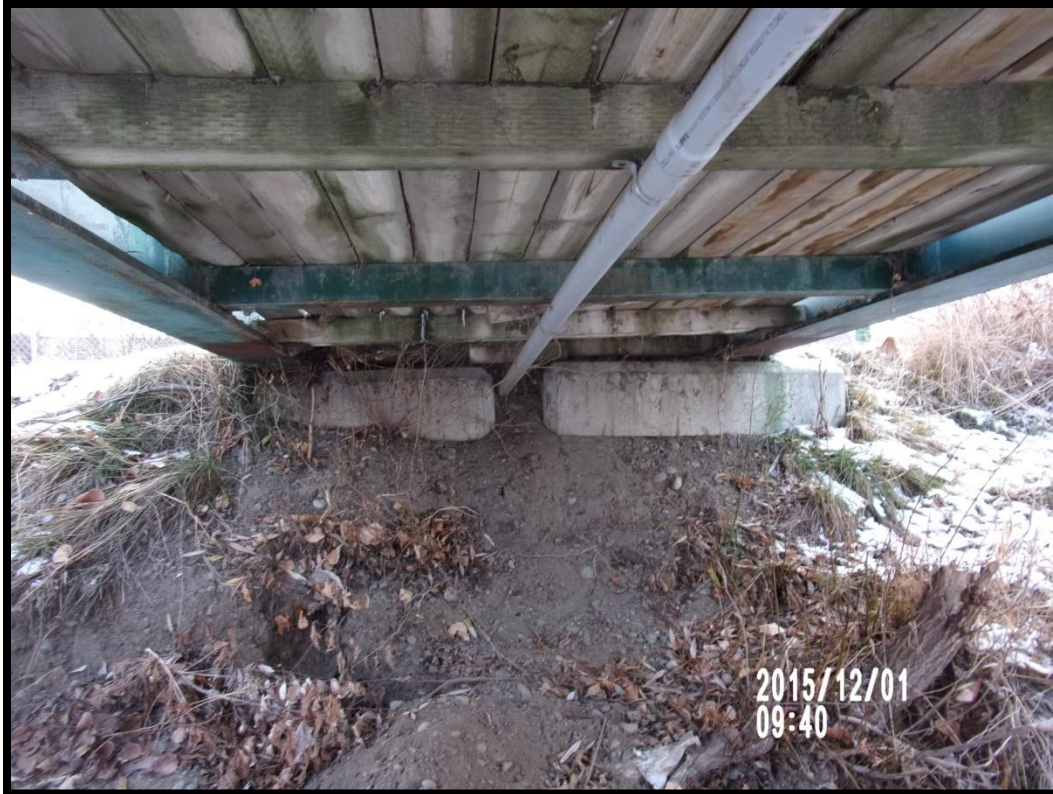
Photo #09 South Abutment. Note Minimal Slope Protection.

This structure is in good condition, however will soon require a new 2 x 6 timber plank deck due to loose planks and deteriorating deck screws and will require minor maintenance to prevent corrosion and have smaller rip rap placed at the west abutment to prevent erosion of existing materials.

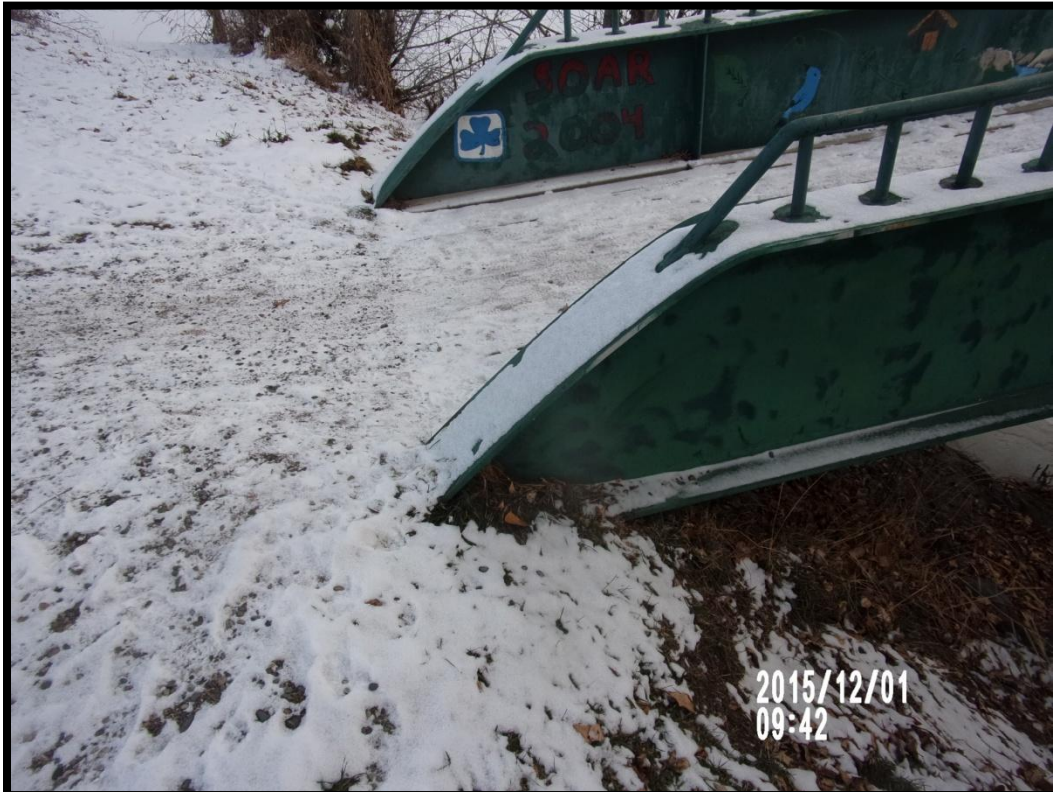
Photo #14 North Abutment. Note: Steel Girder Buried.

Item	Approved		Completed		Description	Comments
	Initial	Date	Initial	Date		
1					Failed Coating On Steel Girders And Handrails.	Clean And Paint Steel Surfaces To Maintain Corrosion Resistance When Required.
2					Steel Floor Beam Angles Are Corroding	Clean And Paint Steel Surfaces To Maintain Corrosion Resistance When Required.
2					Erosion At Abutments.	Replace Gravel Materials At West Abutment And Armour With Rip Rap.
3					One Deck Plank Found Loose And Most Deck Screws Deteriorated.	Repair Loose Plank And/Or Consider Replacing 2 X 6 Plank Decking.
4					Ends Of Bridge Girders Buried In Soil Material.	Remove Soil Materials To Prevent Corrosion Of Bridge Girder Ends.
